SAFETY EVALUATION BY THE OFFICE OF NUCLEAR REACTOR REGULATION
RELATIVE TO INSPECTION AND REPAIRS OF THE REACTOR
COOLANT SYSTEM PIPING

PILGRIM NUCLEAR POWER STATION
BOSTON EDISON COMPANY
DOCKET NO. 50-293

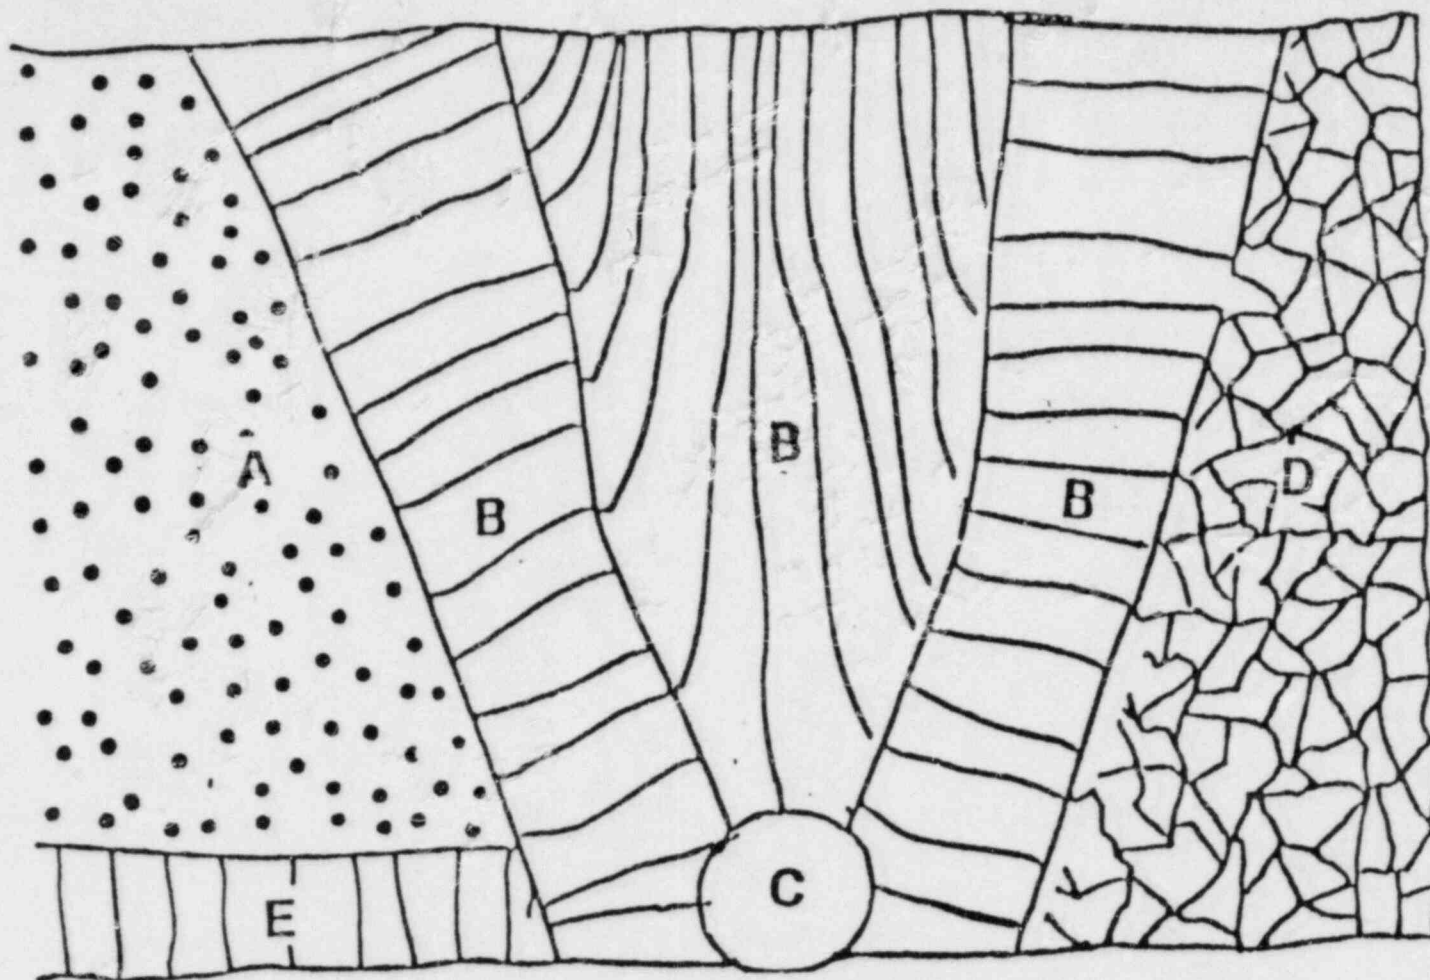
FIGURE 1 Complex Metallurgical Condition of
Safe End to Nozzle Attachment

- (4) The field weld root between the 182 weld surfaced steel nozzle and the Inconel 182 weld surfaced solution annealed 304 stainless steel safe-end was made using the gas tungsten arc process with Inconel 82 weld metal. The gas tungsten arc process is used to weld the root of pipe joints because its ease of control produces higher quality in the difficult weld roots of these joints.
- (5) The rest of the weld was made using the shielded metal arc process with Inconel 182 weld metal (See Figure 1).

The Inconel 182 had crack indications in one of two outlet nozzles and in three of the ten inlet nozzles. These indications were confirmed to be cracks by subsequent metallographic examinations and were further characterized as interdendritic stress corrosion cracks.

The cracks in the inlet nozzle's Inconel 182 weld butter were found to be a maximum of 70% of the wall thickness in depth. The cracks were confined to the Inconel 182 weld butter except for slight crack extensions into the stainless steel safe-end HAZ in a few instances. No cracking was found in the low alloy steel nozzle base material or in the Inconel 82 weld root pass of the field weld. The Inconel 182 weld metal deposit was found to have cracks in both the low alloy nozzle steel and the 304 stainless steel safe-end sides of the joint.

The outlet nozzle Inconel 182 weld surfacing was removed by machining. The nozzle end was resurfaced with Inconel 82 applied by an automatic gas tungsten arc welding process. Local post-weld heat treatment of the nozzle end was then performed.

The new 316 nuclear grade stainless steel safe-ends which were to be welded to the nozzles were weld buttered with Inconel 82. The safe-ends were then welded to their respective nozzles with Inconel 82 weld metal using an automatic gas tungsten arc welding process. All weld procedures were qualified in accordance with Section IX of the Code.
