Florida Power

CORPORATION
Crystal River Unit 3
Doclet No. 90-302

Subject: Licensee Event Report (LER) 96-001-01

FACILITY NAME (1)										DOCKET NUMBER (2)										PAGE (3)												
CRYSTAL RIVER UNIT 3 (CR-3)										0 5 0 0 0 3 0 2										1 OF 0 8												
TITLE (4)																																
Personnel Error by Contractor Results in Operation Outside 10CFR50 Appendix R Design Basis																																
EVENT DATE (5)			LER NUMBER (6)				REPORT DATE (7)			OTHER FACILITIES INVOLVED (8)																						
MONTH	DAY	YEAR	YEAR	SEQUENTIAL NUMBER	REVISION NUMBER	MONTH	DAY	YEAR	FACILITY NAMES						DOCKET NUMBER(S)																	
									N/A						0 5 0 0 0																	
0	1	1	0	9	6	9	6	---	0	0	1	---	0	1	0	3	0	8	9	6	N/A						0 5 0 0 0					
OPERATING MODE (9)		3		THIS REPORT IS SUBMITTED PURSUANT TO THE REQUIREMENTS OF 10 CFR §: (CHECK ONE OR MORE OF THE FOLLOWING) (11)																												
POWER LEVEL (10)		0		0		20.402(b)		20.405(c)		50.73(a)(2)(iv)						73.71(b)

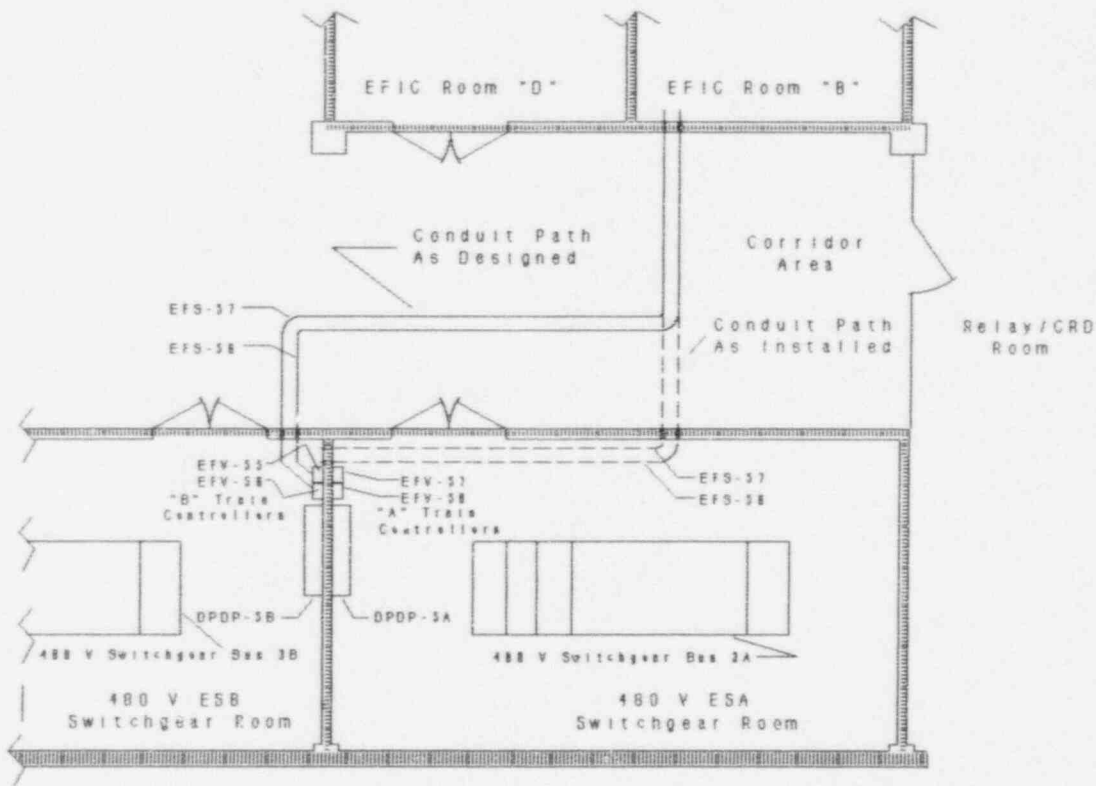
FIGURE 1

On January 10, 1996, Florida Power Corporation's (FPC) Crystal River Unit 3 (CR-3) was in MODE THREE (HOT STANDBY). The plant was in the process of shutting down due to a forced outage associated with an earlier saltwater intrusion through a condenser tube leak. During a walkdown by personnel involved in developing a modification for upgrading CR-3's Thermo-Lag fire barriers, it was noted that conduits EFS56 and EFS57, which contain "B" Train circuits for Emergency Feedwater System [BA] (EFW) components, were routed through the "A" 480-Volt Engineered Safeguards (ES) Switchgear Room. The portion of the "B" Train conduits in the "A" Switchgear Room are not protected by fire barriers and are within 20 feet of redundant "A" train circuits. See Figure 1.

Conduits EFS56 and EFS57 contain circuits which provide flow control signals and motive power to controllers [BA,FC] for the "B" train Emergency Feedwater Flow Control Valves [BA,FCV]. The redundant "A" train circuits are associated with controllers for "A" train Emergency Feedwater Flow Control Valves. A Problem Report was generated to identify a noncompliance with 10CFR50 Appendix R, Section III.G.2.b separation criteria in that circuits and components for both trains of Emergency Feedwater are located in the same fire area and both trains of Emergency Feedwater are subject to loss of flow control if a fire occurred. The Problem Report was initially considered not to be reportable on the basis that the conduit was in the confirmed route of the continuous roving fire watch established in response to NRC Bulletin 92-01 "Failure of Thermo-lag 330 Fire Barrier System to Perform its Specified Fire Endurance Function".

The primary cause of this event was cognitive personnel error by contractor engineering personnel. Conduits EFS56 and EFS57 were installed in 1985 during Refuel 5 as part of a field change to modification 88-10-66-08A "EFIC Electrical Conduit and Cable Installation". The field change was a multi-discipline (electrical and structural) change initiated by the electrical discipline for the purpose of addressing Appendix R. After the electrical design was completed, structural engineering completed the balance of the design for the conduit installation and approved the change notice. The structural design engineer selected a different route for conduit supports from that depicted on layout sketches provided by electrical engineering. It is surmised that this route was selected to take advantage of existing conduit supports and/or due to interferences present in the route selected by electrical engineering. The structural engineer was apparently not aware of the impact this change had on Appendix R criteria. Further, design verification of the field change did not include a final review by electrical engineering.

1. Drawings which indicate the routing of Conduits EFS56 and EFS57 have been revised to depict the correct routing.
2. FPC will conduct a validation of Appendix R drawings using a sample-based approach to compare the as-built configuration against the configuration confirmed by field walkdown. The sample will be both horizontal and vertical. The horizontal sample will consist of validating the location of all fire barrier protected raceways for a selected plant system. The vertical sample will consist of validating the location of all fire barrier protected raceways for a selected fire area. It is expected that field validation will be completed by the end of 1996 consistent with other actions noted in Item 3, below. Depending on the results of the initial validation, a decision will be made to proceed with additional validation.

3. Circuits contained in Conduits EFS56 and EFS57 will be brought back into compliance with 10CFR50 Appendix R. This may include wrapping with Mecatiss per the commitment described in FPC letter 3F1295-05 to NRC dated December 21, 1995. Consistent with commitments in the letter for Mecatiss wrapping, compliance with Appendix R will be achieved by the end of 1996.
