Incident Investigation Team Report

96-002

"Plant Shutdown Due To Circulating Water and Essential Service Water Intake Icing"

Wolf Creek Nuclear Operating Corporation

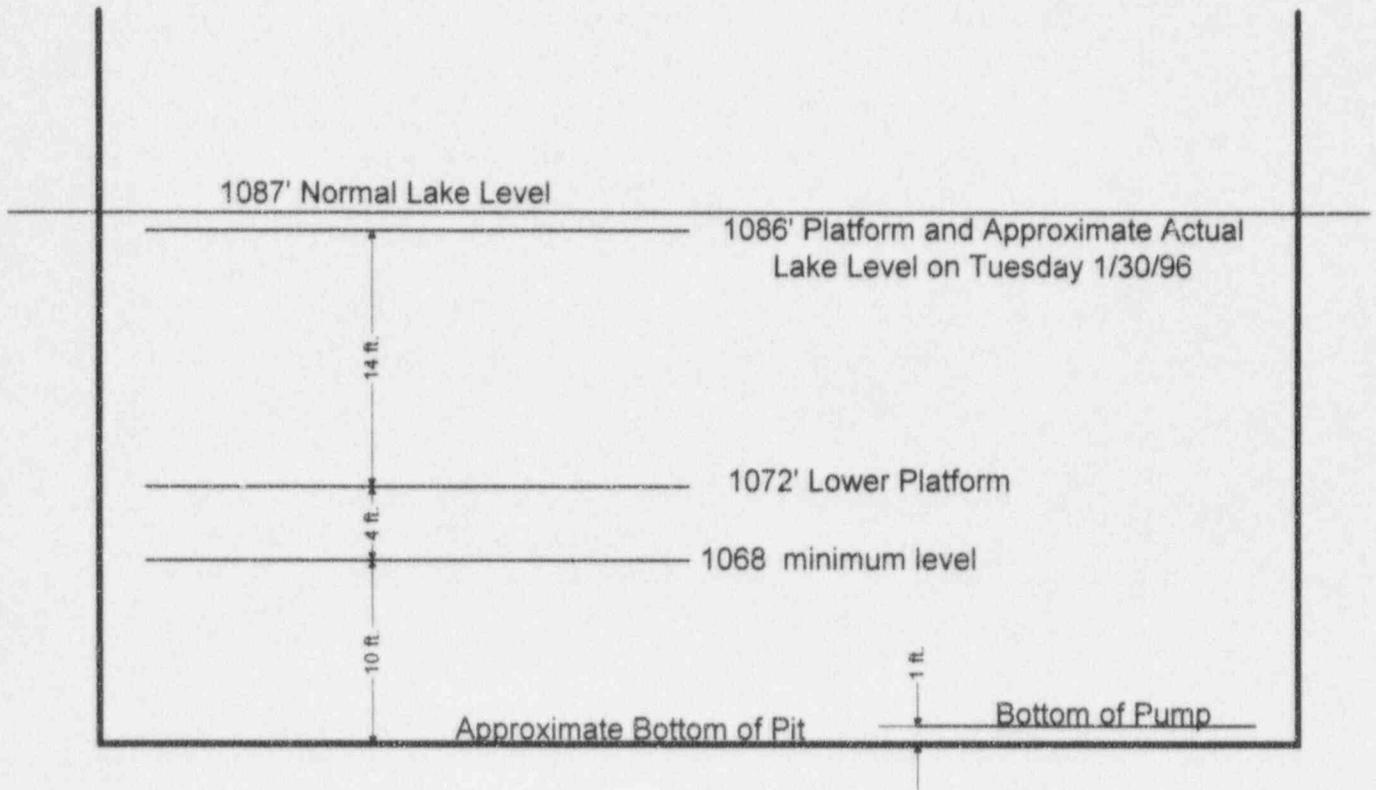
ESW Inlet Bay Elevations

"B" CCW dwarfs other ESW loads present on "B" Train ESW on Tuesday, January 30, 1996. A plot of "B" CCW Heat Exchanger Δ -temperature is attached. It remained steady throughout the day until late afternoon when it decreased slightly. From site operator and control room logs additional RHR load was put on "B" CCW by Operators in an attempt to reverse falling "B" ESW suction fore bay levels at about 2015 hours.
