WOLF CREEK

Subject: Docket No. 50-482: Licensee Event Report 96-001-00

WOLF CREEK GENERATING STATION

Loss of Circulating Water Due to Icing on Traveling Screens Causes Reactor Trip

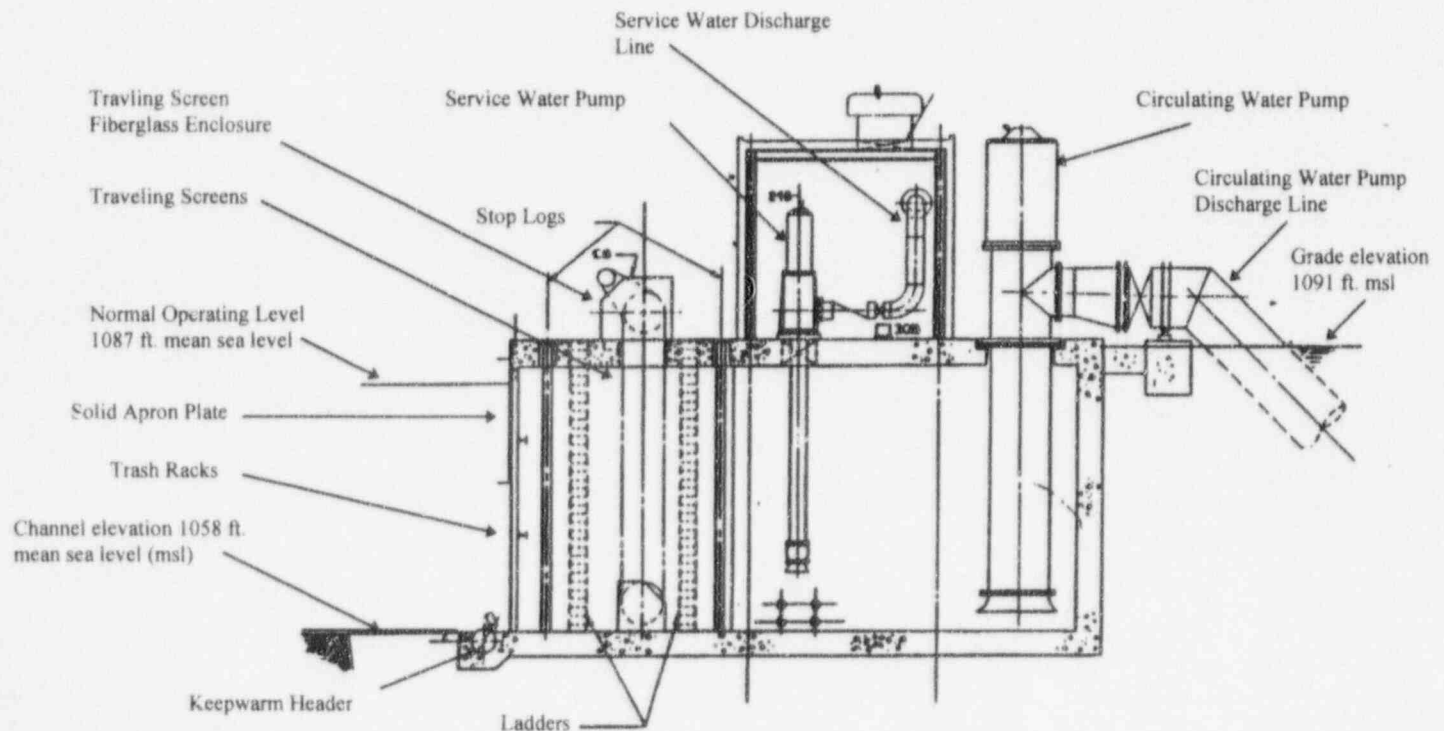
FIGURE 1

The CWSH has three suction bays which are physically separated by concrete walls. There are four 12" pipe sleeves which penetrate the walls that divide the A and B suction bays and the B and C suction bays. The level fluctuations in one bay are noticed to some degree in the others. (Refer to Figure One on Page 13)

Circulating Water System Diagram
