BRUNSWICK STEAM ELECTRIC PLANT
TECHNICAL SUPPORT MEMORANDUM

TSM 91-0856
File No. 5095

PROGRAM or COMPONENT ID: Diesel Generator #3

SUBJECT: Long Term Operability of EDG #3

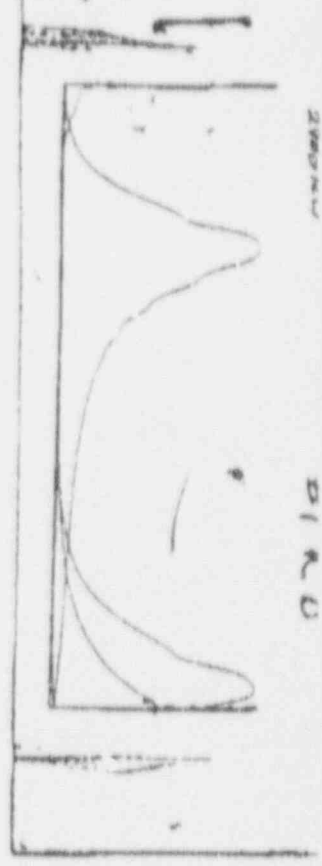
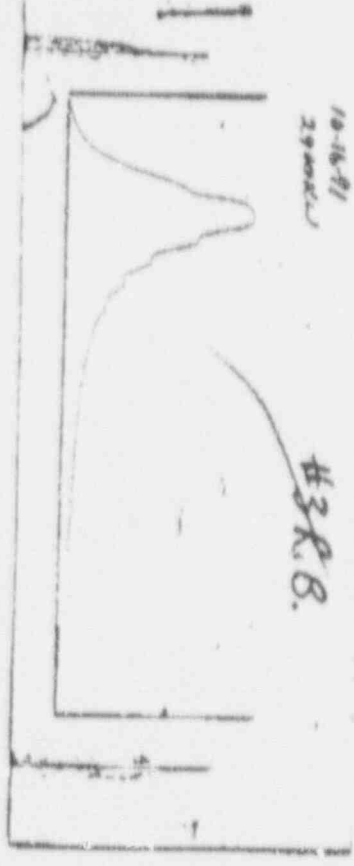
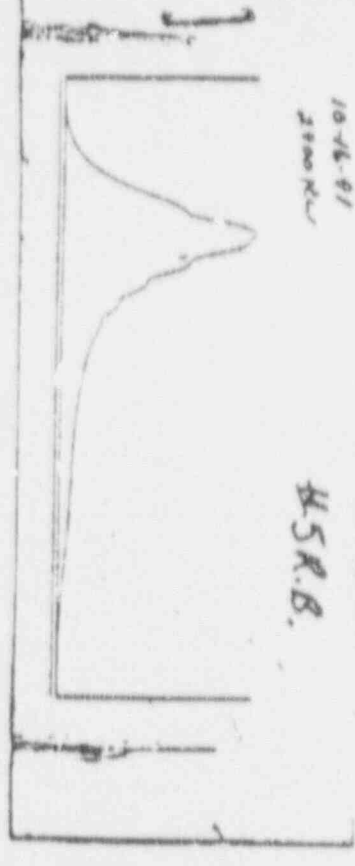
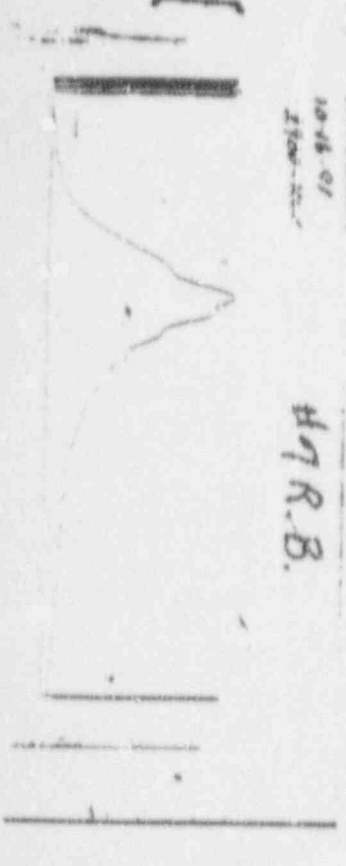
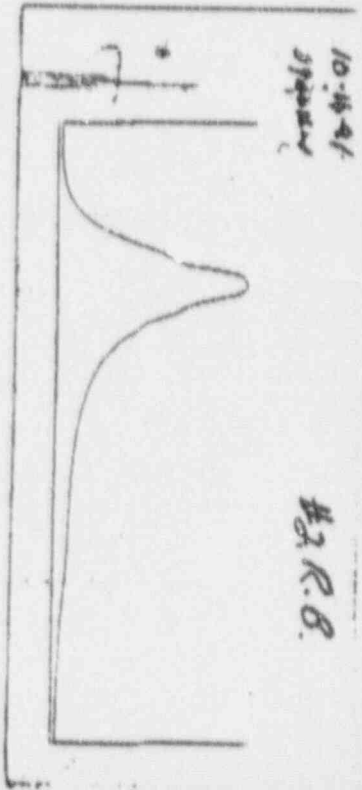
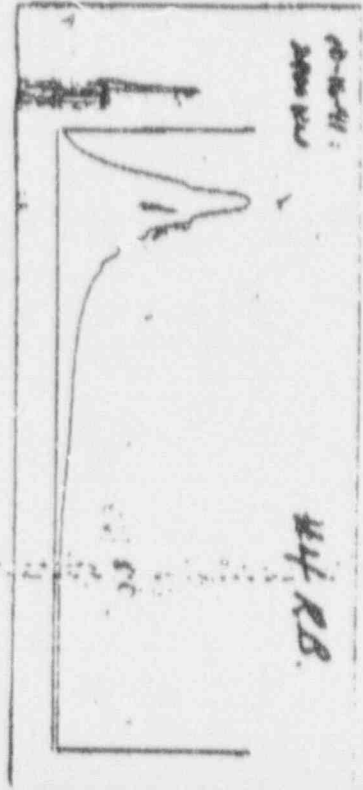
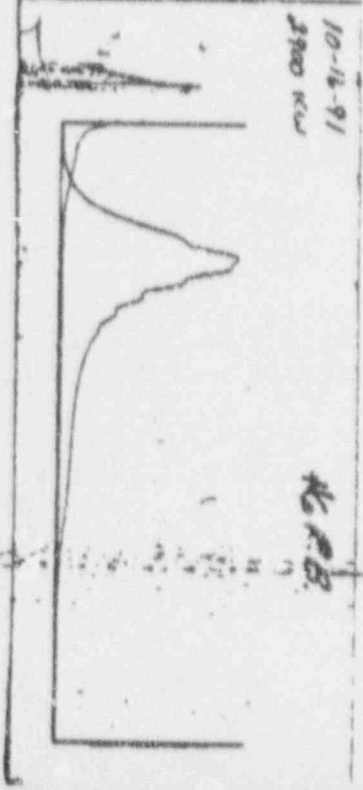
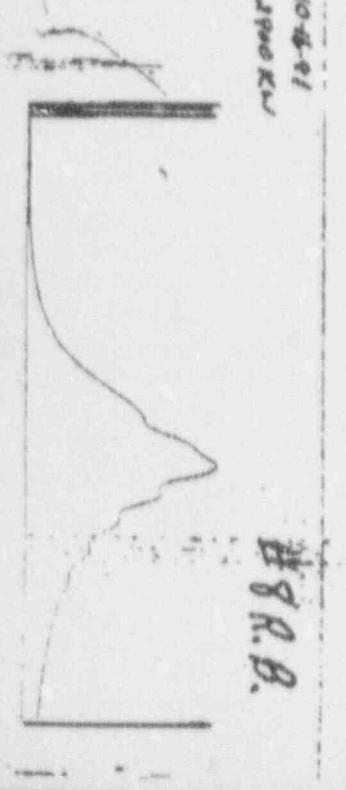
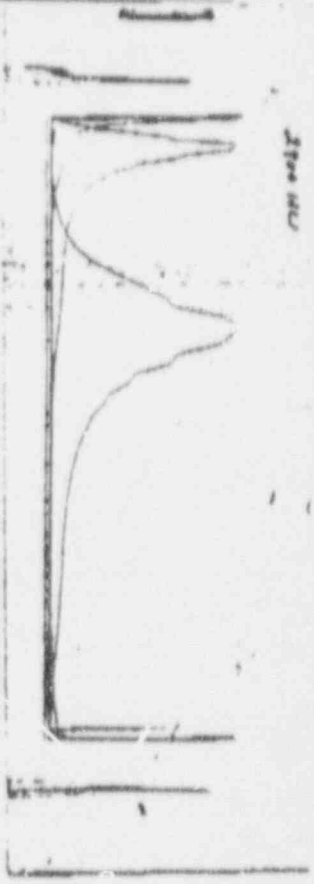
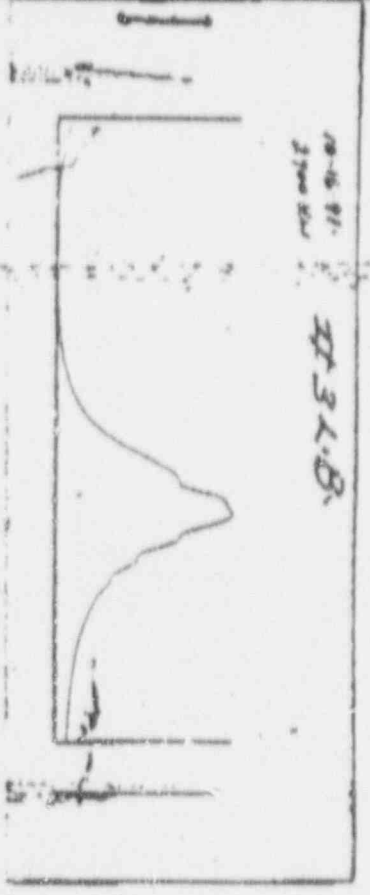
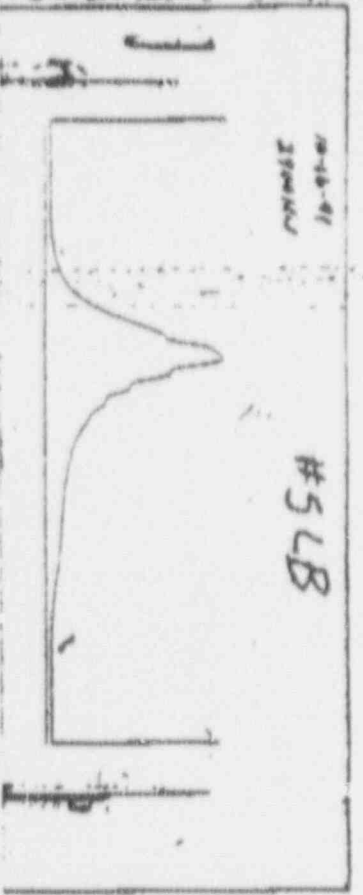
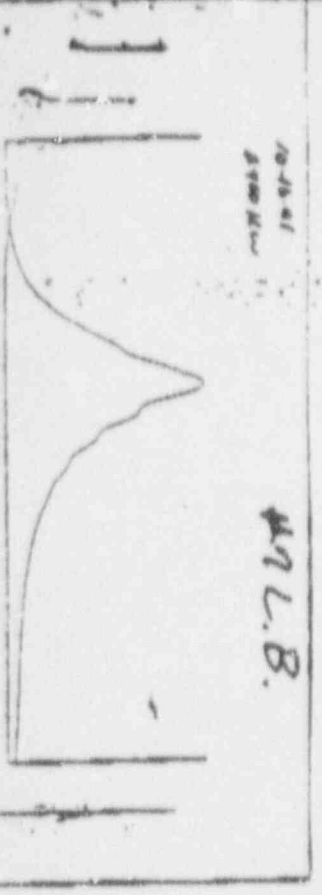
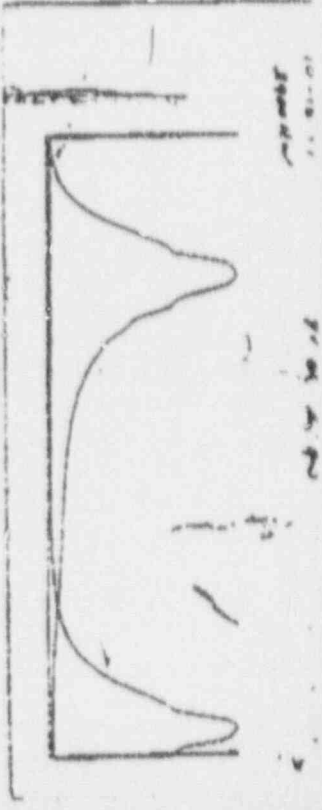
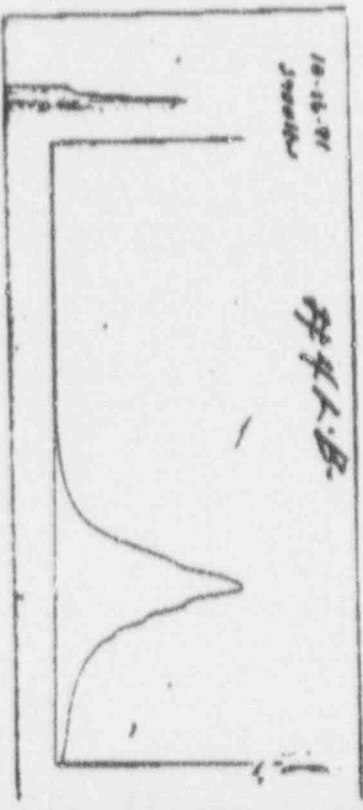
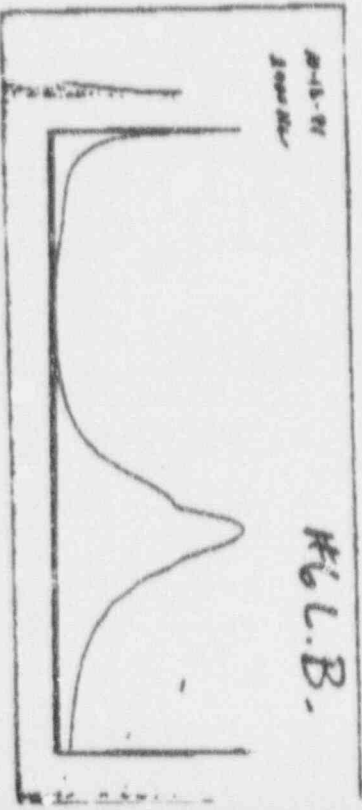
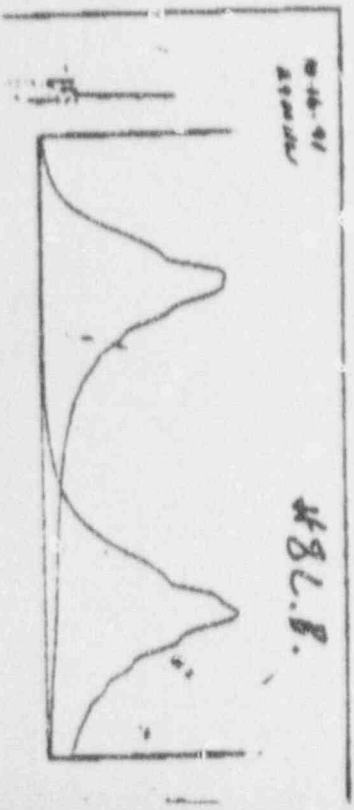
Attachment 1

1) No. The material of construction of intake and exhaust valves are identical except that the exhaust valves are stellite faced. Pull cards were taken on the PMTR run on 10/16/91. The pull cards measure both the compression and ignition pressures of the cylinders during actual running conditions. The compression pressures were approximately 775 psi and were within 40 psi of each other. These values were within the normal range and in close agreement with the last set of pull card readings. This indicates good cylinder compression, and therefore, no valve or valve seat damage. Additionally, besides no degradation of the valves, this analysis shows that the engine is performing well. (Reference Attachment 1)
