Re: Nine Mile Point Unit 2
Docket No. 50-410

This letter provides our response to Nuclear Regulatory Commission I.E. Bulletin 84-03. This bulletin concerns the failure of a refueling cavity water seal at the Haddam Neck plant.

NMP2 REFUELING CAVITY WATER SEAL

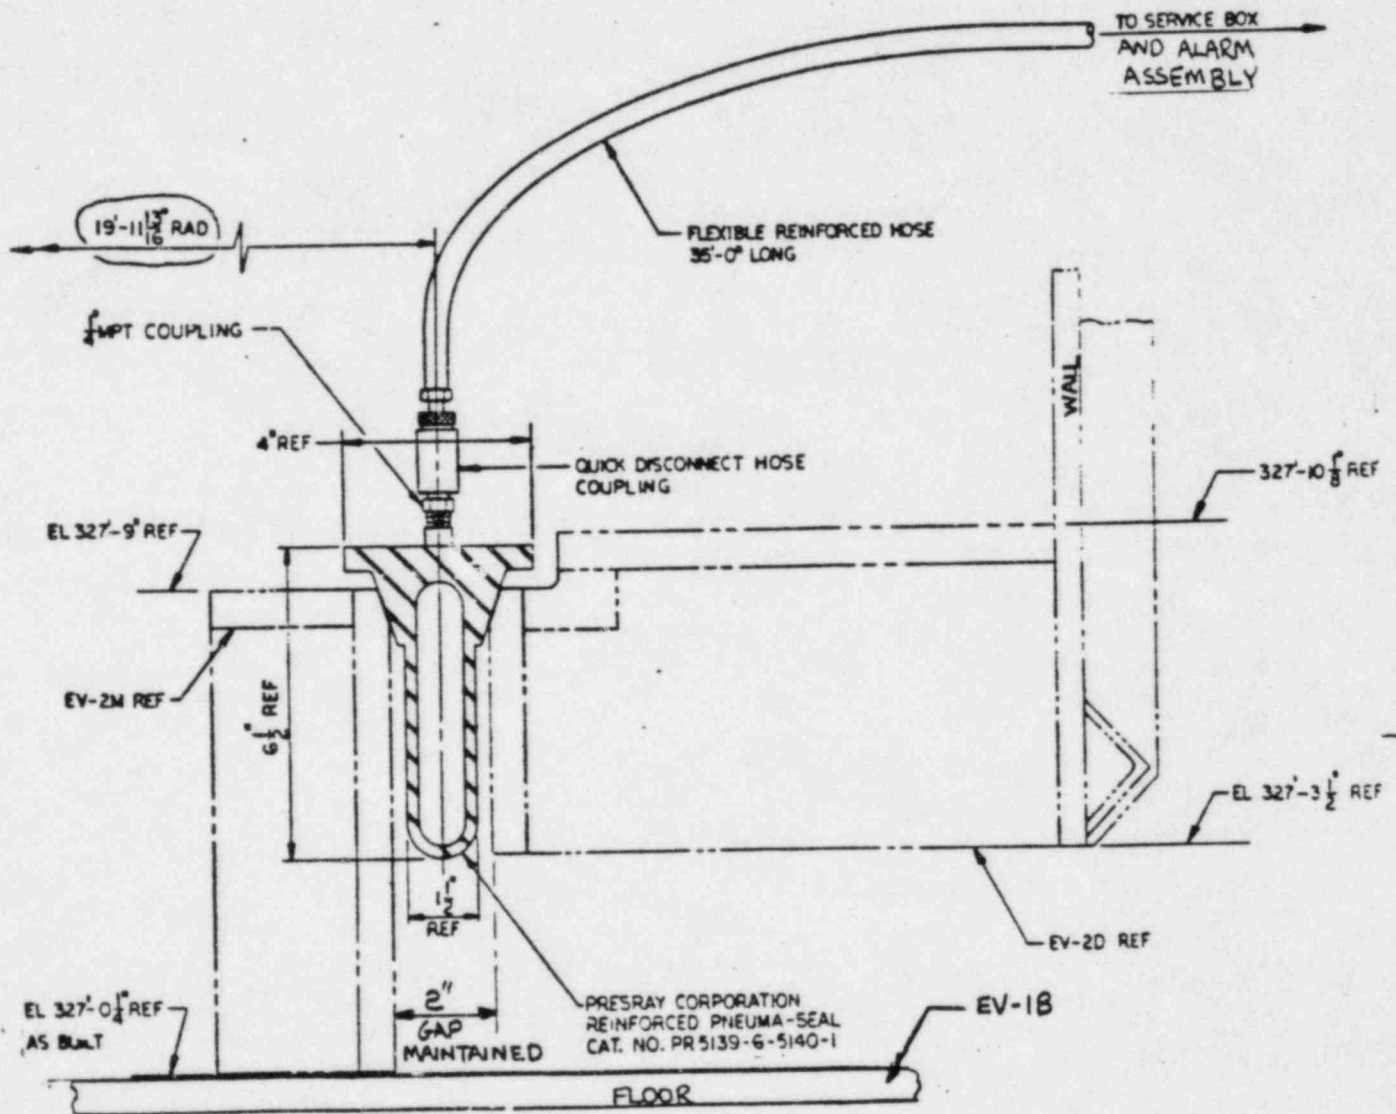
The possibility of an outer refueling seal failure occurring at Nine Mile Point Unit 2 is not considered credible. Nine Mile Point Unit 2's design, installation and machining techniques of the seal support plates differ from Haddam Neck's refueling cavity water seal (see attached sketch). Therefore, detailed evaluation of the consequences of seal failure is not necessary. The Nine Mile Point Unit 2 design maintains an annular width of 2 inches between the two support plates to within $\pm 1/4$ inch. These support plates are integrally attached to either the reactor head cavity pit wall or floor, thus ensuring that the desired width is maintained. The Haddam Neck refueling cavity water seal did not maintain adequate "interference between the width of the seal annulus and the width of the opening, which allowed the seal to be significantly displaced." At Nine Mile Point Unit 2, this interference is achieved by maintaining the width.

The top of the Nine Mile Point Unit 2 seal support plates are chamfered at an angle so to form a matching seat for the seal chamfer. This configuration forms a wedge between the support plates and the seal which, when subjected to water pressure, will wedge even tighter. In contrast, the Haddam Neck seal support plates were not chamfered, thus possibly causing the seal to have hinged and pivoted about the edge of the seal support plates. This pivot action may have induced unwanted movement in the inflatable seal.

As opposed to the Haddam Neck refueling cavity water seal design, the Nine Mile Point Unit 2 design has full contact between the seal and support plates, thus creating an increased contact area and interference between the seal and support plates. This increased contact area and interference mitigates the potential for the seal to be dislodged or pushed through as did the Haddam Neck seal.

As an added safety measure, alarm systems have been provided in the Nine Mile Point Unit 2 design to detect any pressure drop in the inflated seal as well as detect any water leakage past the seal.
