NUREG-0040
Vol. 19, No. 4

Licensee Contractor and Vendor Inspection Status Report

Quarterly Report
October - December 1995

U.S. Nuclear Regulatory Commission

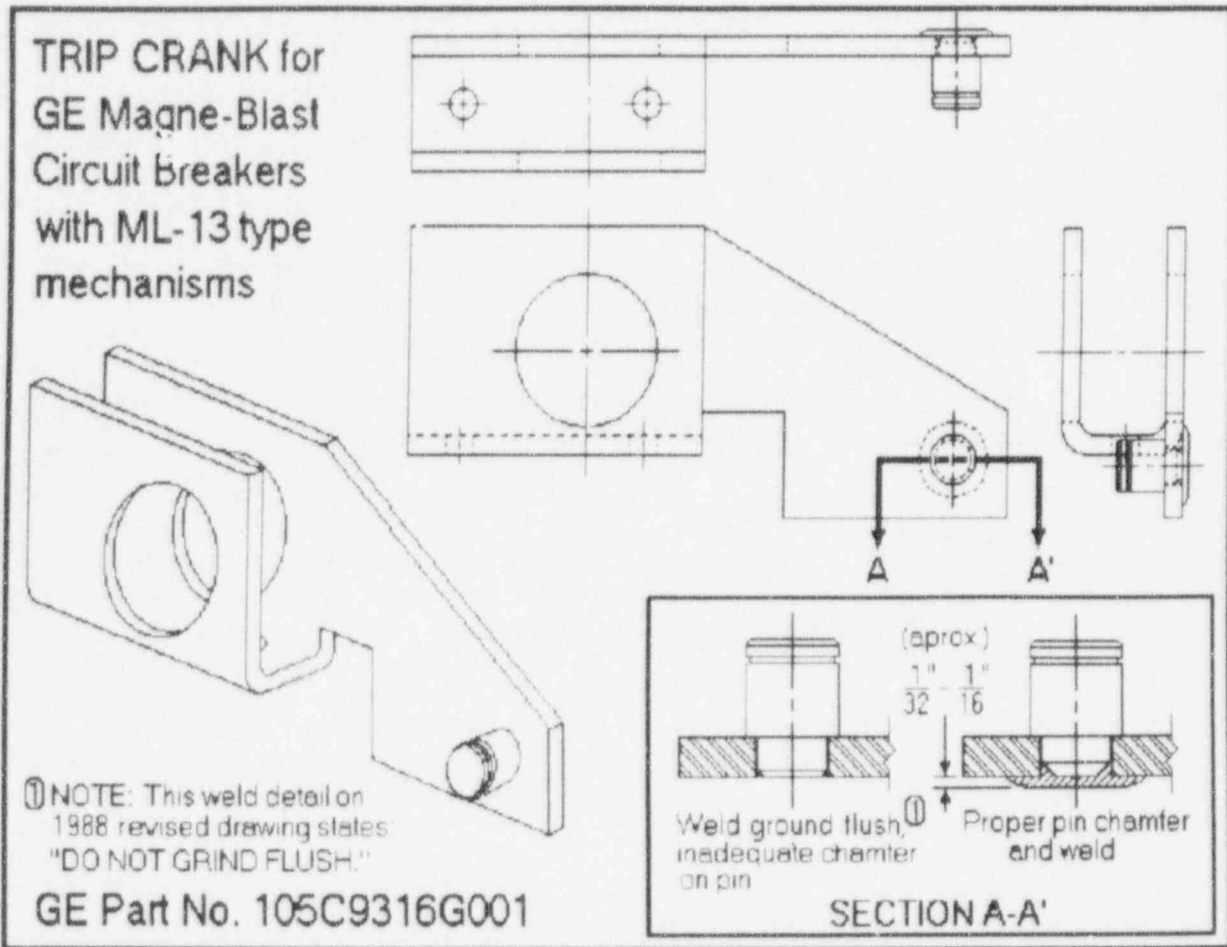
Magne Blast breaker trip cranks had failed on several occasions at the Tennessee Valley Authority's (TVA's) Watts Bar Nuclear Plant (WBN) and one additional failure had been reported at the Shoreham plant. The failure reports to the NRC pursuant to 10 CFR Part 21 were being tracked under NRC Part 21 Report Log No. 93-304. The trip crank is a piece part of the Magne-Blast ML-13 operating mechanism, GE Part Number 105C9316G001. The crank is a stamped, formed and drilled steel plate with a steel pin socket-welded into it (See Figure 1 of Appendix A to this report). The function of the trip crank is to convert the linear force of the trip coil armature or plunger to the torque needed to rotate the breaker trip shaft. Failure of the trip crank could prevent any electrical trip of the breaker. The known failure mode is fracture of the weld that fastens the trip coil armature link pin to the plate portion of the crank under shock loading shear reaction stress on the pin.

In response to the original failures, GE SRP changed the manufacturing process for the crank by requiring some reinforcement (on the weld fastening the pin to the plate) to be left on the back side of the plate and not be ground off. Now specified on the ML-13 drawing (SBP Drawing No. 0105C9316/DCN 083-88-003, May 18, 1988, View "A" weld detail for Group 001 Trip Crank) is: "1/32 TO 1/16 WELD TO REMAIN AFTER GRINDING FLAT SURFACE, DO NOT GRIND FLUSH." The inspectors examined a crank that was in stock at ASD, but tagged for use in non-safety-related applications only. The crank plate was bent at the end and the pin was cocked about 10 to 15 degrees. It appeared that this crank would very likely fail in service, albeit presumably in non-safety-related service, but fail nonetheless.

During the tour of the ASD nuclear work area, the inspectors noted that the ML-13 mechanisms of two AM-4.16 breakers undergoing initial inspection and disassembly had trip cranks that were susceptible to failure with their weld reinforcements ground off and the transition or interface between the pin and the plate clearly visible. The inspector noted that the technician performing the inspection and teardown had not documented this condition in the inspection record, but PDS stated that the technicians were aware of the problem and that in this case, the technician had not come to that portion of his inspection yet. PDS confirmed subsequent to the inspection that the trip cranks in question had been replaced and the customer notified with recommendations for inspection of other breakers.

A. Trip Crank for GE Magne-Blast Circuit Breakers

To ensure that faulty trip cranks are not used in safety-related breakers, PDS is now relying on the 1988 design change and its dedication process to screen out improperly fabricated cranks, as evidenced by, for example, the fact that the unsatisfactory crank found by the inspector had been rejected for nuclear use. Although the amount of chamfer on the small end of the pin that is inserted into the plate and the penetration depth allowed by the depth to which the shoulder is machined into the pin both significantly affect the amount of pin surface area in contact with the weld filler material, these attributes are not specified to be checked during manufacture, as they cannot be seen afterward. The dedication at the time of this inspection relied solely on a 100-lbf static load test and the presence of 1/32 to 1/16 inch of pin weld reinforcement on the back side of the plate. With respect to faulty cranks in the field, SBP is considering issuing a SAL on this problem and in the mean time PDS has put out instructions to the service shops to inspect the cranks as breakers come through for service and replace the cranks as necessary. The inspectors concluded that the vendor's action thus far was satisfactory in resolving this issue, but that it would be complete only with the issuance of a SAL.
