U.S. NUCLEAR REGULATORY COMMISSION
REGION IV

NRC Inspection Report: 50-445/92-20 Unit 1 Operating License: NPF-87
50-446/92-20 Unit 2 Construction Permit: CPPR-127
Expiration Date: August 1, 1992

Facility Name: Comanche Peak Steam Electric Station, Units 1 and 2

Areas Inspected: Special, announced inspection of the circumstances surrounding the loss of spent fuel pool cooling on May 12, 1992. The special inspection team reviewed the following areas:

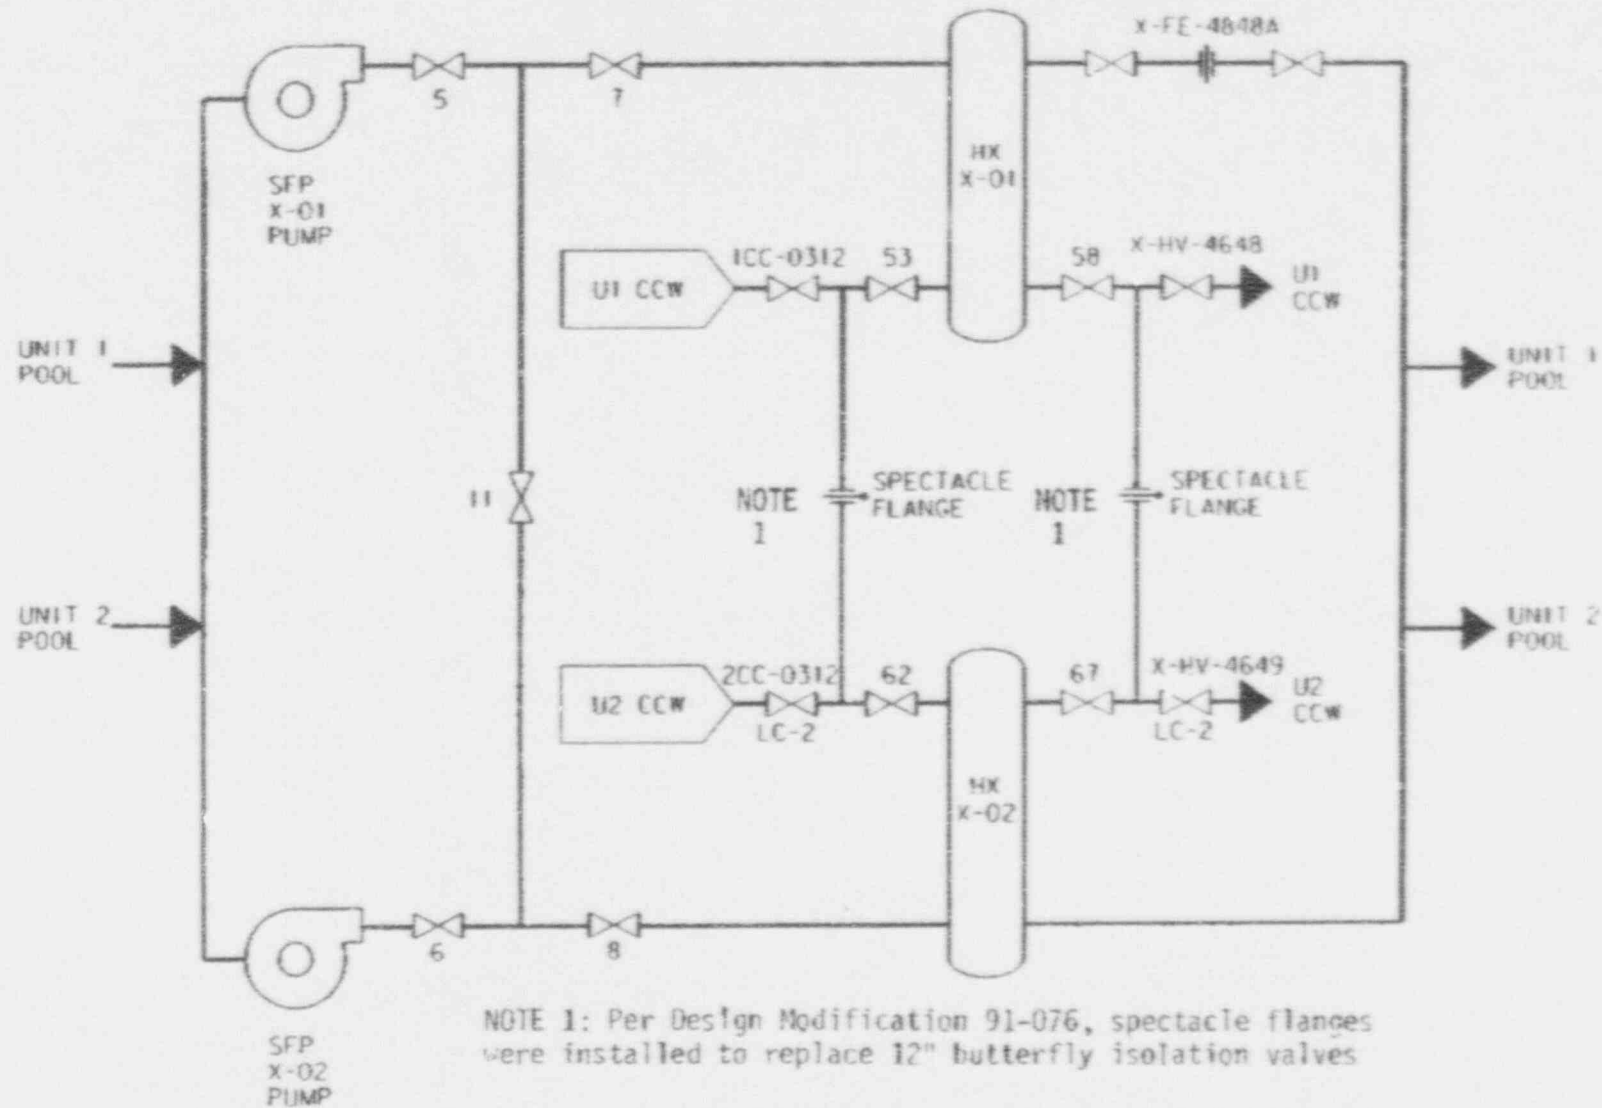
"ATTACHMENT 2"

The chronology of the event as given below is excerpted from a licensee evaluation report designated FX-92-417. Through review of operations logs, personnel interviews and plant tours, the team verified the chronology developed by the licensee's investigation team and considers that it accurately depicts the sequence of events as they occurred on May 11, and May 12, 1992. A schematic representation of the system arrangement is provided as Attachment 2 to this report.
