LICENSEE EVENT REPORT (LER)

FACILITY NAME (1) Fort St. Vrain, Unit No. 1	DOCKET NUMBER (2) 0 5 0 0 0 2 1 6 7	PAGE (3) 1 OF 017
---	--	----------------------

TITLE (4)
During SR 5.1.2c-X, Only 1/2 Of Total RSD Material Was Discharged From CRD#21

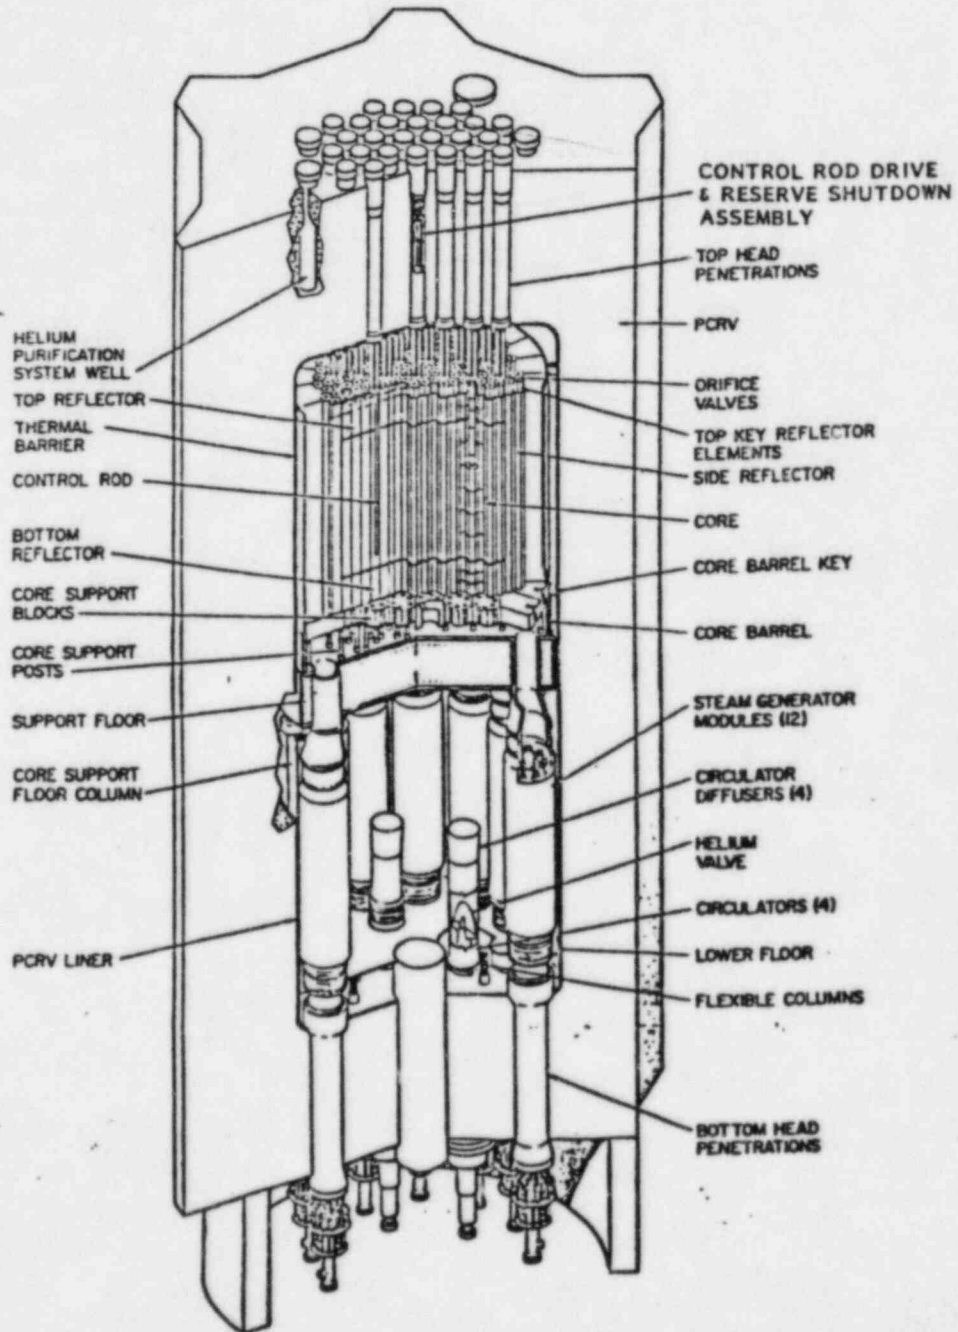
Figure 1. Reactor Arrangement

A steel guide tube extends from the underside of the hopper to the top control reflector block of the associated core region. The guide tube engages the top reflector block, forming a clear passageway for the reserve shutdown material to fall from the hopper, through the guide tube, and into the core (see Figures 1 and 2).
