REVIEW AND DISCUSSION OF VERTICAL FRACTURES REPORTED AT WV SITE:  
working draft

Raymond C. Vaughan  
Coalition on West Valley Nuclear Wastes

May 31, 1992

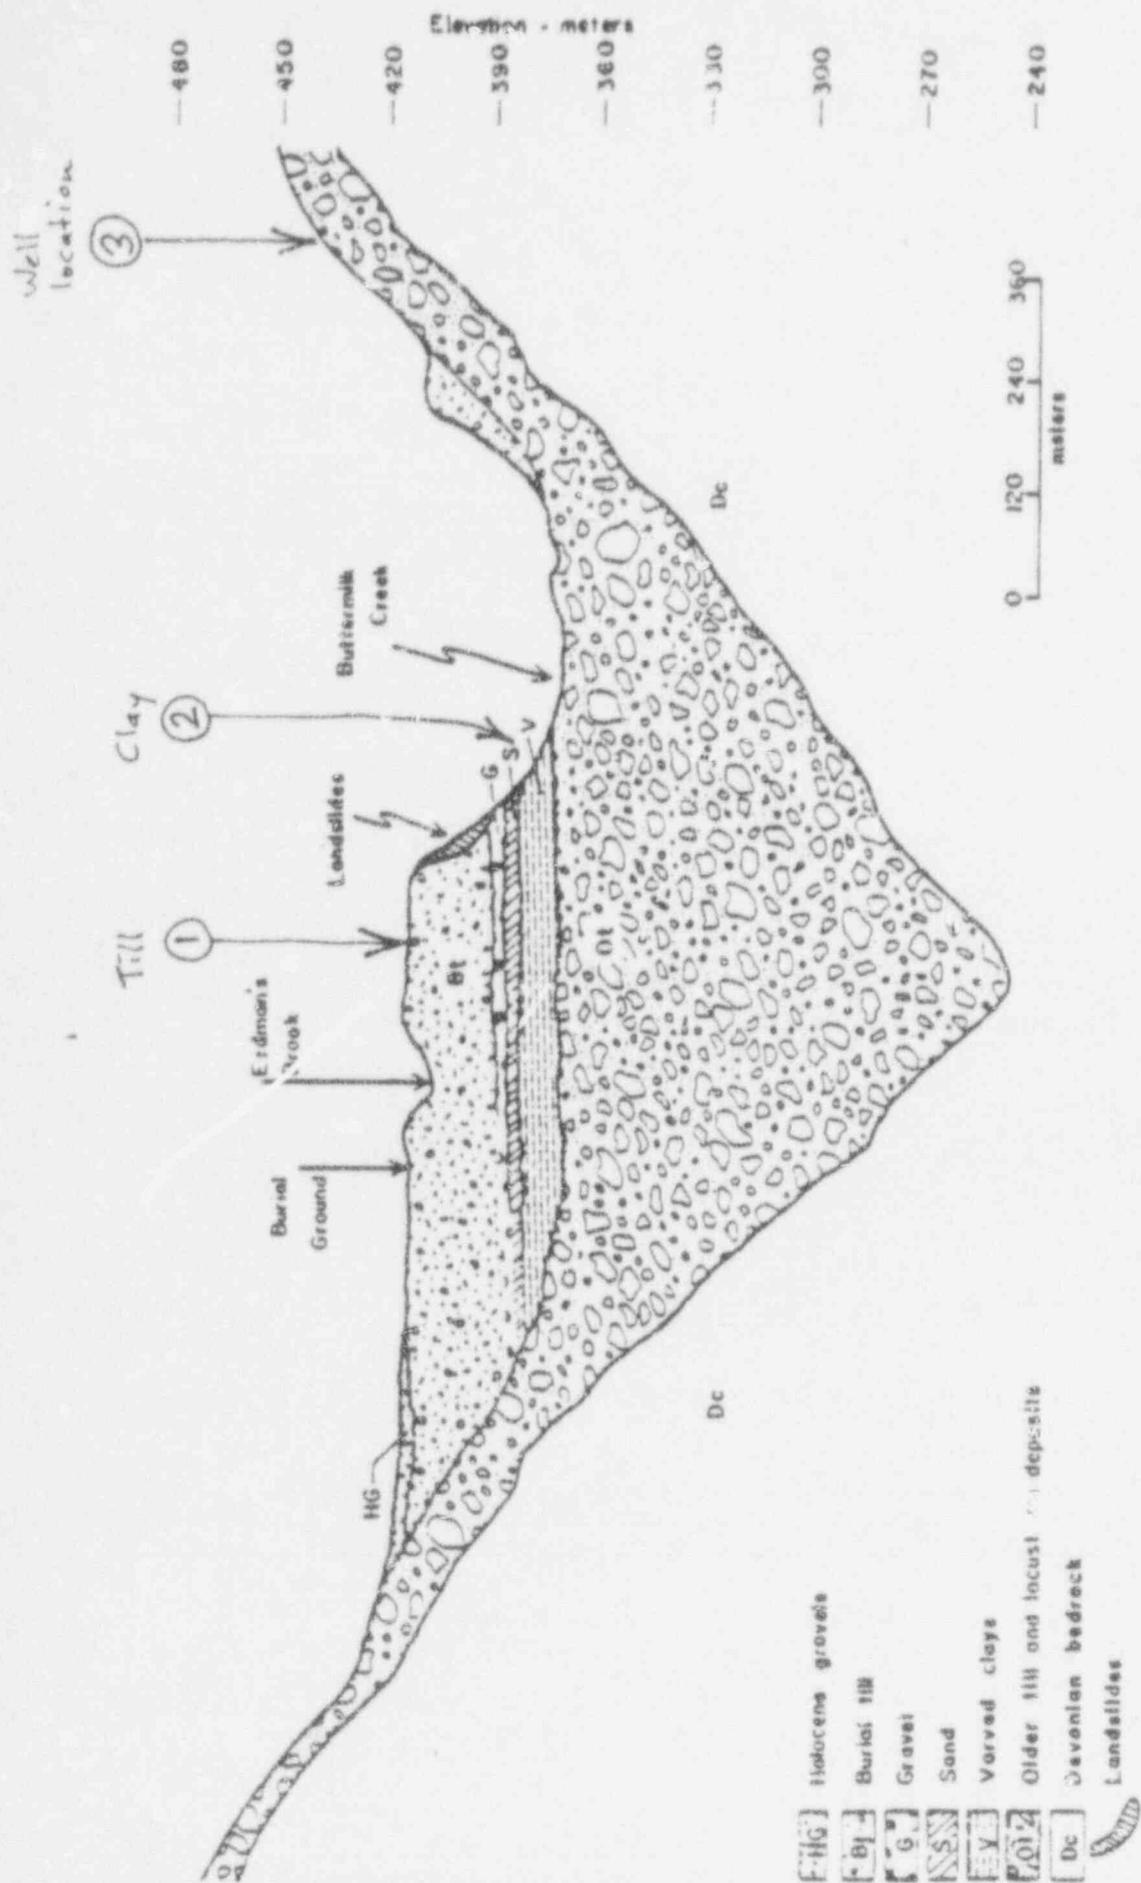
Figure 5. Generalized east-west cross section of glacial deposits at the Western New York Nuclear Service Center.

From Dana, Fakundiny et al. (1979). Note the vertical exaggeration. Numbers in circles show the approximate locations of the three reported cases of fractures.

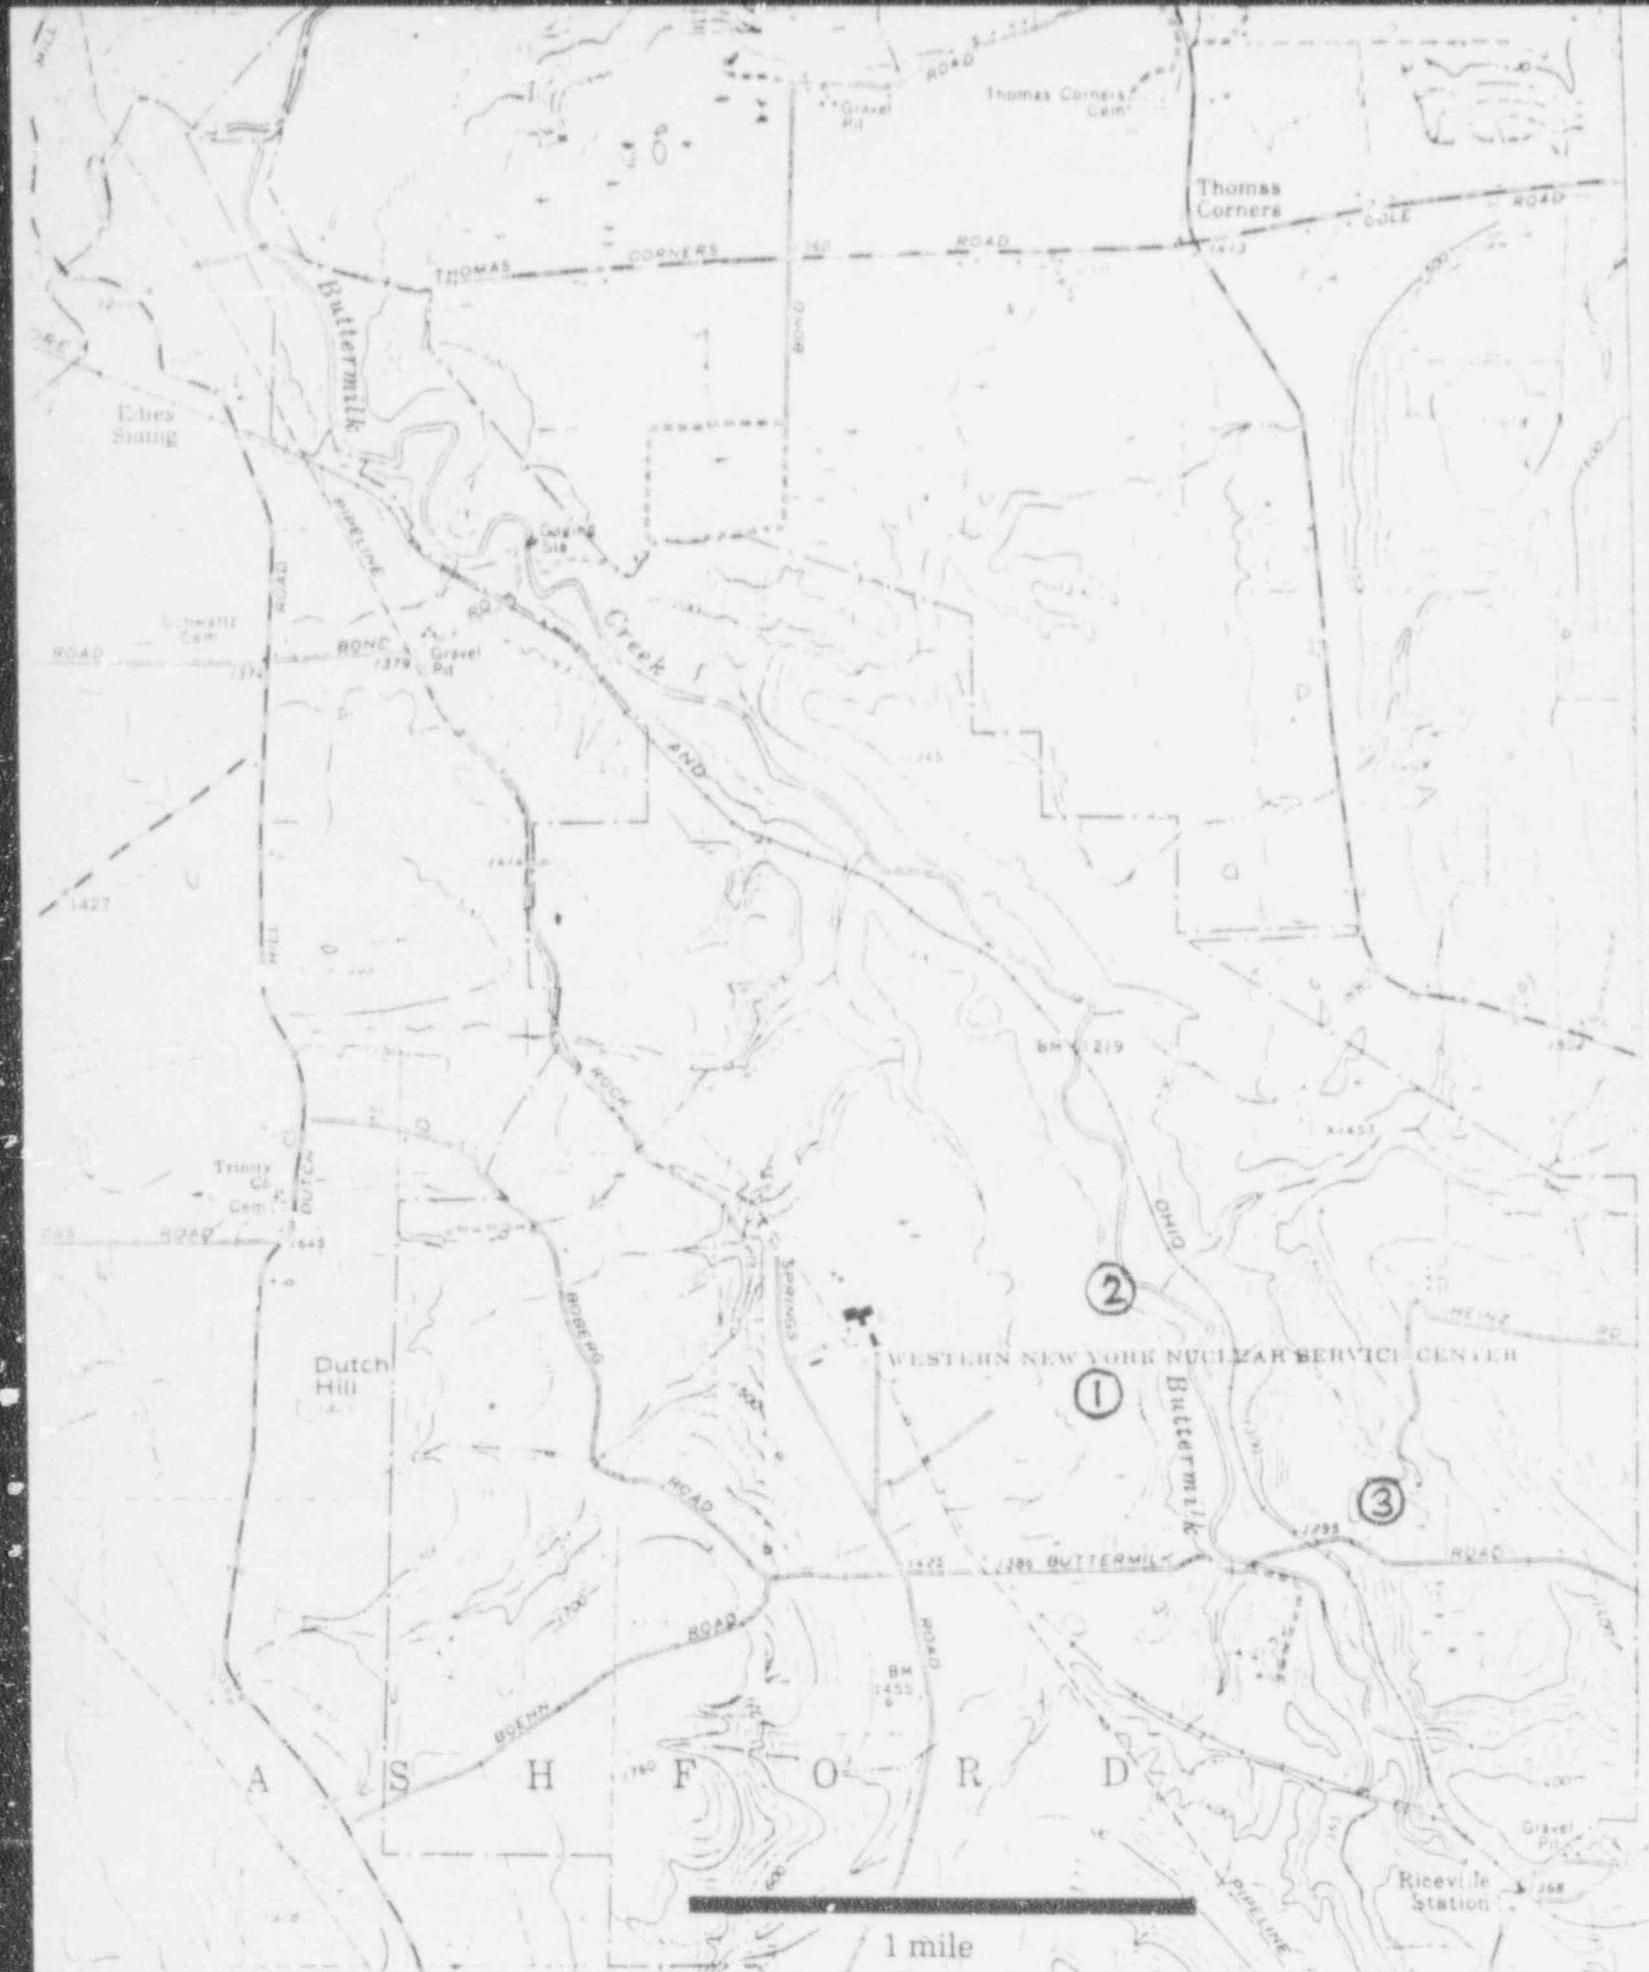
Portion of USGS topographic map, Ashford Hollow quadrangle.

Numbers in circles show the approximate locations of the three reported cases of fractures.
