LICENSEE EVENT REPORT (LER)

FACILITY NAME (1) SURRY POWER STATION, UNIT 1	DOCKET NUMBER (2) 0 5 0 0 0 2 8 0	PAGE (3) 1 OF 0 4
---	--	----------------------------

TITLE (4)
SPURIOUS SAFETY INJECTION

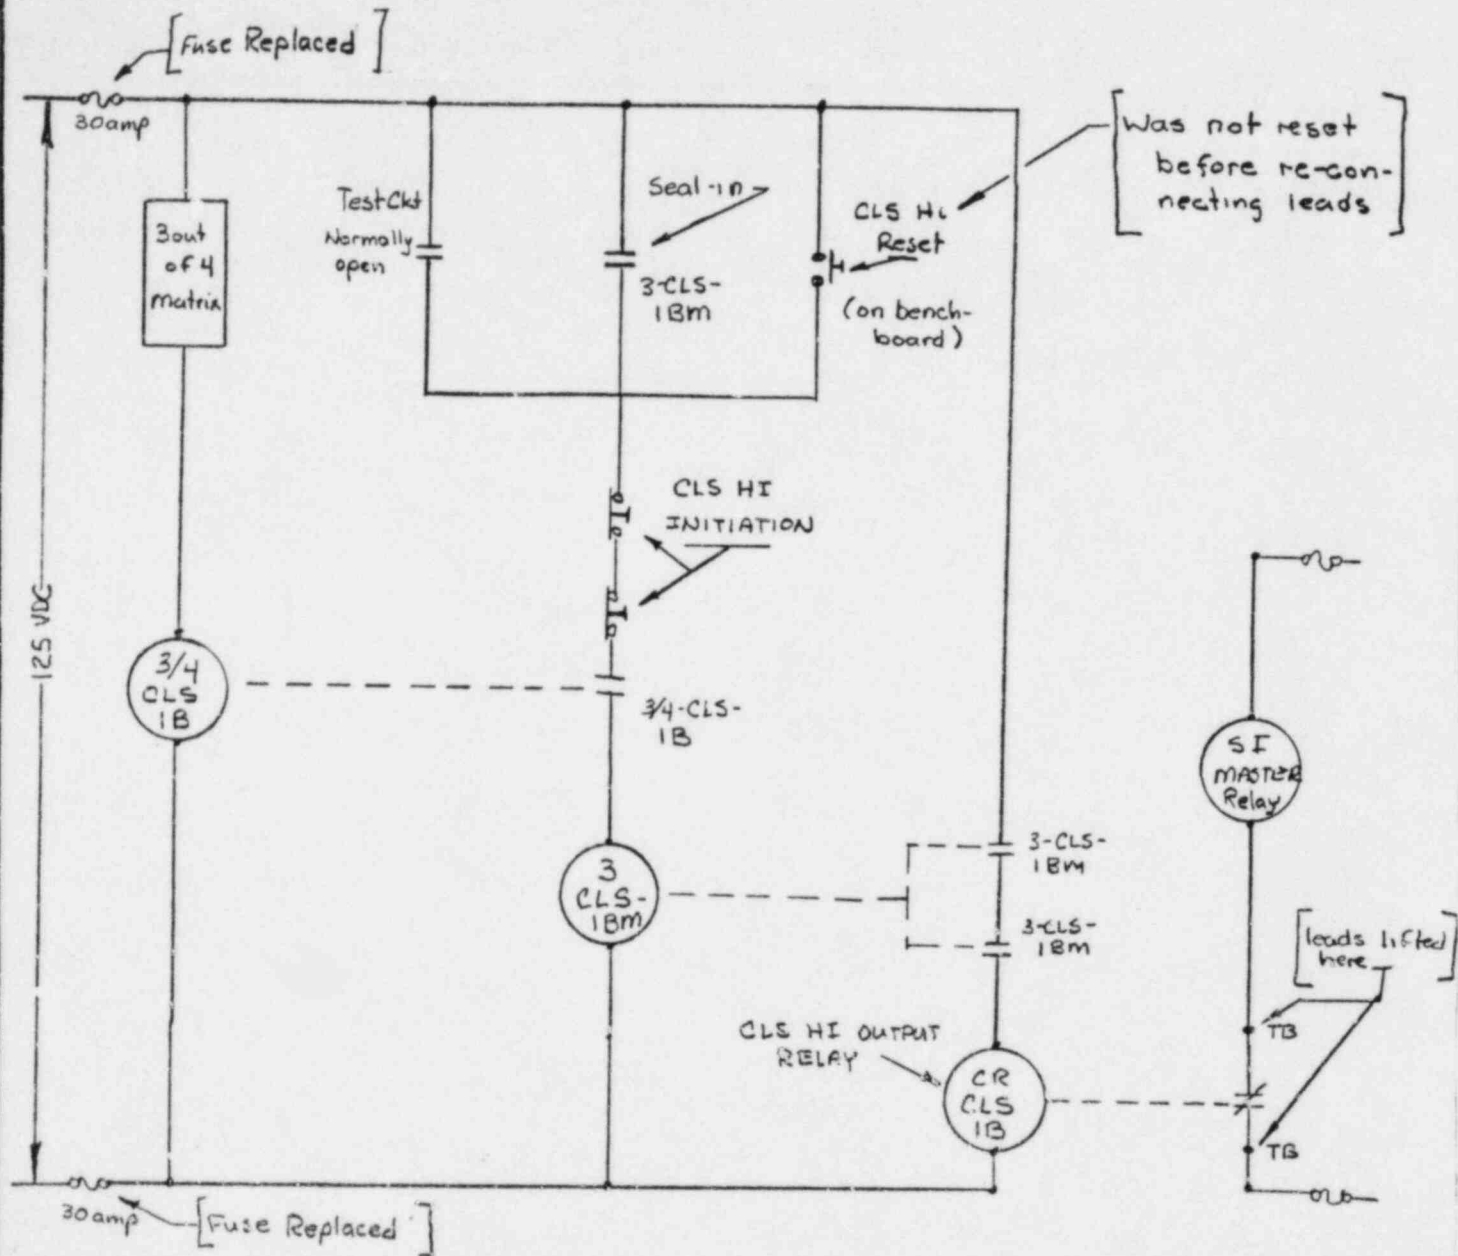
CLS-HI TRAIN B

The spurious SI was due to an inadequate procedure. The inadequate procedure was due to an oversight during the procedure development, review and approval process.

For the remaining discussion, refer to the attached figure. To prevent an inadvertent SI, whenever CLS-HI is de-energized, the interface between CLS-HI and SI must be removed (lifting of leads). Due to the arrangement of the CLS-HI relays, the CLS-HI memory circuit (3-CLS-IBM) must be reset before the CLS-HI/SI interface is re-instated. The controlling procedure did not require the resetting of CLS-HI, hence a spurious SI occurred when the CLS-HI/SI interface was re-instated.

Outstanding work procedures that required the de-energizing of CLS-HI were held in abeyance until the procedures could be modified to require the resetting of CLS-HI.
