SONGS 2 EMERGENCY DIESEL GENERATOR 2G003  
CAMSHAFT ASSEMBLY FAILURE  
RCE 91-022

## EXECUTIVE SUMMARY

### DESCRIPTION OF 2G003 FAILURE

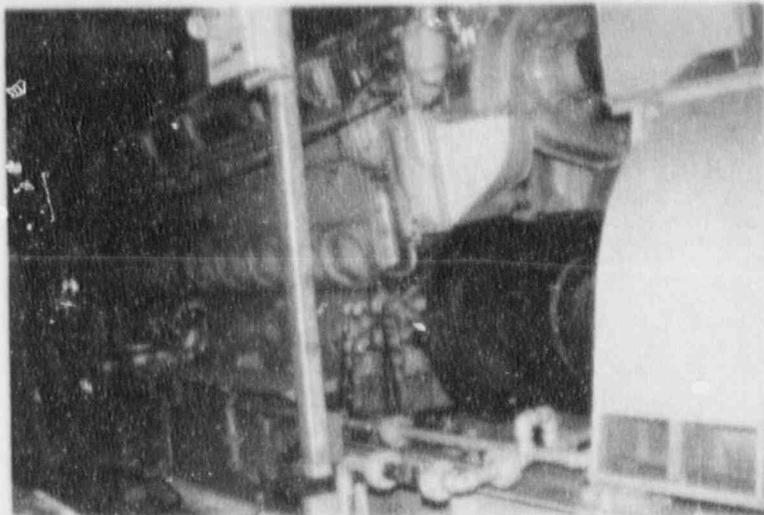
Figure B.1: Overall view of the left side and rear end of the 20 cylinder engine of 2G003.

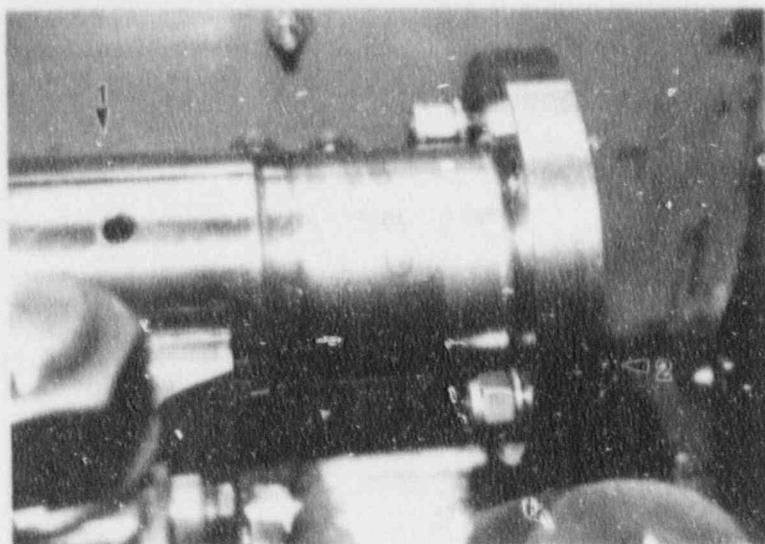
Figure B.3: View of the rear end of the left rear camshaft segment. Arrow 1 points to the camshaft bearing surface associated with camshaft bearing block number 1, and arrow 2 points to the broken dowel bolts at the separated camshaft to stubshaft flange connection. The good condition of the camshaft bearing surface for bearing block number 1 supports the accepted failure scenario, where the initiating event was the bearing cap coming loose.

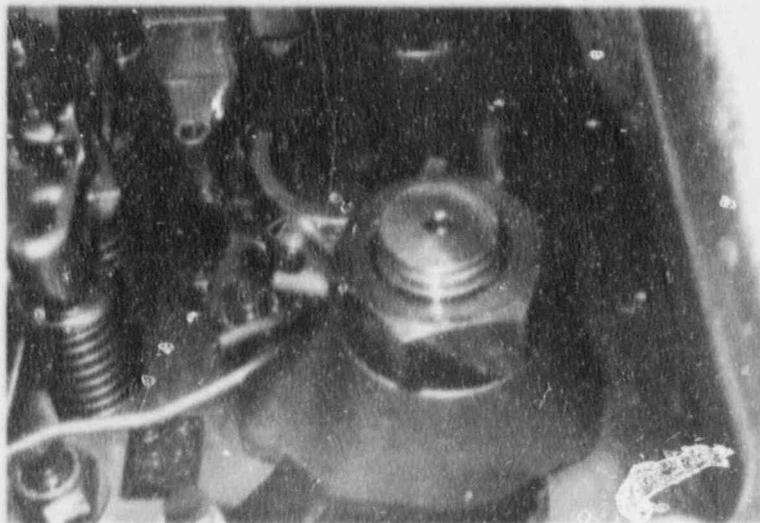
The inboard and outboard bolts from the Number 1 Camshaft Bearing Block were found loose on the top deck of the EDG indicating that the bolts came out of position during the event. A 5th order torsional resonance has been known to exist in the 20 cylinder engine, which caused a detrimental vibratory motion in the gear train and left rear camshaft assembly. This resonance coupled with normal vibration provided a motive force for the short bolts to lose preload and back out. Appendix D discusses in detail the 5th order torsional resonance.

Figure B.4: View of the left rear top deck area in the vicinity of cylinder number 20. The arrow points to bearing cap number 1, shown where it was found lying on the top deck.

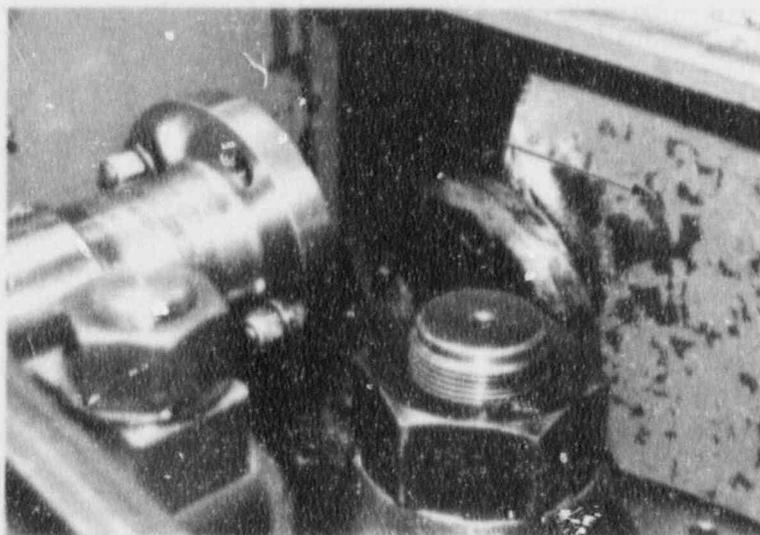
Figure B.5: View of the rear end of the left rear camshaft segment flange and the stubshaft flange. The arrow shows the direction in which the stubshaft moved after the bracket detached from the end sheet and the flange connection was pulled apart. Note the deformation and discoloration of the end sheet. The chamfered wear surface on the stubshaft flange was the result of the stubshaft flange rubbing against a crab bolt, when the camshaft gear and stubshaft continued to rotate, after the bracket detached from the engine.

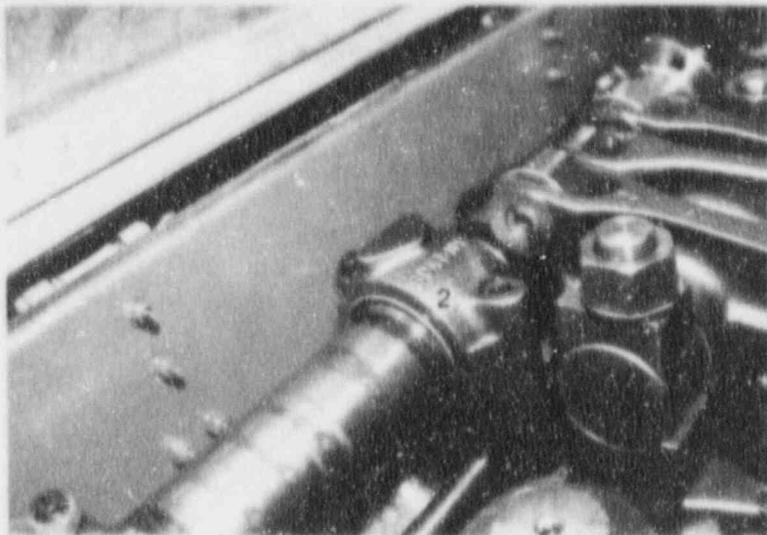
The outboard bolt of bearing block 2 was found lying on the top deck while the outboard bolt of bearing block 3 was found loose but in place. The outboard bolts on bearing blocks numbers 2 and 3 were short bolts. The outboard bolts of both bearing block 2 and 3 were found with approximately 5 deformed threads and the bolt holes had approximately 5 stripped threads indicating the bolts had lost preload and backed partially out, prior to being stripped out. The inboard bolts on bearing blocks 2 and 3 were correct length bolts. The inboard bolt on bearing block 2 was found loose, but not backed out, while the inboard bolt of bearing block 3 was found tight. The inboard bolt threads and hole threads for both bearing block 2 and 3 were basically intact but excessively worn. Thus, it is evident that the correct length inboard bolts in bearing block 2 and 3 held better in the event than the short bolts in the outboard locations of bearing blocks 2 and 3, and the short bolts in the inboard and outboard locations of bearing block 1.

Figure B.7: View of the left rear top deck and bearing block number 2. The inboard bearing block bolt was in place but loose, and the outboard bolt was found lying on the top deck.

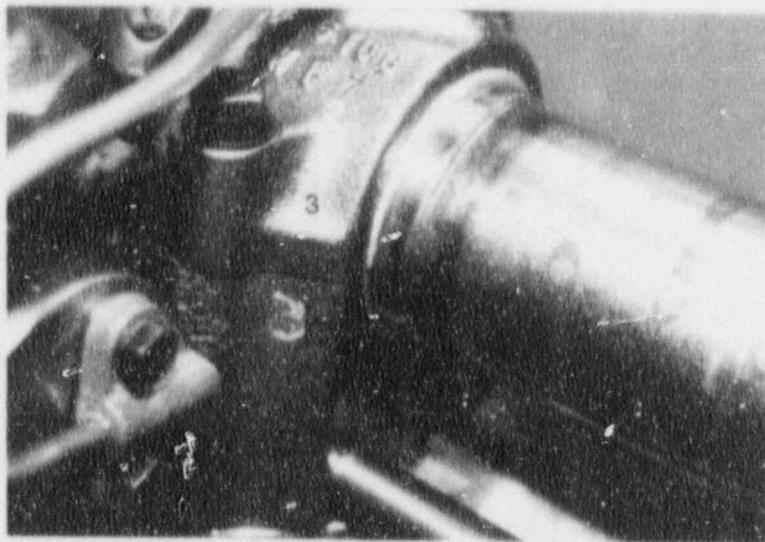
Figure B.8: View of the left rear top deck and bearing block number 3. The inboard bearing block bolt was found in place and tight, and the outboard bolt was found in place but backed out a few threads.

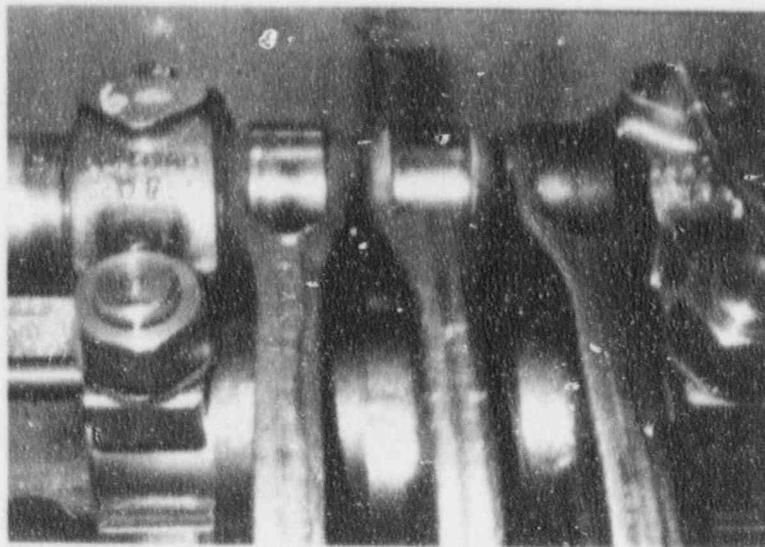
Figure B.9: View of the left rear top deck and bearing blocks number 5 and 6 which correspond to cylinder number 18. Note, the lack of lubrication damage and discoloration of the rocker arm rollers, and the charred material sprayed on the top deck.

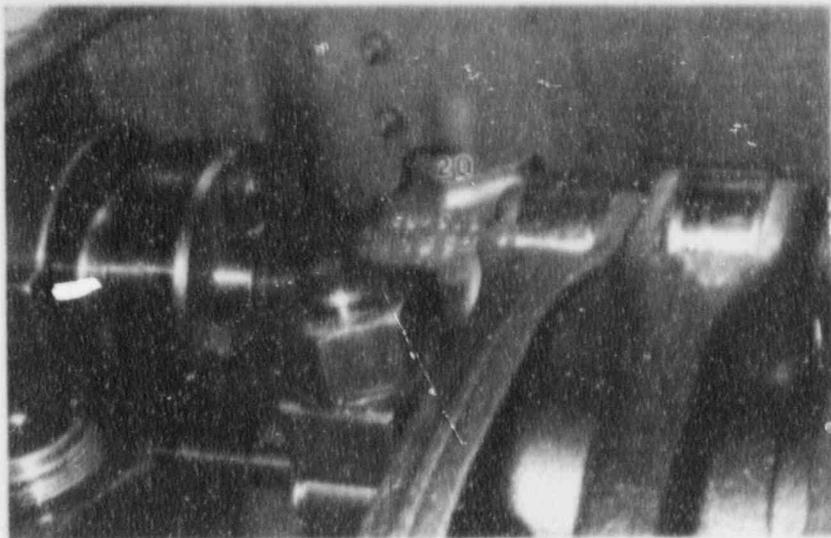
Many of the camshaft bearing blocks and rocker arm assemblies downstream of bearing block number 1 were found to have significant damage due to inadequate lubrication and wear. The most severe damage was found on the most downstream camshaft bearing block corresponding to bearing number 20 and cylinder number 11.

Figure B.10: View of the left front top deck area in the vicinity of the stubshaft to camshaft flange connection, bearing block number 20, and cylinder number 11. Note, the discoloration due to heat buildup, the loss of lubrication damage to the rocker arm rollers, and the charred material sprayed on the top deck. The lack of lubrication damage was greatest in this area.

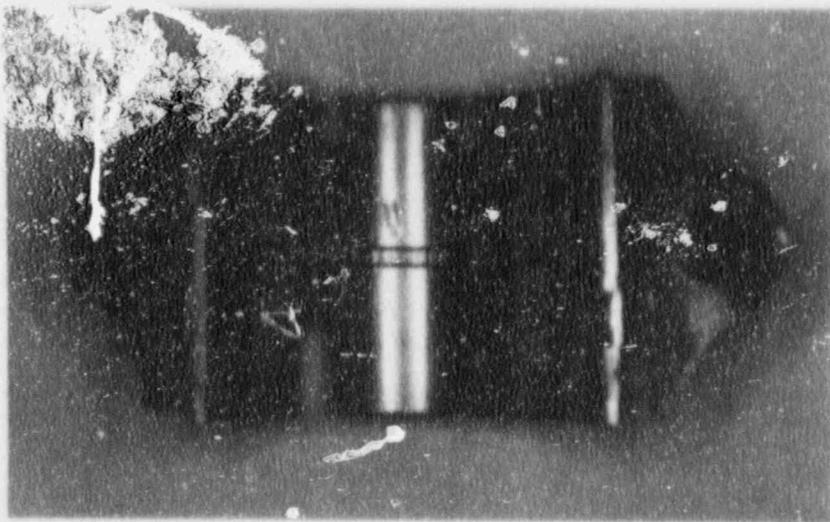
The bearing shells for camshaft bearing block number 1 were found to be free of damage while most of the downstream bearings were found to be damaged due to inadequate lubrication. This indicates that bearing block number 1 was the source of the loss of lubrication for the downstream bearings.

Figure B.11: View of the bearing surface of bearing block number 1. Note, there is no loss of lubrication damage, which supports the accepted failure scenario, where the initiating event was the bearing cap coming loose.

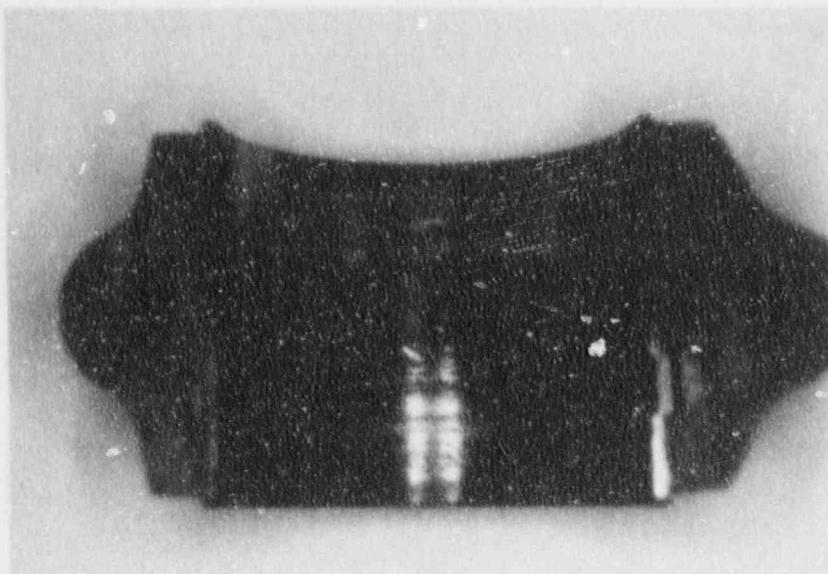
Figure B.12: View of the bearing surface of bearing block number 5. Note, the damage due to loss of lubrication.

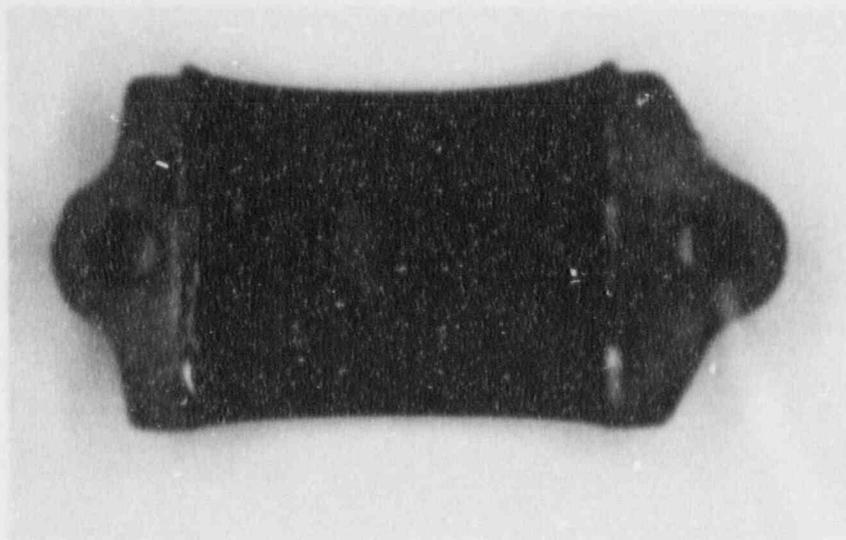
Figure B.13: View of the bearing surface of bearing block number 20. Note, the damage due to loss of lubrication. The lack of lubrication damage was greatest in this area.

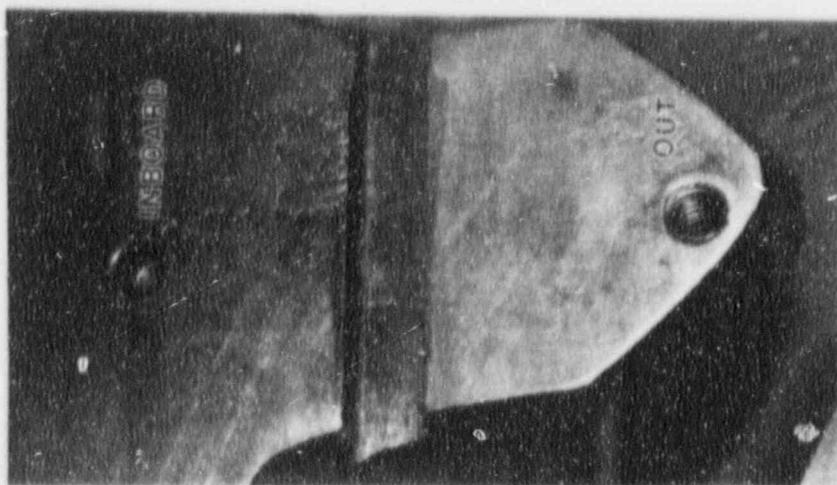
The inboard and outboard bolts on bearing block 1 were found to be a nominal 4 1/2 inches in length, rather than the 4 5/8 inches specified by the vendor manual. The bearing block bolt holes were worn due to previous failures and work activities. This resulted in less than normal thread contact area which contributed to the bolts losing preload and backing out. Appendix A briefly discusses the work history of 2G003, and Appendix C discusses in detail the short bolts and worn bearing block bolt holes. Appendix G discusses in detail the mechanical testing of bearing block bolts to determine the effect of short bolts.

On bearing block 1, the threads of the outboard bolt and bolt hole were found intact indicating that the outboard bolt must have lost preload and backed completely out under vibration. The first approximately 5 threads of the inboard bolt were deformed and the first approximately 5 threads of the bolt hole were stripped, indicating that the inboard bolt lost preload, vibrated partially out, and then was pulled out. Since approximately 6 1/2 threads is the engagement of a short bolt, the bolt had vibrated approximately 1 1/2 threads out, 1/16 inch, prior to being stripped out. The inboard and outboard bolts for bearing block number 1 had polished areas and wear marks corresponding to the bolts coming loose, backing out, and vibrating in place for sometime.

Figure B.14: View of engine block top left deck at the location of camshaft bearing block number 1. Note, approximately 5 threads of the inboard bolt hole are stripped while the threads of the outboard bolt hole are basically intact. The condition of these bolt holes supports the accepted failure scenario, where the initiating event is the bearing cap coming loose as a result of the bolts losing preload. Both the inboard bolt and outboard bolt were found to be short.

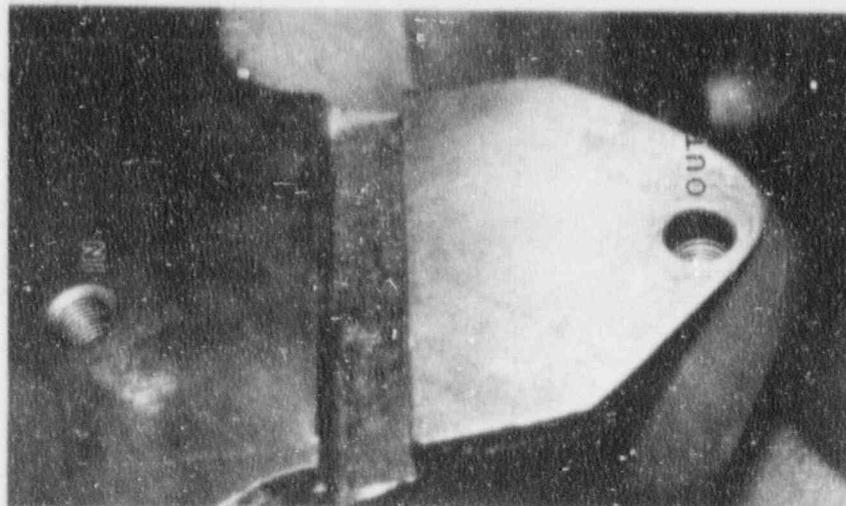
Figure B.15: View of engine block left top deck at the location of camshaft bearing block number 2. Note, the threads of the inboard bolt hole are basically intact while approximately 5 threads of the outboard bolt hole are stripped. The inboard bolt was found to be the correct length while the outboard bolt was found to be short.

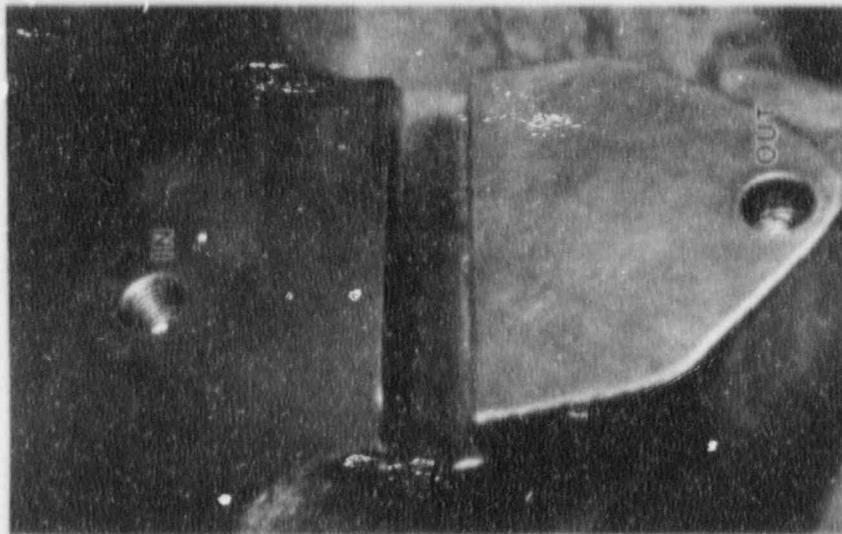
Figure B.16: View of engine block left top deck at the location of camshaft bearing block number 3. Note, the threads of the inboard bolt hole are basically intact while approximately 5 threads of the outboard bolt hole are stripped. The inboard bolt was found to be the correct length while the outboard bolt was found to be short.

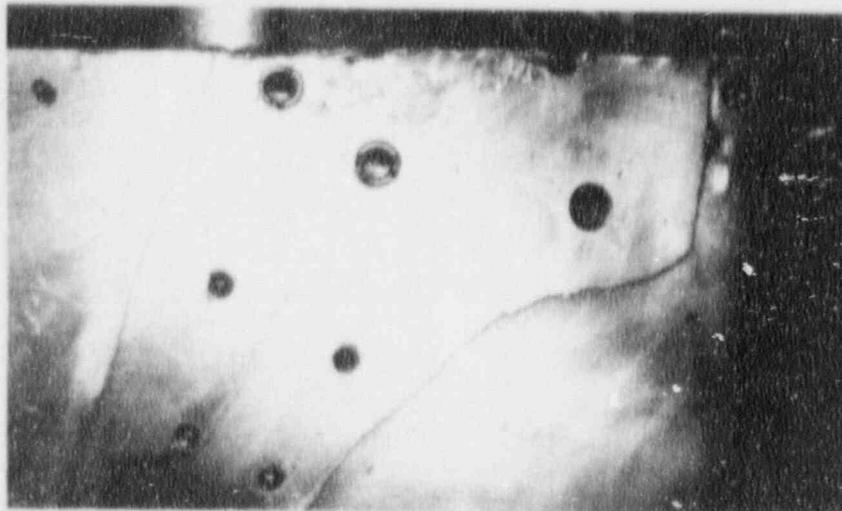
The camshaft stubshaft bracket detached from the end sheet shortly before the camshaft to stubshaft flange connection separated due to the evidence of material deformation on the top of the end sheet, and the absence of flange wear marks which would indicate that the flange connection failed first.

Figure B.17: Side view of the left rear end sheet at the location of the stubshaft support bracket. Note, the deformation of metal cause by a hammering of the bracket against the end sheet, for a short time, after the bracket detached from the end sheet.

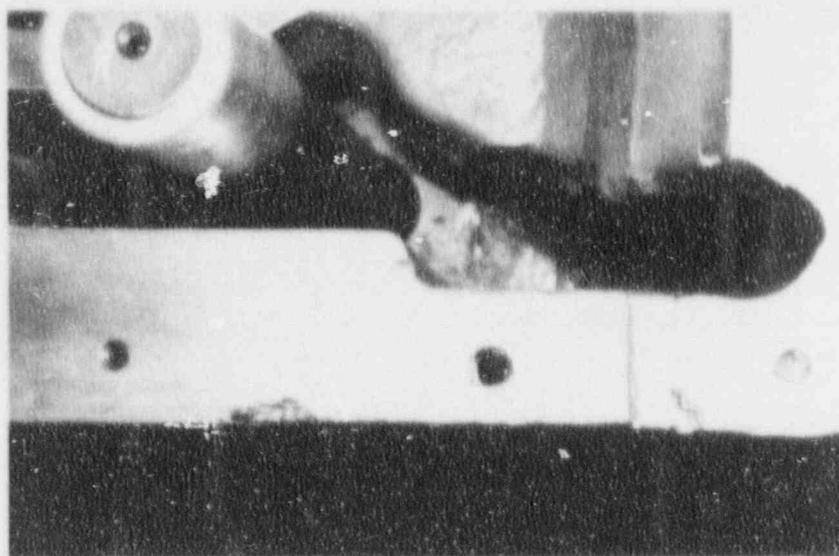
Figure B.18: Top view of the left rear end sheet at the location of the stubshaft support bracket. Note, the deformation of metal cause by a hammering of the bracket against the end sheet, for a short time, after the bracket detached from the end sheet.

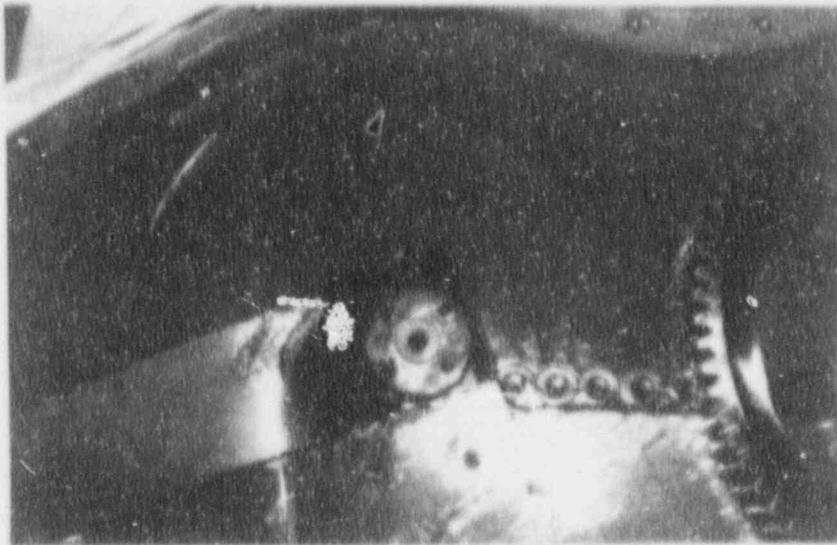
Figure B.19: Side view of the left rear end sheet. Note, the arrow shows where the camshaft gear contacted the camshaft gear housing just prior to the bracket detaching from the end sheet, and after the bracket detached from the end sheet.

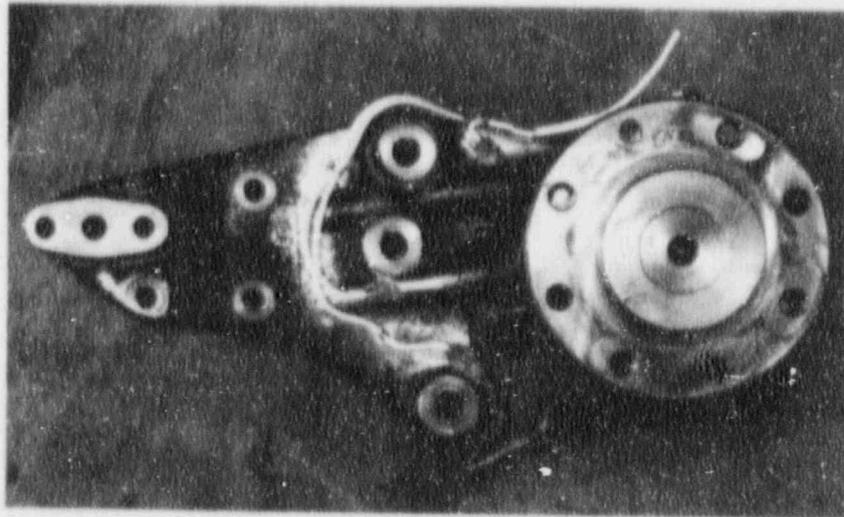
Figure B.20: View of the left rear stubshaft support bracket. Note, the bracket was not broken as in previous EDG failures. The wires are associated with strain gages which were used during previous testing of the bracket.

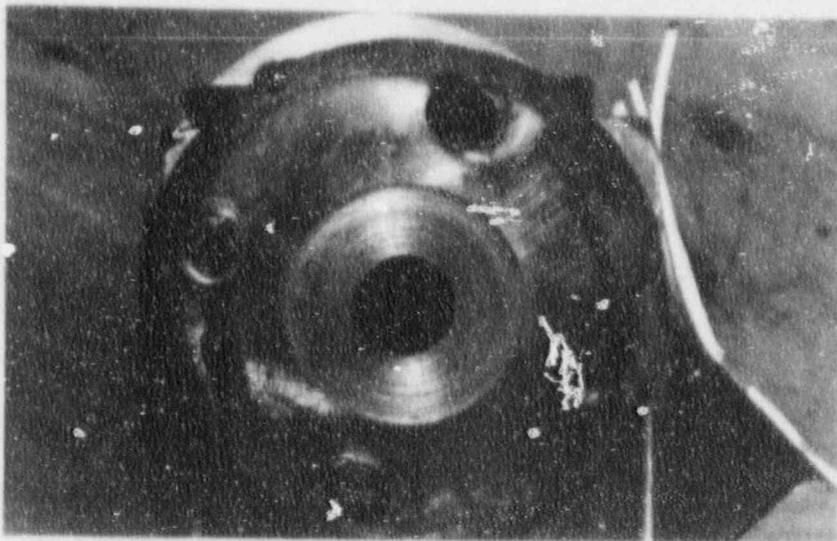
The failure mode of the stubshaft to camshaft flange dowel bolts was ductile tearing due to a combination of torsional and tensile overload.

Figure B.21: View of the left rear stubshaft flange. Note, the elongation of the dowel bolt holes due to torsional loading of the flange as the camshaft was seizing, and rubbing against the crank bolt.

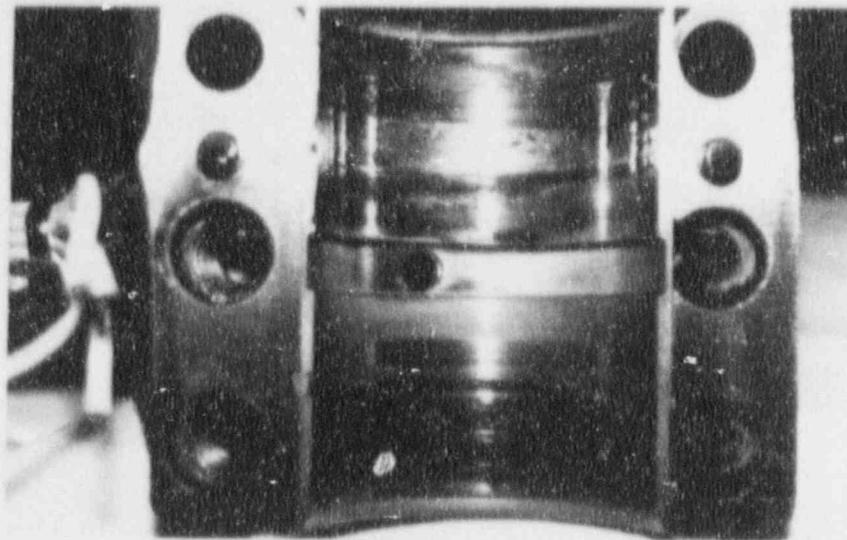
Note, the left rear stubshaft bracket bearing, which is upstream of bearing block number 1, was found with some damage due to severe camshaft gear vibration and loss of lubrication. However, the loss of lubrication damage has been attributed to a loss of lubrication flow after the bracket detached from the engine case, and the fact the camshaft gear continued to rotate on the idler gear until the engine was shutdown.

Figure B.22: View of the lower half of the stubshaft support bracket bearing. Note, the damage to the top half of the bearing surface was similar to the bottom half of the bearing. The damage has been attributed to severe camshaft gear vibration after the stubshaft flange began to fail, and a loss of lubrication damage after the bracket detached from the end shell and the camshaft gear continue to rotate on the idler gear.

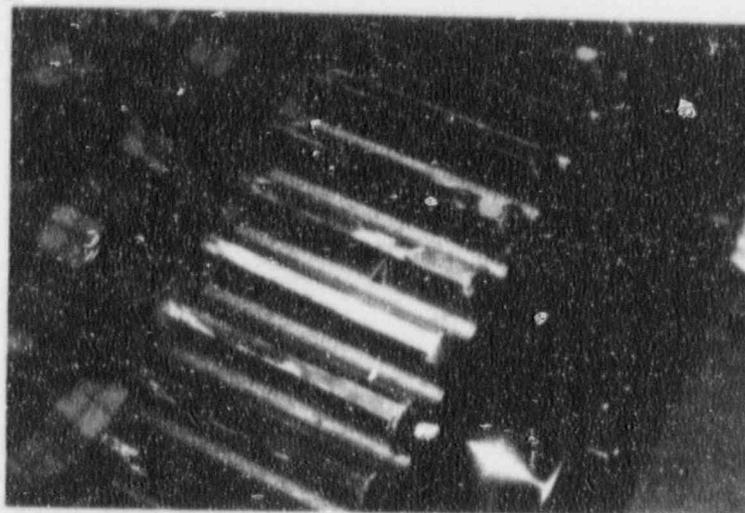
An inspection of the gear train revealed extensive damage with evidence of gear misalignment and broken bolts meshing between the gears.

Figure B.23: View of the teeth of the left rear camshaft gear. The arrow points to damage due to the meshing of a metal fragment in the gear train. Note, there was extensive damage to the entire gear train due to gear misalignment and the meshing of metal fragments.

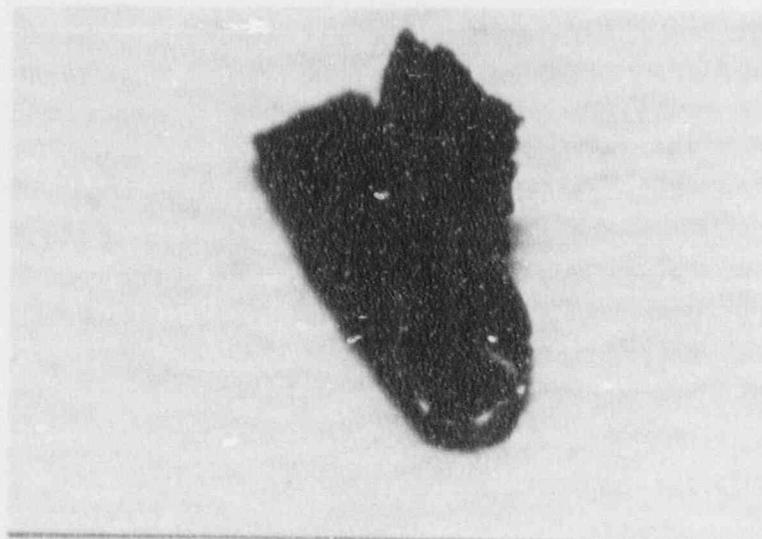
Figure B.24: View of a metal fragment that was meshed in the gear train. Note, the fragment has taken the shape of the gear teeth.

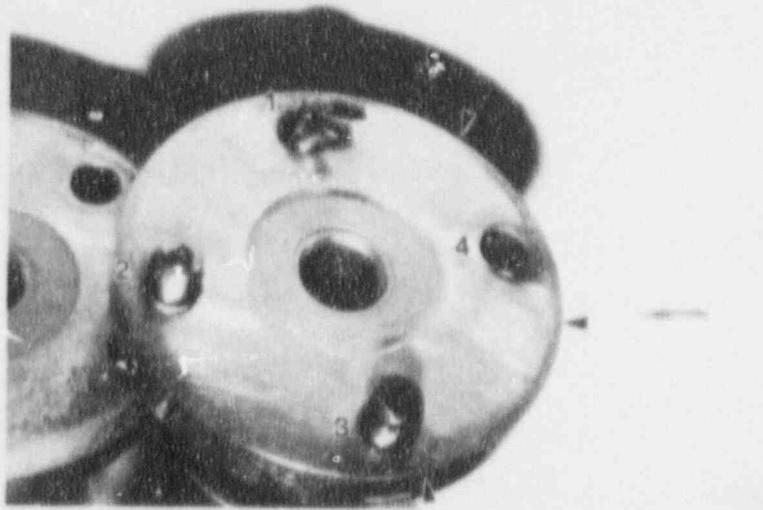
The camshaft flange was found with a crescent shaped polished wear mark in the vicinity of a dowel bolt hole indicating that one dowel bolt failed first and that the flange connection lost some rigidity during operation. The failure of the one dowel bolt resulted in increased vibration in the vicinity of the camshaft to stubshaft flange connection, the stubshaft bracket, and the camshaft bearing blocks. Appendix E discusses in detail the analysis of the stubshaft flange failure, and Appendix G discusses in detail the mechanical testing of the dowel bolts.

Figure E.1: View of the left rear camshaft flange with remnants of the 3 broken dowel bolts. The numbering of the bolts is arbitrary and for discussion purposes only. The arrows point to the crescent wear mark which indicated bolt number 4 fractured first. Note, the bluish discoloring and deformation of the broken bolts, and the elongation of the flange bolt holes.

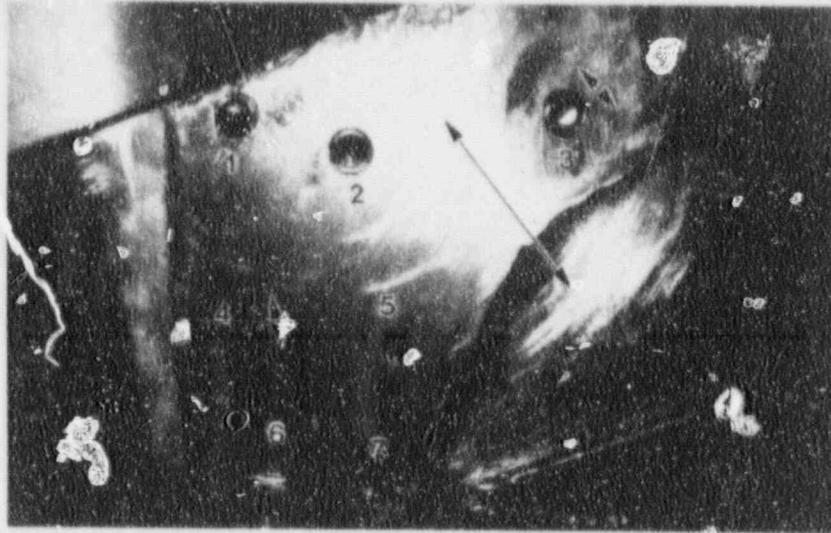
The 6 horizontal and 2 vertical bolts which hold the camshaft bracket to the end sheet failed by reverse bending fatigue followed by overload. Laboratory analysis determined that the bolts failed by overload after approximately 41,000 fatigue cycles. Since the EDG rotates at 900 rpm and is subject to 5th torsional resonance, 41,000 cycles equates to approximately 9 minutes of operation. Appendix F discusses in detail the failure analysis of the stubshaft bracket failure.

Figure F.1: Side view of the left rear end sheet at the location of the stubshaft support bracket. Note, bolt holes numbered 1-5 and 7 are the location of the primary bolts that attach the bracket, while bolt hole number 6, and a bolt hole directly below bolt hole number 6, attach the lubrication oil manifold to the bracket. The small arrows show the direction of reverse bending of the bolts while the long arrow shows the direction of reverse loading of the entire bracket.

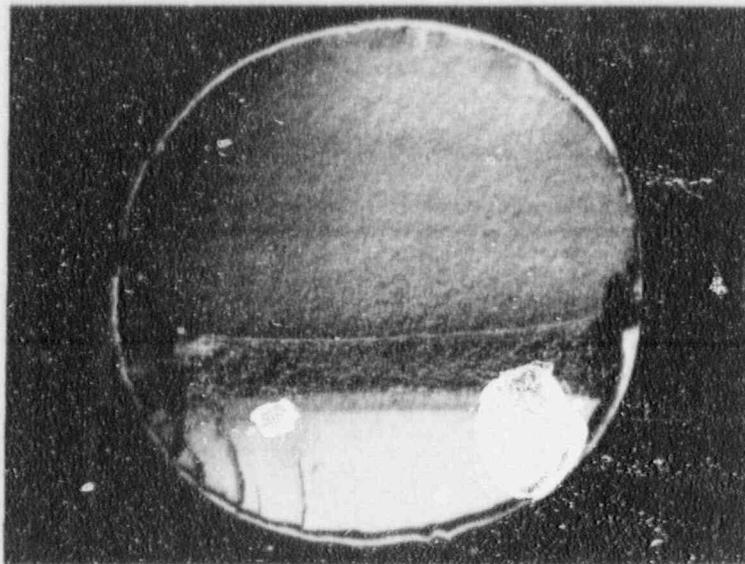
Figure F.4: SEM fractograph of bolt number 3, illustrating the reverse bending fatigue fracture. The width of the overload zone with respect to the overall cross-section was estimated to be 10 percent, indicating the fracture occurred under relatively low stress conditions.

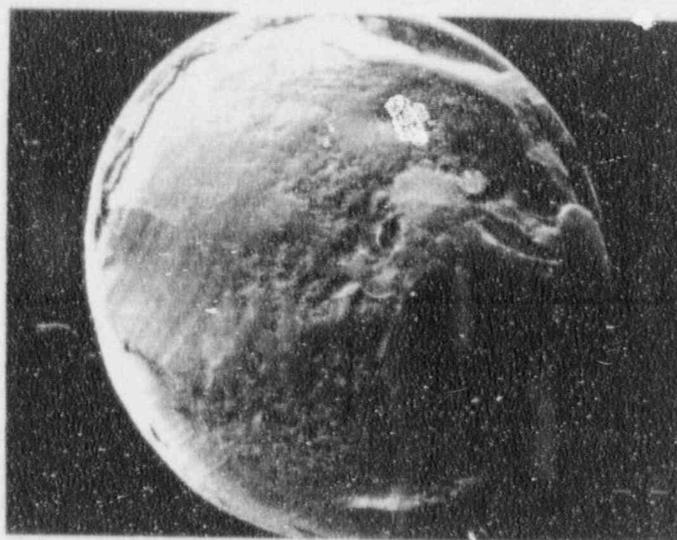
Figure F.13: View of the fracture surface of vertical bolt number 9, as shown in Figure F.2, which was significantly rubbed, but as determined by the mating fracture surface, the fracture was indicative of a reverse bending fatigue condition.

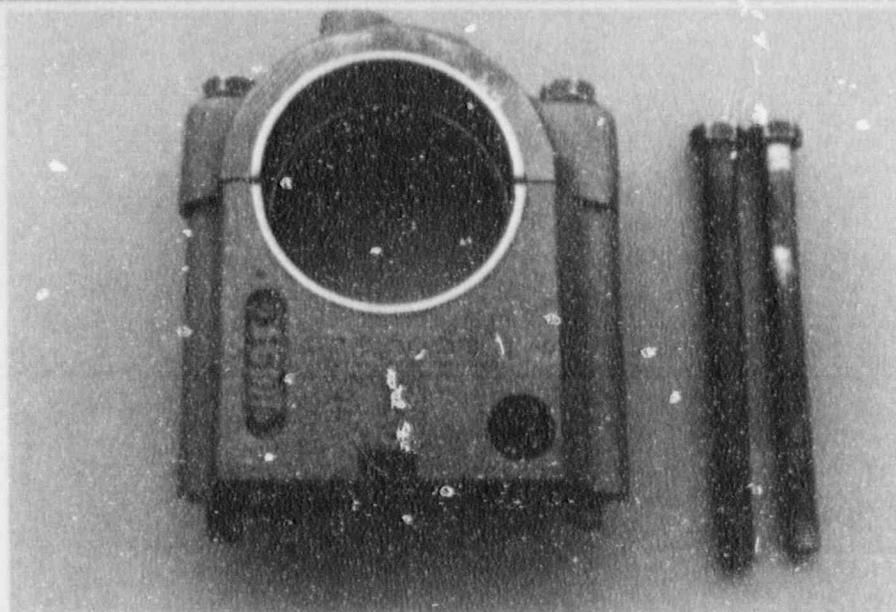
Figure G.1: Typical camshaft bearing block, shown with a correct length bolt at the outboard (left) location and a short length bolt at the inboard (right) location. Also, a correct length and short length bolt are shown for comparison.

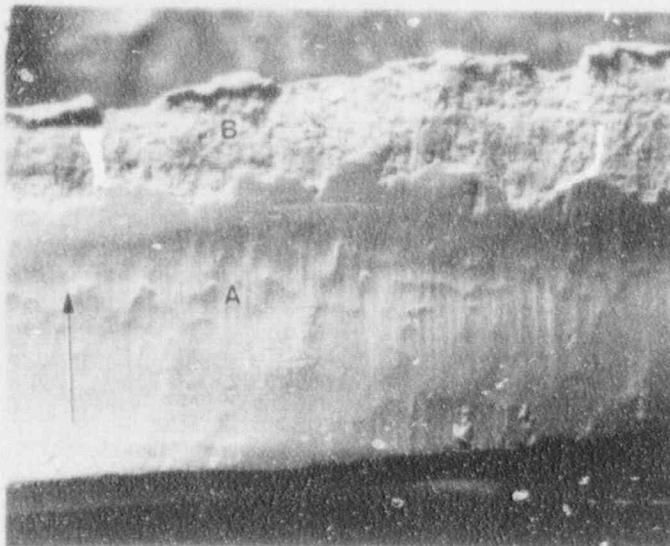
Figure G.3: Back scattered electron fractograph of the stripped threads found entrapped on the threads of the outboard bolt of bearing block number 3, illustrating the presence of rubbed zone (A) in a direction of the arrow and a relatively undamaged sheared zone (B), at 80 X magnification.

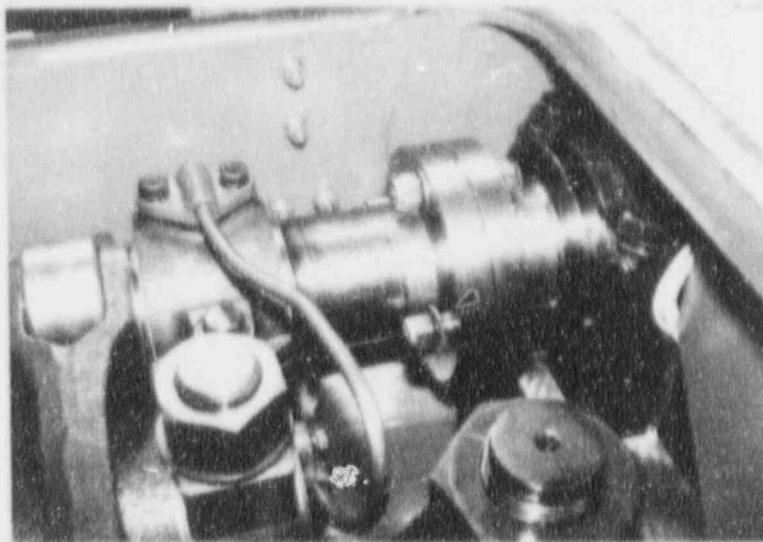
tight, bearing block bolts were replaced in the vicinity of the left rear camshaft gear to ensure they were the correct length, and it was concluded that 3G003 was not experiencing a camshaft bearing block problem. However, during the inspection, the left rear camshaft to stubshaft flange connection was found to be degraded. One of 4 dowel bolts was found to be broken while cracks were found in the other 3 dowel bolts. The root cause of the 3G003 flange degradation has been attributed to a combination of poor quality 1144 alloy dowel bolting material coupled with 5th order torsional resonance and normal engine vibration. Appendix I discusses in detail the 3G003 stubshaft flange connection degradation event.

Figure K.1: View of the as-found condition of the degraded left rear camshaft to stubshaft flange connection on the 20 cylinder engine of 3G003. The arrow points to the dowel bolt that was found broken.

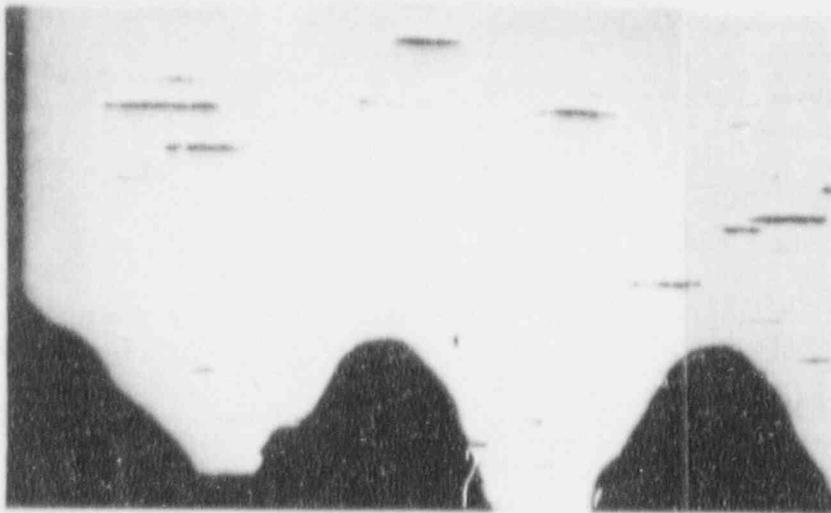
Figure K.4: An optical photograph of the longitudinal microsection of broken bolt 1, in the as-polished condition, illustrating the presence of large sulfide stringers and fine sulfide inclusions, at 50 X magnification.

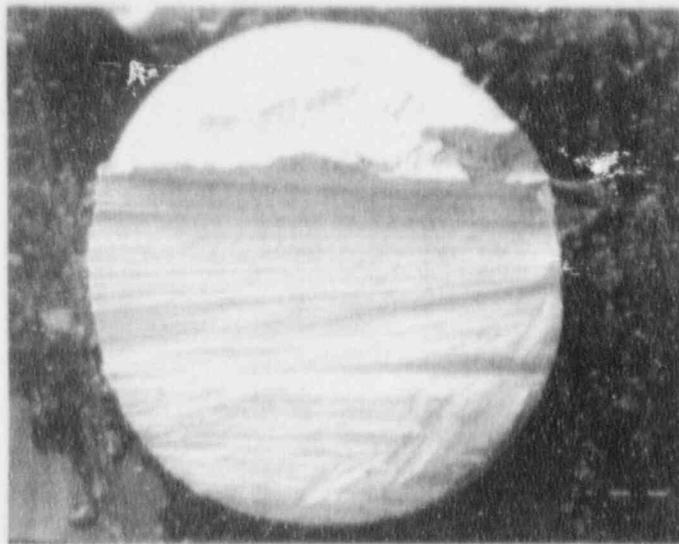
Figure K.7: A SEM fractograph of cracked bolt number 2, illustrating crack propagation to approximately 20 percent of the cross section of the bolt, at 6 X magnification.

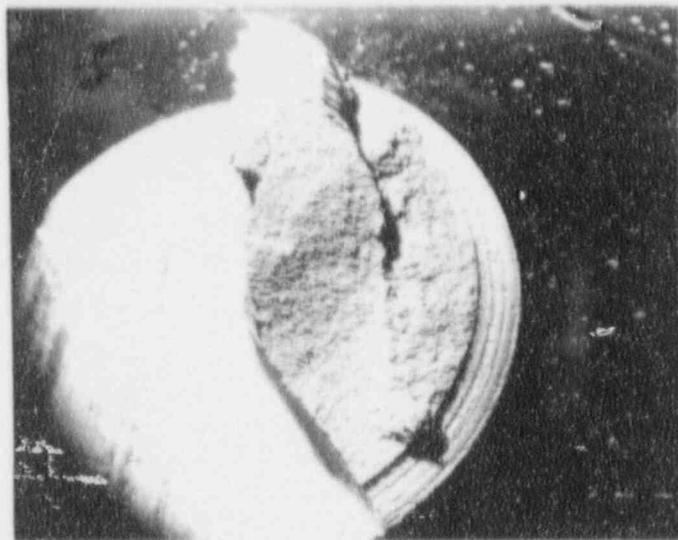
Figure K.13: A SEM photograph of cracked bolt 3, illustrating crack propagation to approximately 40 percent of the cross section of the bolt, at 9 X magnification.

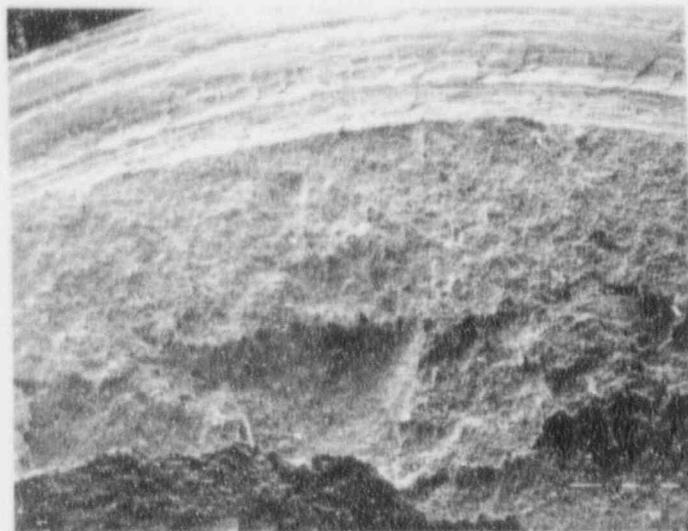
Figure K.14: A SEM photograph of cracked bolt 3, illustrating the fatigue fracture, at 50 X magnification.

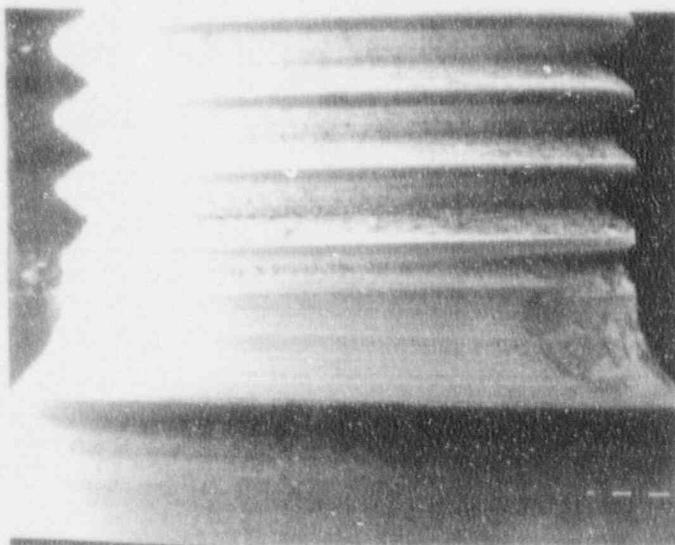
Figure K.18: A SEM photograph of cracked bolt 4, illustrating crack initiation the root of the first thread, at 7 X magnification.
