This letter forwards Licensee Event Report (LER) 96-007-00 documenting an event that occurred at Millstone Nuclear Power Station, Unit No. 2 on February 20, 1996. This LER is being submitted pursuant to 10 CFR 50.73(a)(2)(i).

FACILITY NAME (1) Millstone Nuclear Power Station Unit 2	DOCKET NUMBER (2) 05000336	PAGE (3) 1 of 5
---	-------------------------------	--------------------

TITLE (4)
Reactor Coolant System Cooldown Rate Exceeded Technical Specification Limit

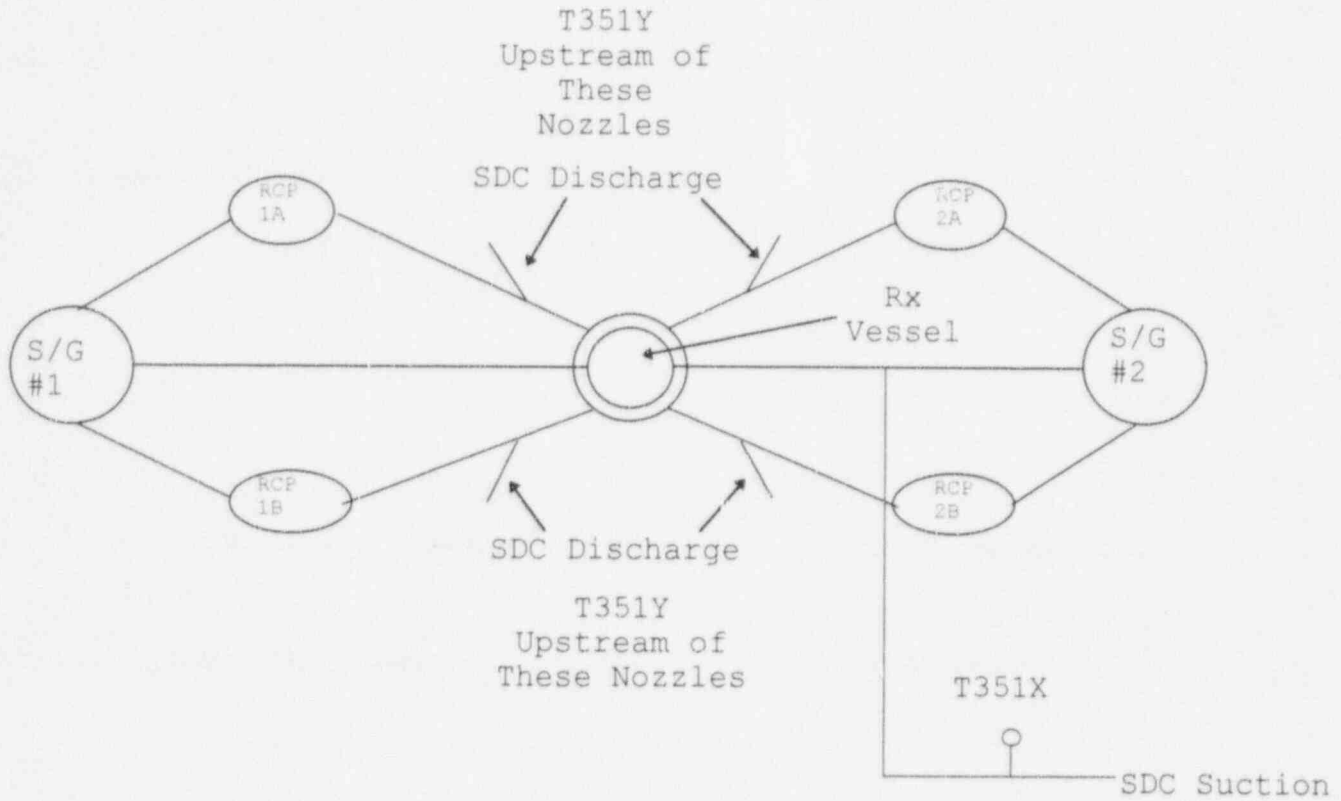
Shutdown Cooling System - RCS Penetrations Versus Locations of T351X & 351Y

- The temperature sensor located in the SDC discharge to the RCS cold leg (RTD T351Y) reacts quickly to changes in SDC flow rate and reactor building closed cooling water (RBCCW) flow rate through the SDC heat exchangers. The temperature sensor reacts quickly since it is located, downstream of the discharge of the SDC heat exchangers, and before SDC mixes with the RCS.

- RTD T351Y more conservatively assesses cooldown rates at the reactor vessel downcomer due to changes in SDC system flow and RBCCW temperature changes than RTD T351X which is located on the SDC suction line off of the RCS Loop 2 hot leg. RTD 351X represents the temperature of the RCS water exiting the core region of the reactor vessel.

The plant surveillance procedure used to monitor RCS heatup and cooldown rates required that the RCS cooldown rate be assessed at least once every 30 minutes during a plant cooldown. During SDC operation, the procedure specified the use of RTD T351X temperature values, rather than T351Y, to monitor cooldown rate. The plant computer heatup/cooldown monitoring software program assists the operators and was developed to reflect the same procedure requirements. During the April 24, 1994, July 28, 1994, and December 15, 1995 RCS cooldowns, the RTD T351X temperature, which was being monitored, remained on a steady cooldown rate during SDC system manipulations. However, subsequent review of the RTD T351Y temperature exhibited large temperature swings in conjunction with the same SDC system manipulations. Using only RTD T351X temperature indications to calculate cooldown rate during the three events concealed the magnitude of the reactor vessel downcomer cooldown rate.

Changes to the plant operating and surveillance procedures, the plant heatup/cooldown monitoring computer program, and the operator training program will be implemented to allow operators to properly monitor and control the RCS heatup/cooldown rate. The procedure changes and operator training will be completed prior to entering mode 4 during plant startup.
