Carolina Power & Light Company

BRUNSWICK STEAM ELECTRIC PLANT UNIT 1 and 2
DOCKET NO. 50-325 and 50-324
LICENSE NO. DRP-71 and 62
LICENSEE EVENT REPORT 1-92-017

TITLE (4) INCOMPLETE CLOSURE OF ITE TYPE K-3000 BREAKER CONTACTS

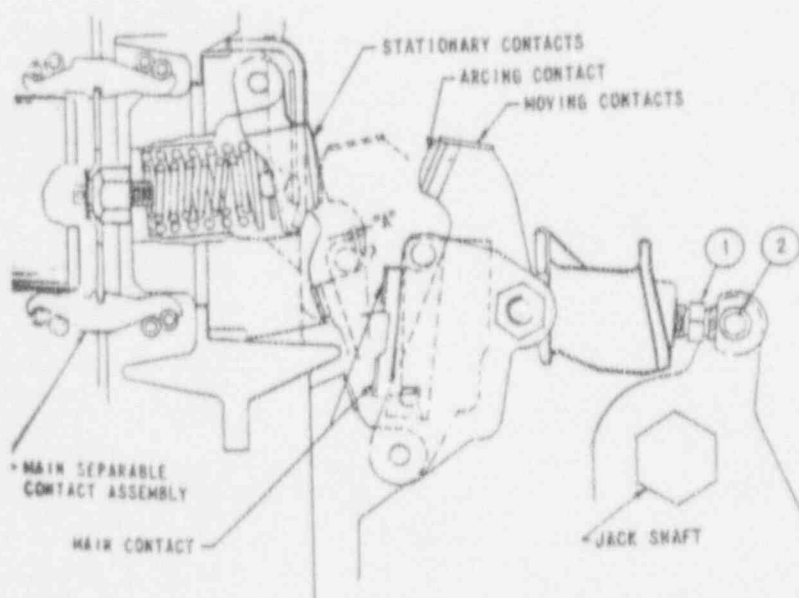
Fig. 3 — Contact Pressure Check and Adjustment

Step 7.7.10 - If other leading arcing contacts are not within 0.032" of touching, loosen lock screw and turn adjustment screw for appropriate contacts so that all leading arcing contacts will touch within 0.032".

When the above steps were performed earlier, it was necessary to tighten down (i.e., increase the pressure of) the contacts to obtain 0.032". In order to meet the 0.032" parameter without increasing contact pressure, it was decided to adjust back the first leading arcing contact (the one that had touched first in step 7.7.9). This would allow the contact to touch later in the closing cycle, consequently bringing the other contacts within 0.032" without having to increase (or increase as much) their contact pressure (Step 7.7.10). The adjustment was made and the breaker did close completely; the reduction in contact pressure corrected the closing problem.

ABB was again contacted to discuss the failure of the breaker to completely close. When Technical Support explained to the vendor what had been done, the vendor indicated that the adjustment to reduce contact pressure on the leading arcing contacts may have compromised the contact pressure setting for the main contacts. [Note: The main contact pressure setting was performed in earlier steps in the OPM (steps 7.7.1 and 7.7.2)]. Technical Support was under the impression that the 7.7.1 and 7.7.2 steps were a "gross" setting and that 7.7.9/7.7.10 was the fine tuning. They were not aware/did not understand that steps 7.7.1/7.7.2 were critical and performance of these steps set the minimum desired contact pressure.

1. Readjust contact pressure on 1-E6-AV4-52, 2-E7-AZ1-52, and 2-E8-AZ5-52.
