# POWER REACTOR EVENTS

United States Nuclear Regulatory Commission

Date Published: November 1984

Period Covered: May-June 1984

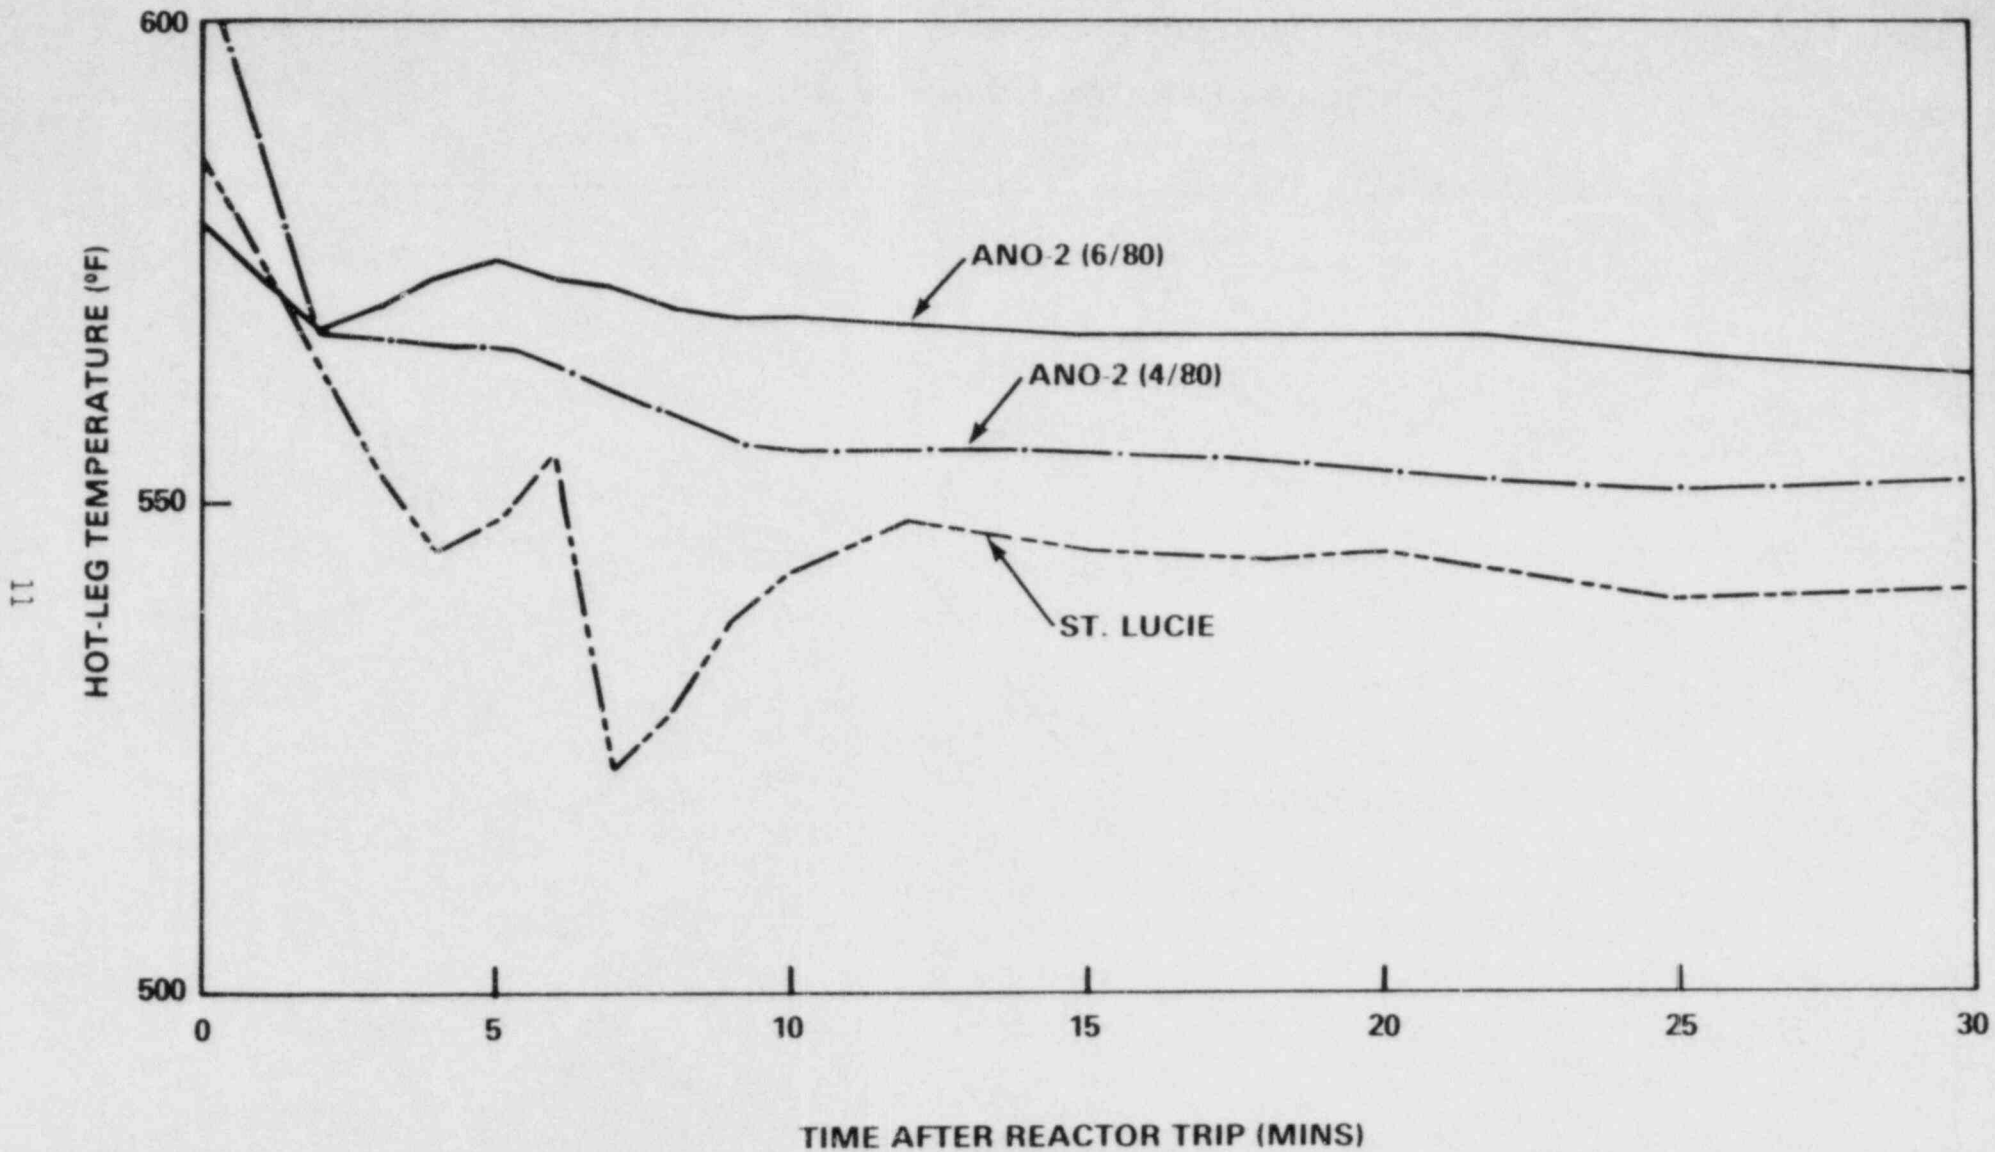
FIGURE 1 NATURAL CIRCULATION RESPONSE OF CE-DESIGNED PLANTS — HOT-LEG TEMPERATURE

A comparison of the natural circulation response of CE-designed plants is shown in Figure 1. The two events at Arkansas Unit 2 were initiated by loss-of-offsite power caused by tornadoes or lightning. The St. Lucie Unit 1\* event did not involve the loss of electrical power, but resulted from the manual tripping of the RCPs due to a loss of component cooling water to the pumps. The St. Lucie event is particularly significant as it relates to natural circulation since (1) the operator restarted an RCP because of his concern that natural circulation had not been established based on increasing hot leg temperature (five minutes after reactor trip), and (2) a steam bubble formed in the upper head of the reactor vessel because of a rapid depressurization of the RCS during natural circulation.

In Figure 1, the differences between the responses of the Arkansas Unit 1 and St. Lucie plants are related to the causes of the events and how steam pressure is controlled. On loss-of-offsite power, the main condenser is not available and the steam pressure is controlled by the relief valves at a higher pressure than when the steam dump system is available (St. Lucie). The hot leg temperature differences between the two Arkansas events are due to operator actions to reduce the steam pressure by opening the atmospheric relief valves shortly after reactor trip during the April event. As a result, the duration of the transitional phase after RCP coastdown is reduced. After natural circulation is established, the hot leg temperature is relatively constant or decreasing, which is characteristic of fully developed natural circulation flow.

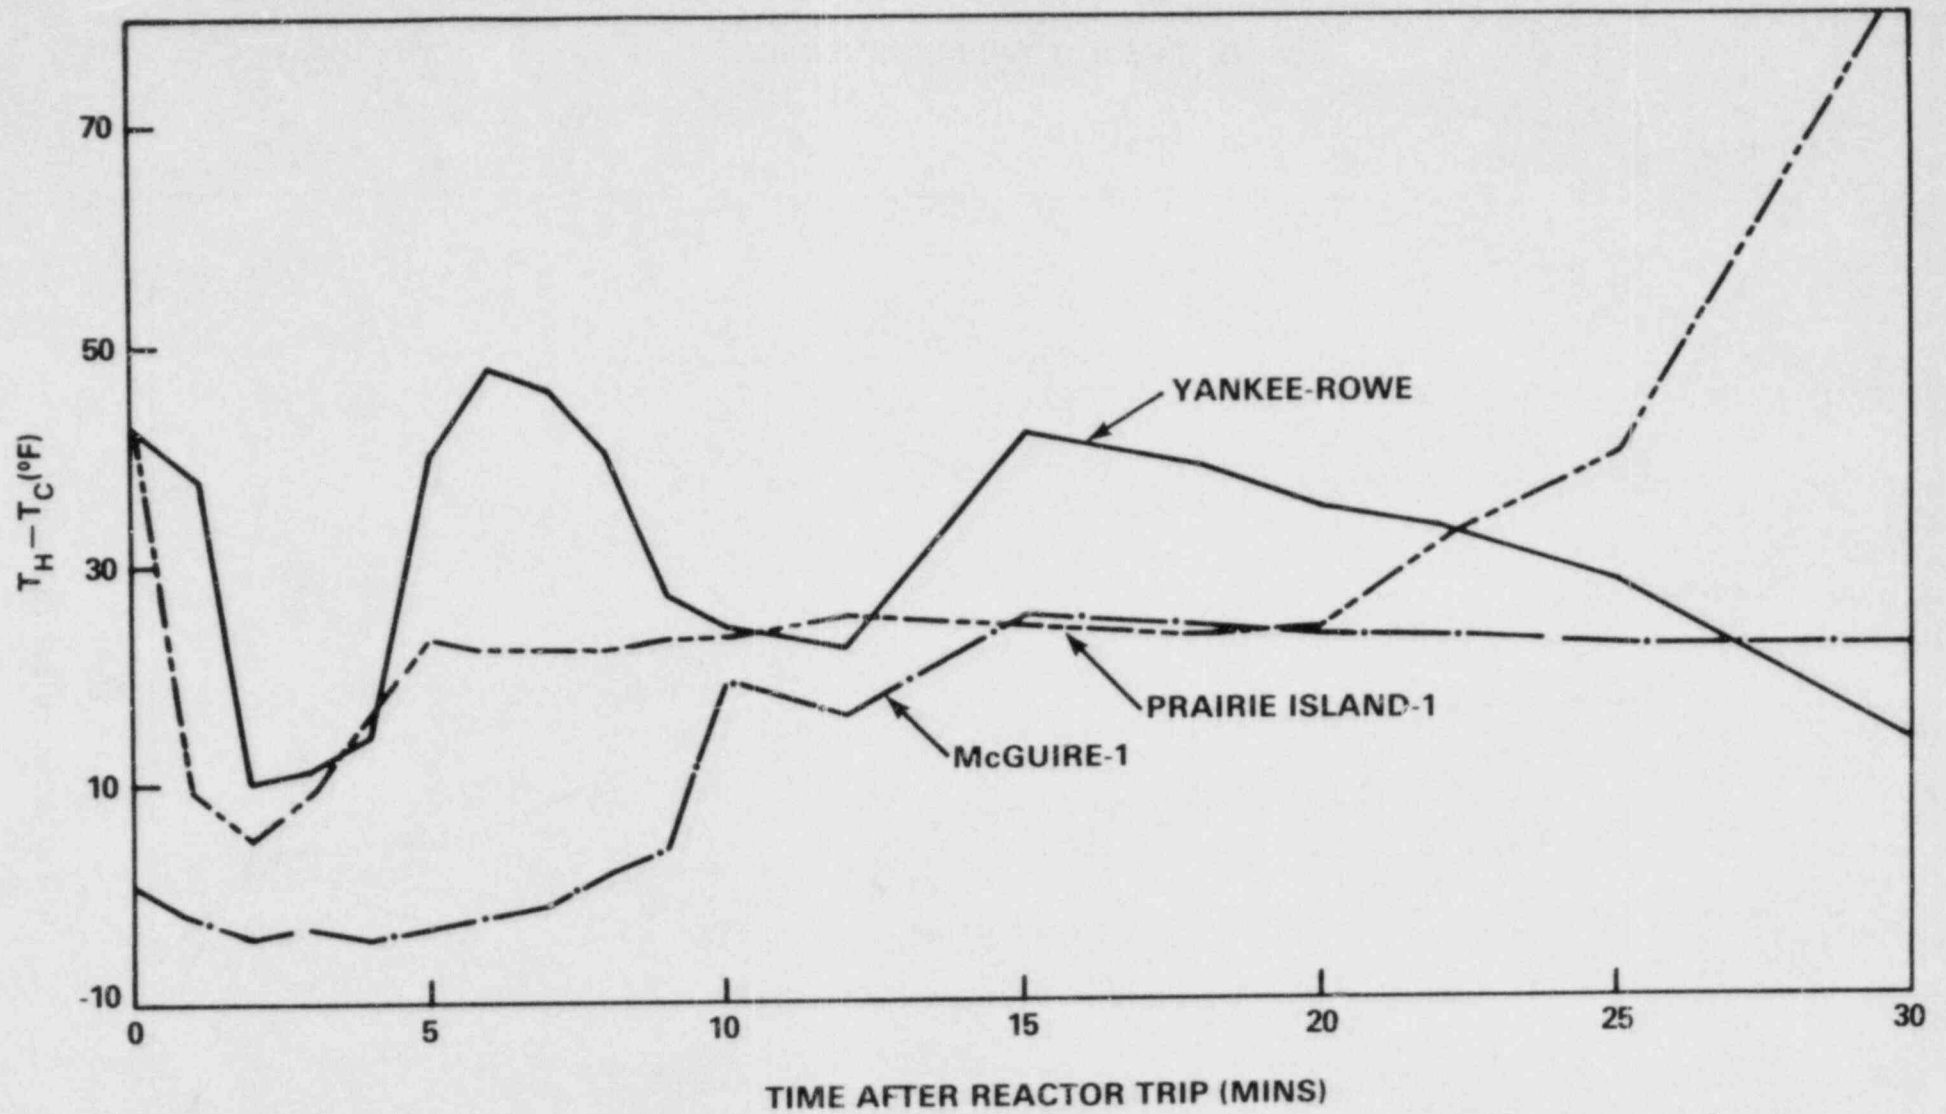
FIGURE 2 NATURAL CIRCULATION RESPONSE OF W-DESIGNED PLANTS - LOOP DIFFERENTIAL TEMPERATURE

The responses of W and CE plants were generally comparable, largely because of similarities between the RCS and steam generator designs. Also, there was no significant difference in the responses of W plants which have a different number of reactor coolant loops (McGuire Unit 1 and Yankee-Rowe have four loops, and Prairie Island Unit 1 has two loops).\*\* The comparison of the temperature differences between the hot and cold coolant loops in Figure 2 shows that this parameter responds in the same manner for different Westinghouse designs, even with extenuating conditions during the transition to fully established natural circulation flow. Note that the remaining RCP was tripped at 4 minutes and 9 minutes after the reactor trips at Yankee-Rowe and McGuire, respectively.

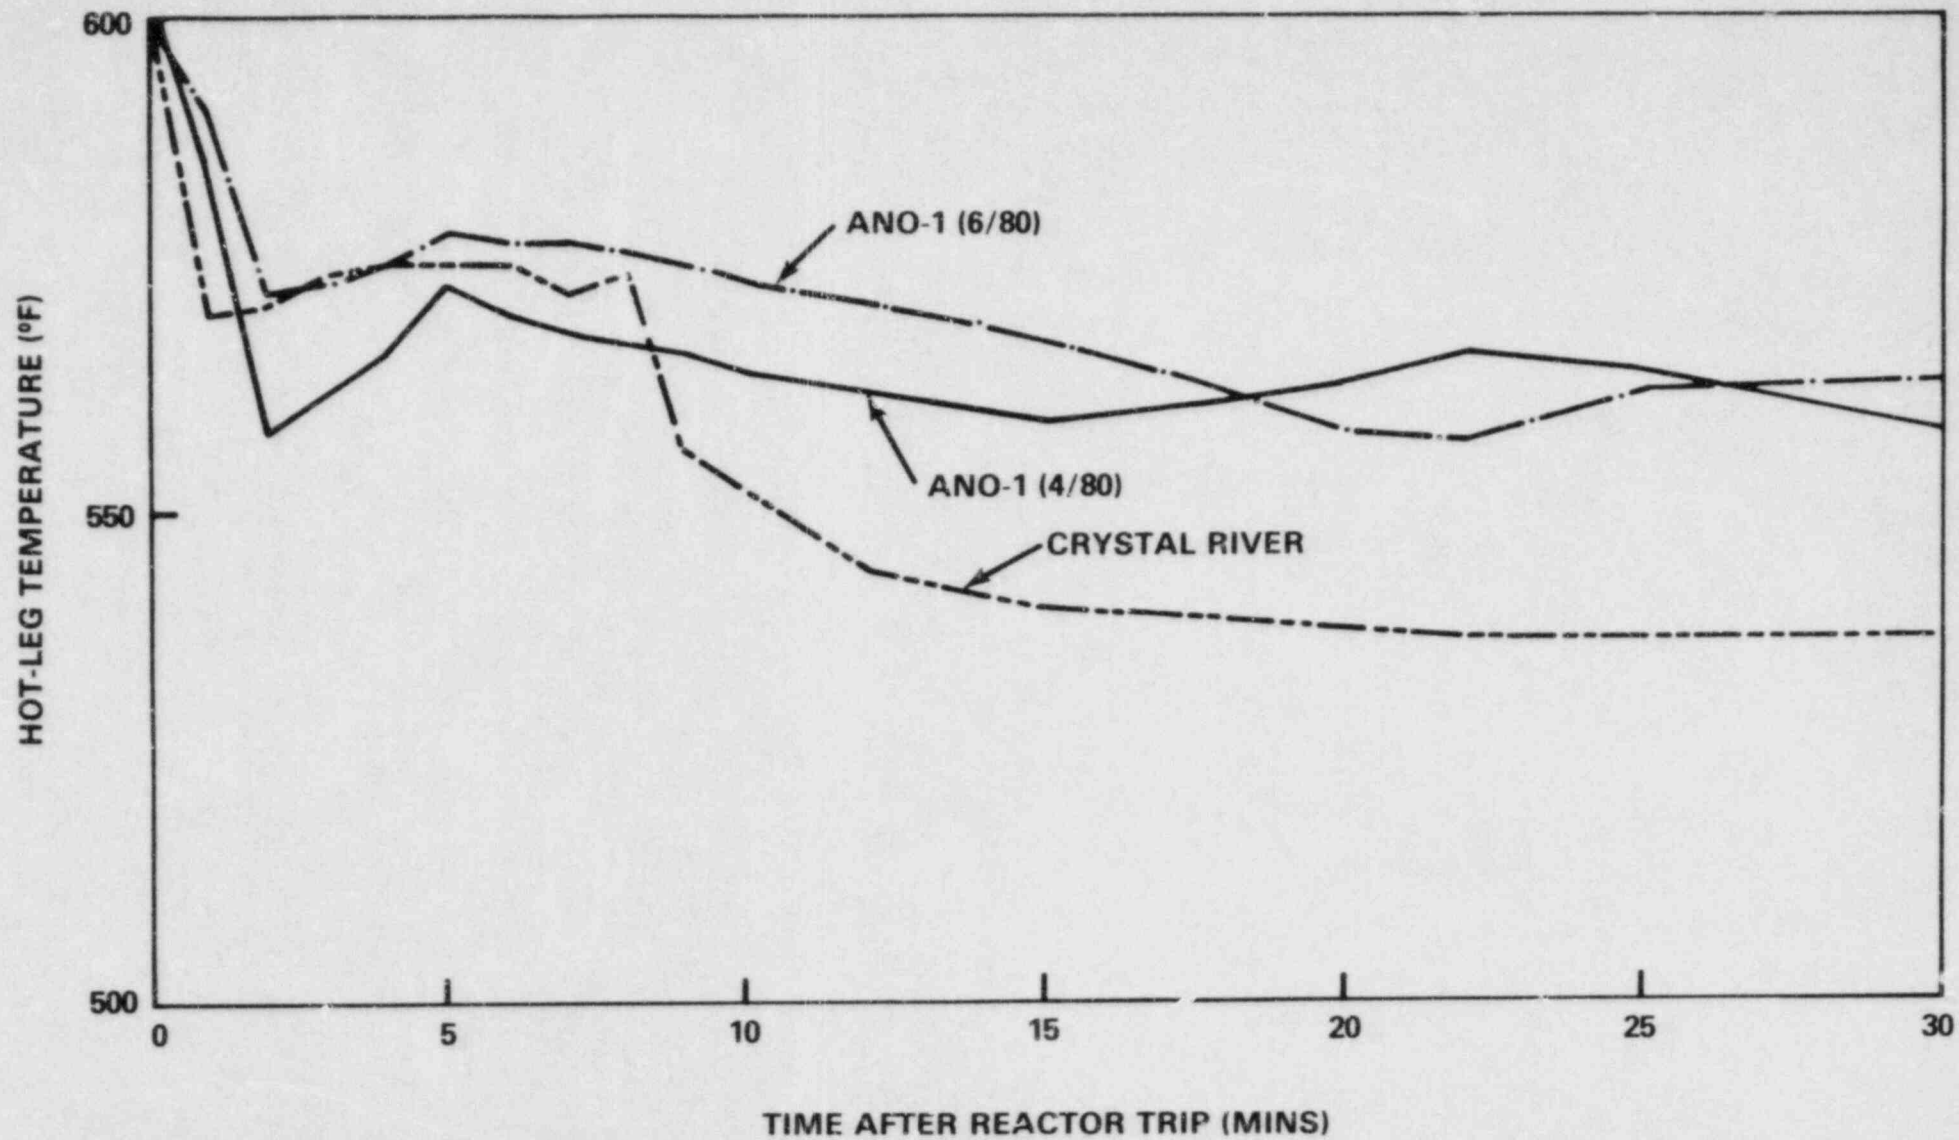
FIGURE 3 NATURAL CIRCULATION RESPONSE OF B&W-DESIGNED PLANTS — HOT LEG TEMPERATURE

The hot leg temperature responses of a B&W-designed plant following the loss-of-offsite power are shown in Figure 3. The small effects of safety injection on natural circulation can be seen in comparing the temperature responses during the two events at Arkansas Unit 1. The event in April 1980 involved the manual initiation of the high pressure injection system immediately following reactor trip and during coastdown of the RCPs. The primary effect was to reduce the magnitude of the reactor coolant temperature and to reduce the natural circulation flow rate by reducing the loop differential temperature.

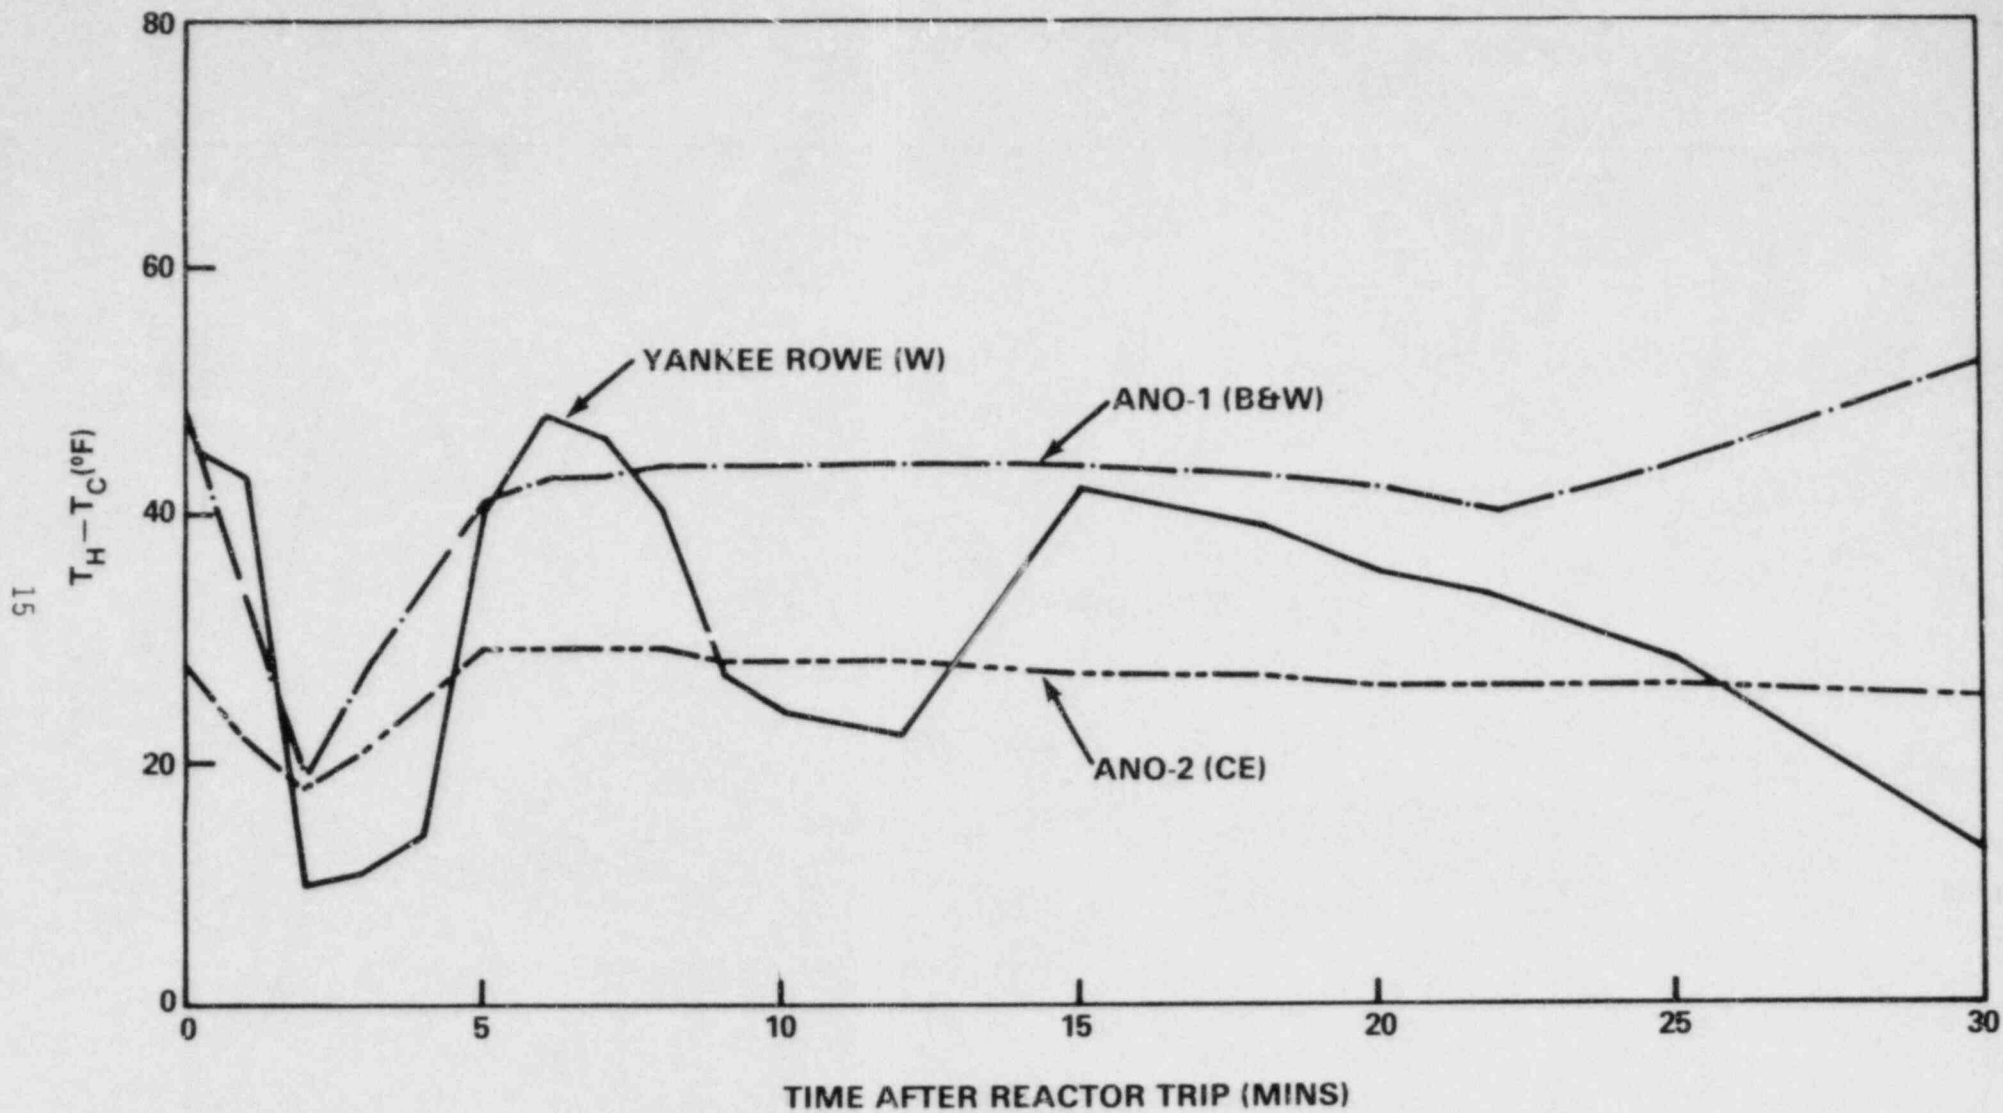
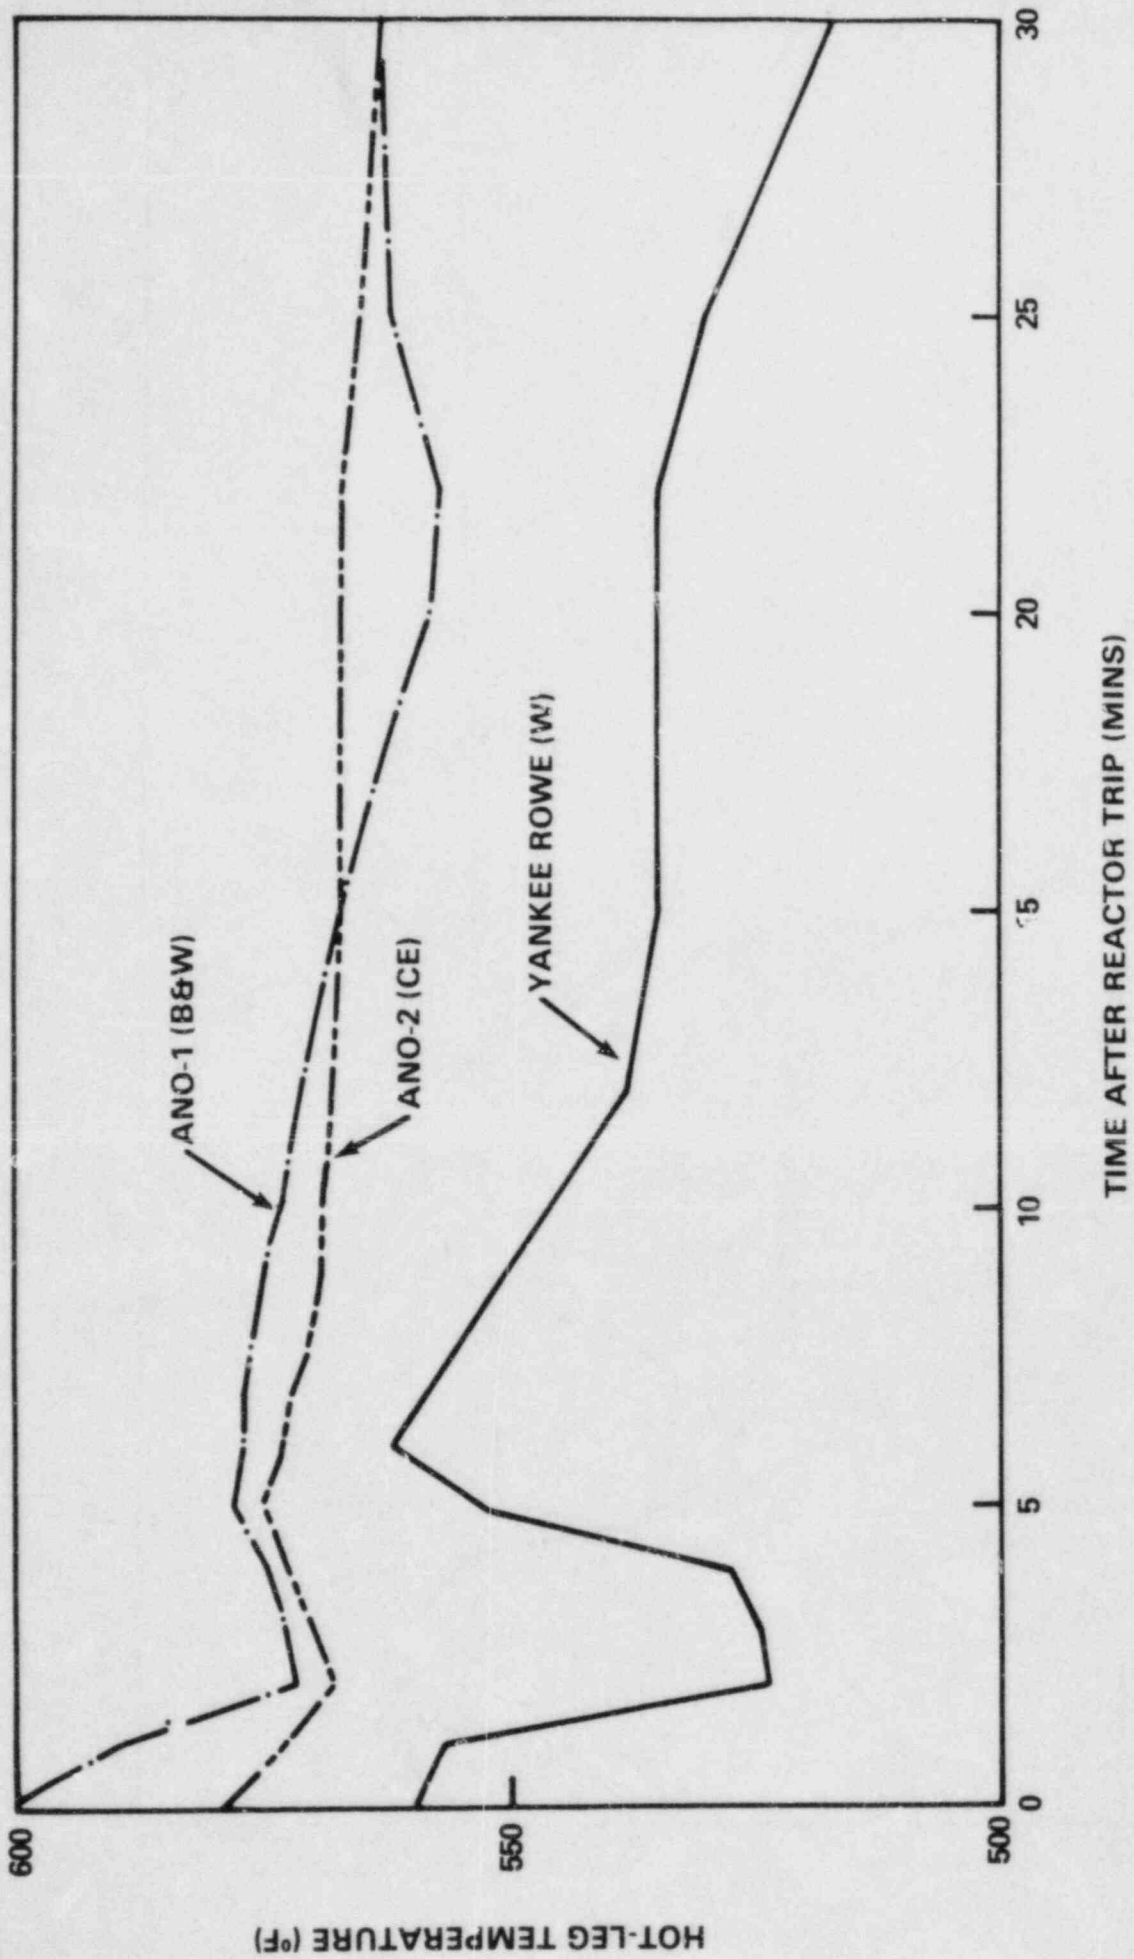
Figures 4 and 5 show the temperature responses of the three PWR designs (B&W, W, CE) during natural circulation cooling. In general, the trends of the parameters during the transition to establish natural circulation flow are the same when the conditions affecting the parameters discussed previously are considered. These comparisons show that design of the nuclear steam supply system is not a major factor affecting single phase natural circulation cooling, but that the conditions affecting the thermal-hydraulic response (e.g., steam pressure control) are more important in understanding the response of PWRs during natural circulation.
