Houston Lighting & Power

ST-HL-AE-4137

South Texas Project
Unit 2

Supplement to Special Report Regarding
Standby Diesel Generator 23 Valid Failure on November 26, 1990

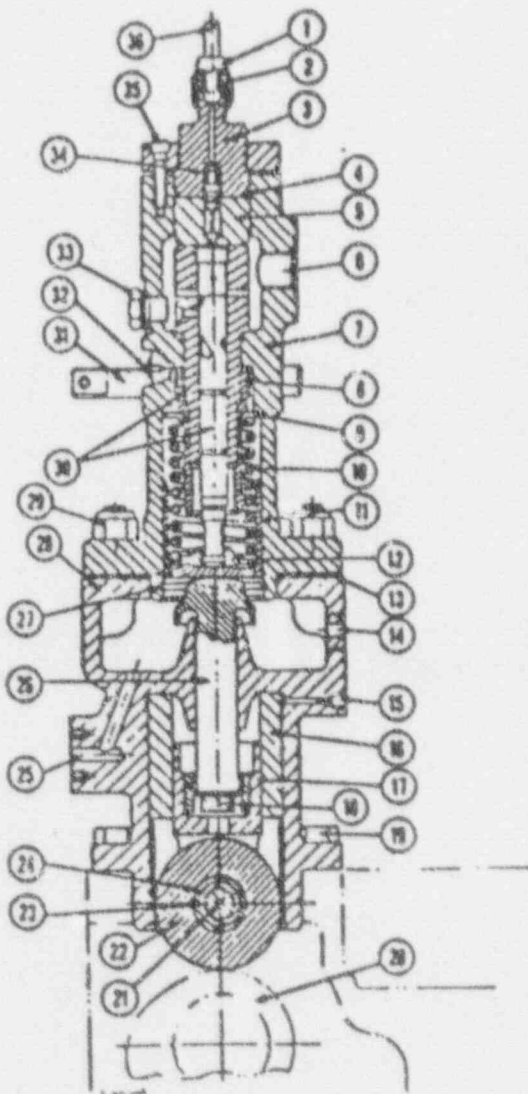
Fig. 8-4 Fuel Injection Pump and Pedestal

Upon disassembly of the fuel lines, a crack was found across the threaded portion of the delivery valve holder. The delivery valve holder, located on top of the fuel injection pump, is the connection point for the high pressure fuel injection pump discharge line (see attached figure, item #3). The delivery valve holder, stop, and spring were replaced, and post-maintenance testing was satisfactorily completed on November 27, 1990. SDG 23 was declared operable on November 27, 1990, at approximately 1144.

A crack across the threads in the delivery valve holder for Unit 2 SDG 21 injection pump 4L was discovered on October 23, 1990, and injection pump 4L was replaced. The delivery valve holder was sent for failure analysis along with the failed SDG 23 component from the November 26 event.

An update on the results of the Cooper-Bessemer analysis was received in a letter dated February 5, 1991. Cooper-Bessemer found from metallurgy lab tests that the material (from the failed delivery valve holders) agrees with the manufacturer's specification, but the stress condition produced by tightening the tapered fitting into the holder is aggravated by the sulfide stringers present in the material.

The cause of the event is a less than adequate design of the delivery valve holder which is prone to cracking. Overtorquing of the fuel line nuts was identified as a root cause for cracks previously found on delivery valve holders. Failure of the SDG manufacturer to clearly address the issues concerning torquing of fuel line nuts caused inappropriate torque values to be implemented. After maintenance procedures were changed, however, no wholesale replacement of potentially affected components was performed because non-destructive testing did not detect cracks, and the likelihood of oil spraying as a result of the leak is very small.

1. The injection pump 1L delivery valve, delivery valve holder, and delivery valve spring were replaced on November 27, 1990.
2. STP has prepared a plan of action for implementing recommendations of the CBOG for resolving the delivery valve holder cracking problem. Installation of the new design will be completed on Unit 1 SDGs no later than its fourth refueling outage (scheduled for Fall 1992), and on Unit 2 SDGs no later than its third refueling outage (scheduled for Spring 1993).
