U.S. NUCLEAR REGULATORY COMMISSION

Report No. 50-440/92004(DRS)

Facility Name: Perry Nuclear Power Plant

Inspection on March 26 - June 23, 1992 (Report No. 50-440/92004(DRS))

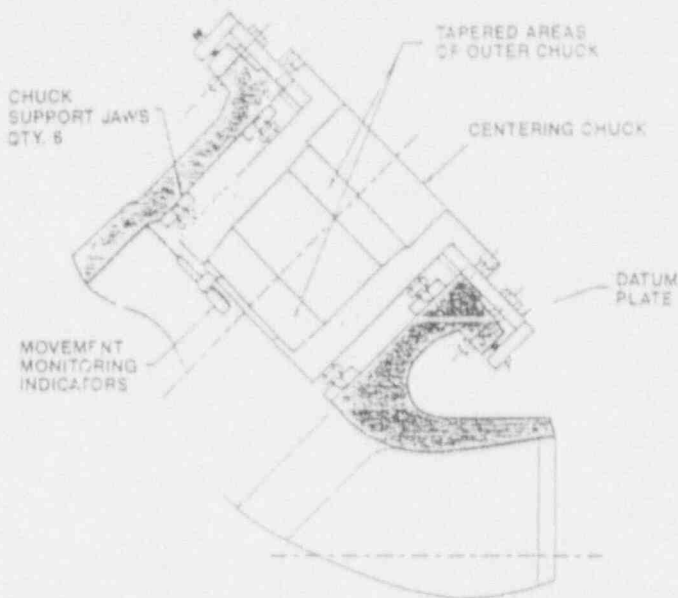
# OUTER CHUCK INSTALLATION

**Only one set-up for all steps**
