NUREG/CR-5892
UCRL-ID-113638

Highway Accident Involving Unirradiated Nuclear Fuel in Springfield, Massachusetts, on December 16, 1991

Presented to
the Nuclear Regulatory Commission

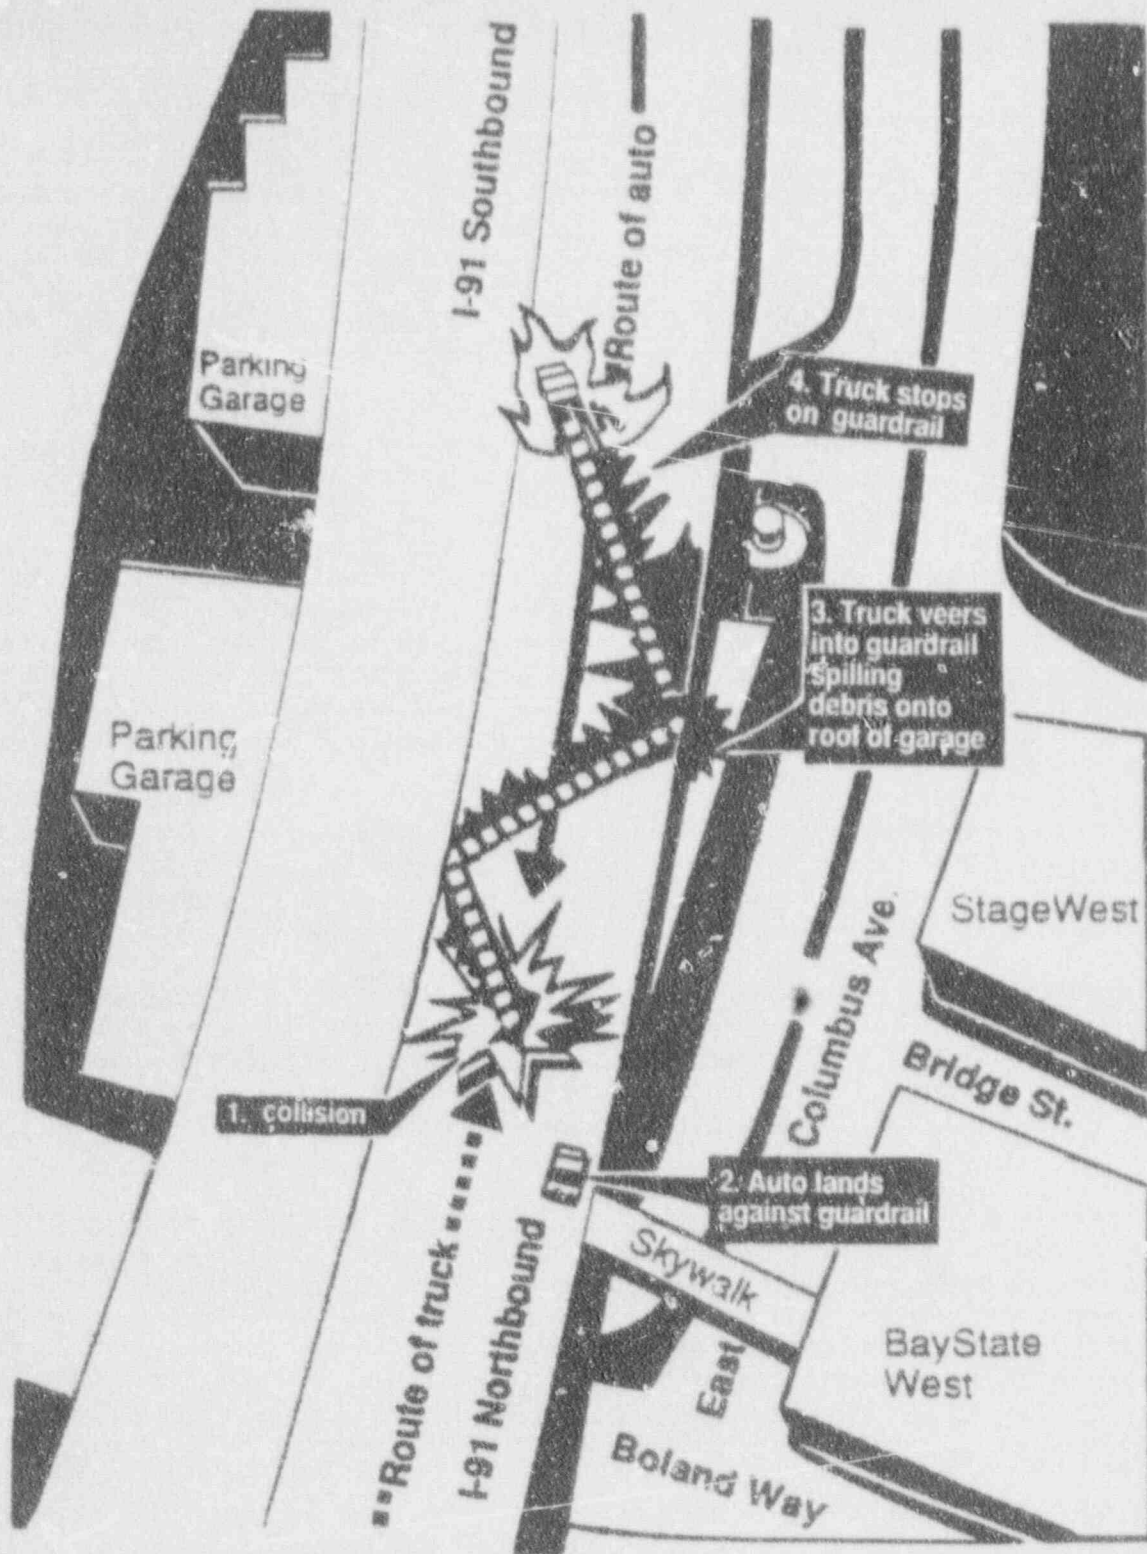
Figure 2.1 Site of Collision and Path of Vehicles Following Collision

A sketch of the accident scene is presented in Figure 2.1. Both the car and the truck were reported to be traveling in the center lane. The driver of the truck veered left in an attempt to avoid the collision. The car appeared to continue in a straight path and struck the tractor of the truck at an angle causing damage to the passenger side of the car and the passenger side of the truck. The initial impact appeared to involve the fuel tank and/or storage compartment on the right side of the tractor. (See Figure 2.4 for a view of an undamaged tractor in the vicinity of the impact.)

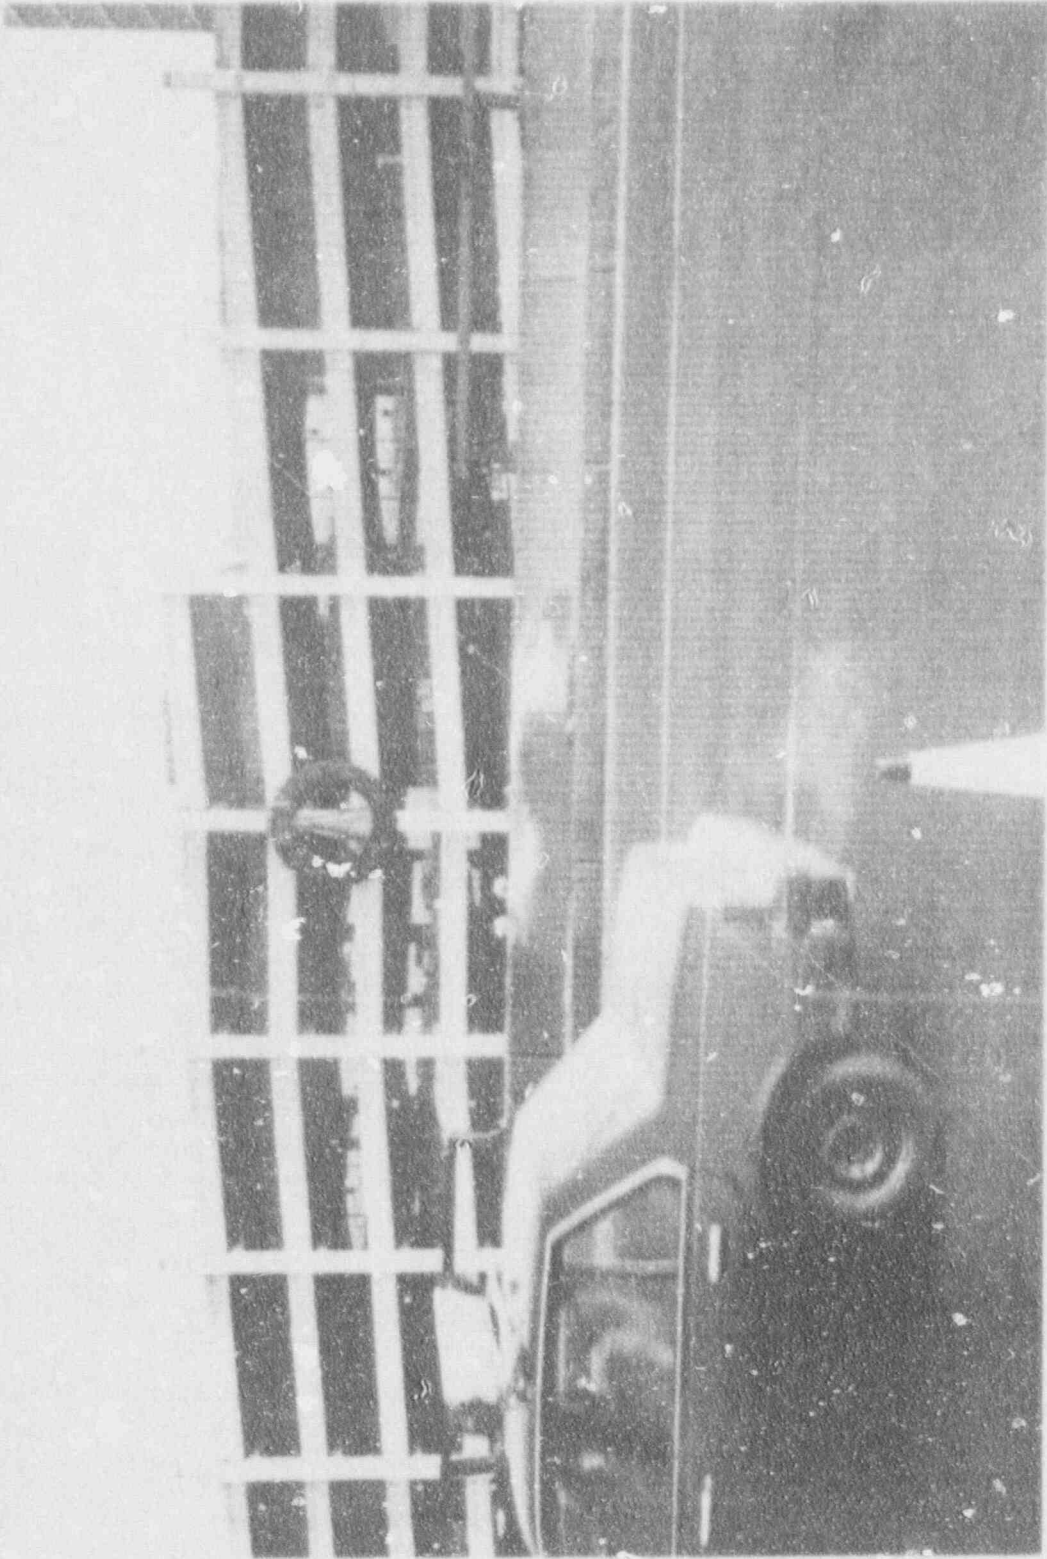
Figure 2.2 Concrete Barrier at Outside of Roadway at Site of Collision

Following the initial impact, the truck continued northbound veering toward the center of the Interstate and impacting the small curb and guardrail that separates the northbound from the southbound lanes. The impact was a glancing blow that apparently dislodged the left front wheel of the tractor and probably damaged some of the air tanks and/or tubing that provide compressed air to operate the brakes, suspension, and several accessories. The co-driver (also an experienced driver) was sleeping in the sleeper portion of the tractor and reported hearing an explosion during this impact. The source of this explosion is speculative, but one possibility could be the failure of any one of several compressed air components. This could also explain the loss of air pressure in the braking system.

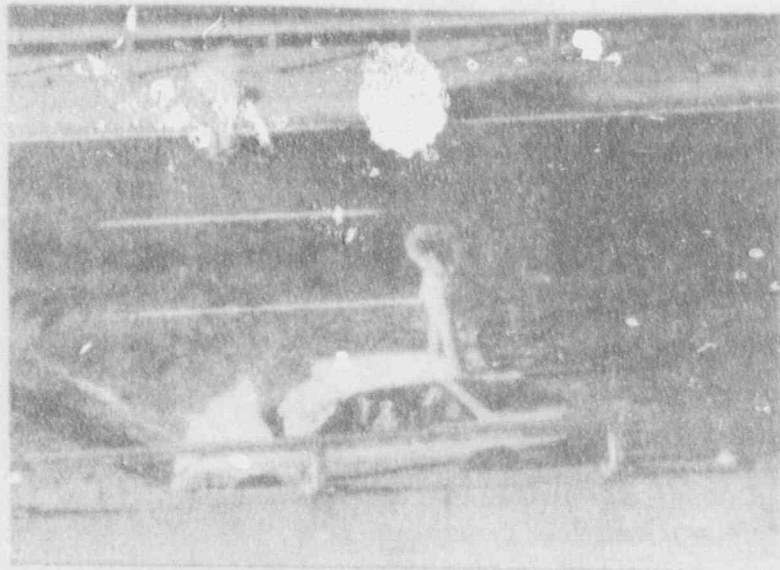
Figure 2.7 Damaged Car Following Collision

The car suffered extensive damage to its front, right corner. Following the accident, one front wheel with the strut attached and several smaller components of the car can clearly be seen lying in the roadway as shown in Figure 2.7. The car does not appear to have been involved in any fire.

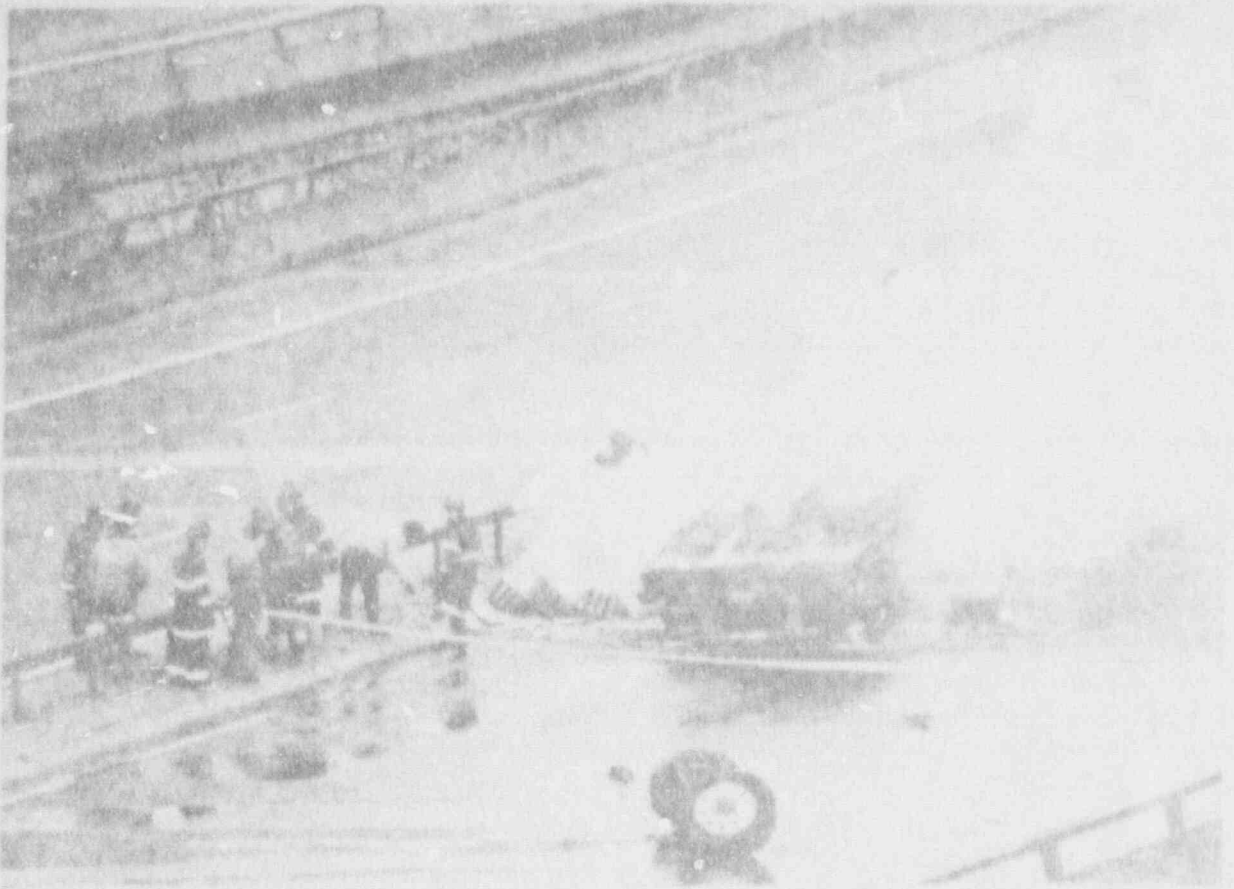
Figure 2.8 Photograph of Accident Scene Near End of Fire

During the impact with the concrete barrier, it is apparent that at least one of the truck's fuel tanks ruptured. The fluid on the roof of the parking garage was burning so it must be concluded that some of the combustible fluids in the engine compartment were also burning.

The tractor-trailer came to rest against the center guardrail with the tractor and trailer almost perfectly in line (see Figure 2.8). After the truck came to rest against the guardrail, the driver was able to get out of the tractor on the passenger side (the driver's side door was jammed). Fire was observed in the engine compartment and around the tires at the rear of the tractor. The co-driver reported stepping into a large puddle of diesel fuel on exiting from the tractor. At this time the fire was restricted to the engine and tires of the tractor. The fire gradually expanded to engulf the entire tractor and the tractor was reported to have burned vigorously for at least three-quarters of an hour.

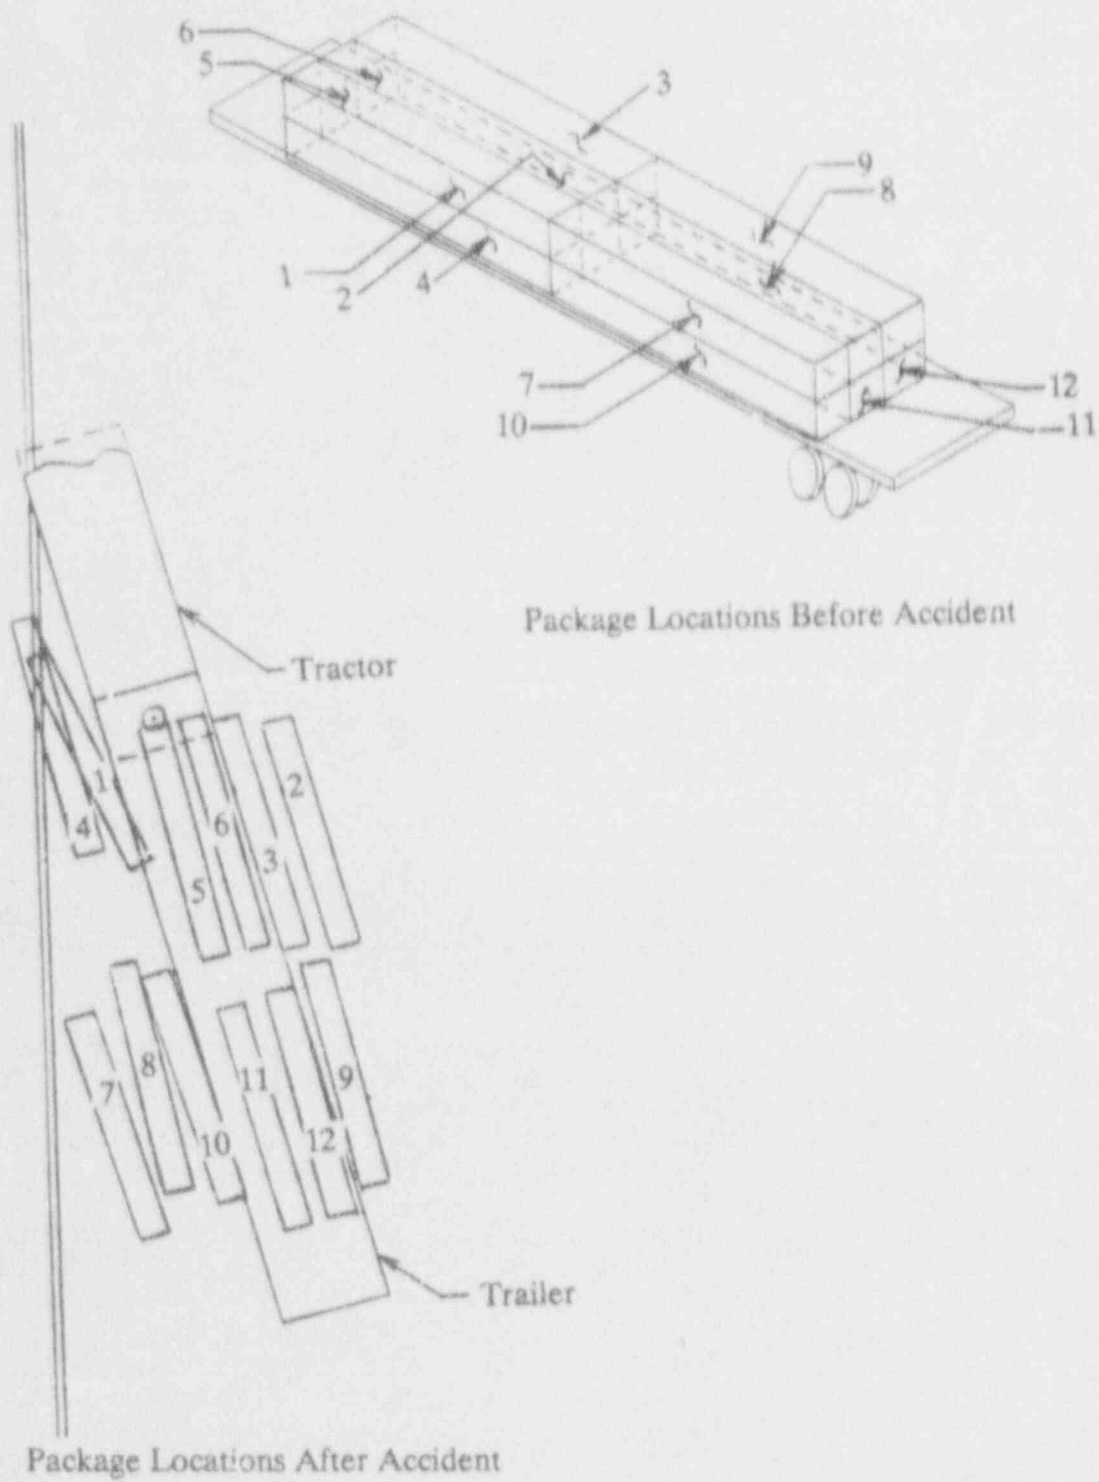
Figure 4.1 Probable Container Locations During Fire

- (3) The fire progressed from the front of the trailer to the rear causing damage to the front of each wooden outer containers before there was substantial damage to the rear of the container. This resulted in containers falling and rotating at one end while the other end was raised upward. Eventually the containers fell and rotated to the point where their center-of-gravity was outside the supporting container or the truck bed and the individual containers fell to the roadway.

The containers on the trailer have been given identification numbers for reference purposes that correspond to the container locations at the time of shipment. These identification numbers are indicated in Figure 4.1. The most reasonable interpretation of the information that is available in the videos of the fire and post fire cleanup permits the second portion of Figure 4.1 where the final locations of the containers are shown schematically and the identification numbers are also indicated to characterize the movement of the containers as they fell off the trailer. Figure 4.2 is part of the record of removal of the damaged containers following the fire. This figure also gives an indication of the location of the containers at the conclusion of the fire; however, the perspective in this photo hampers precise identification of the container locations.
