NUREG/CR-5885
BNL-NUREG-52331

Metallurgical Evaluation of Weld Overlaid Pipe Sections From Brunswick Unit 2 Nuclear Power Station

Brookhaven National Laboratory

Prepared for
U.S. Nuclear Regulatory Commission

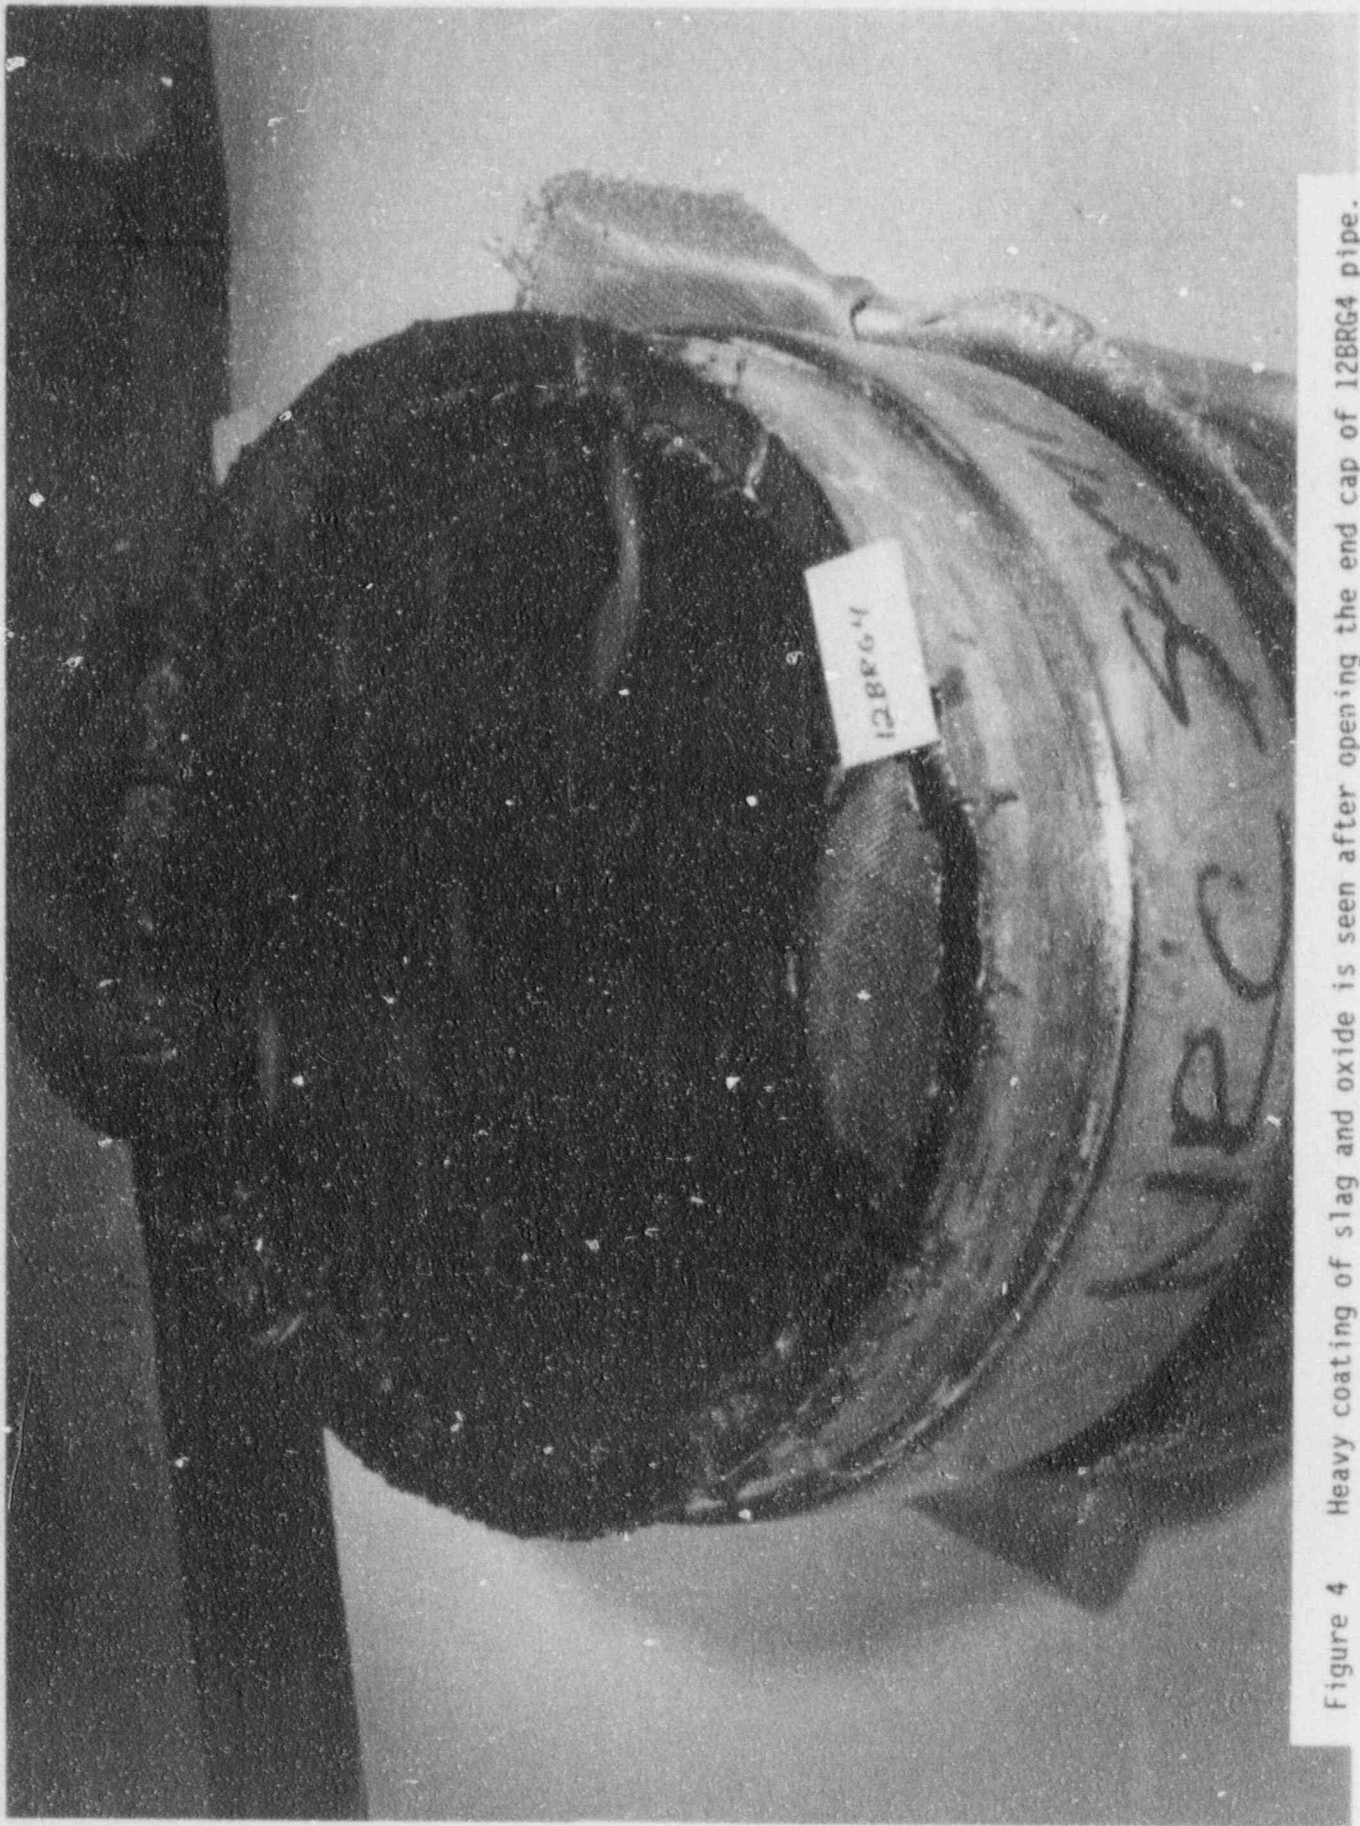
Figure 4 Heavy coating of slag and oxide is seen after opening the end cap of 12BRG4 pipe.

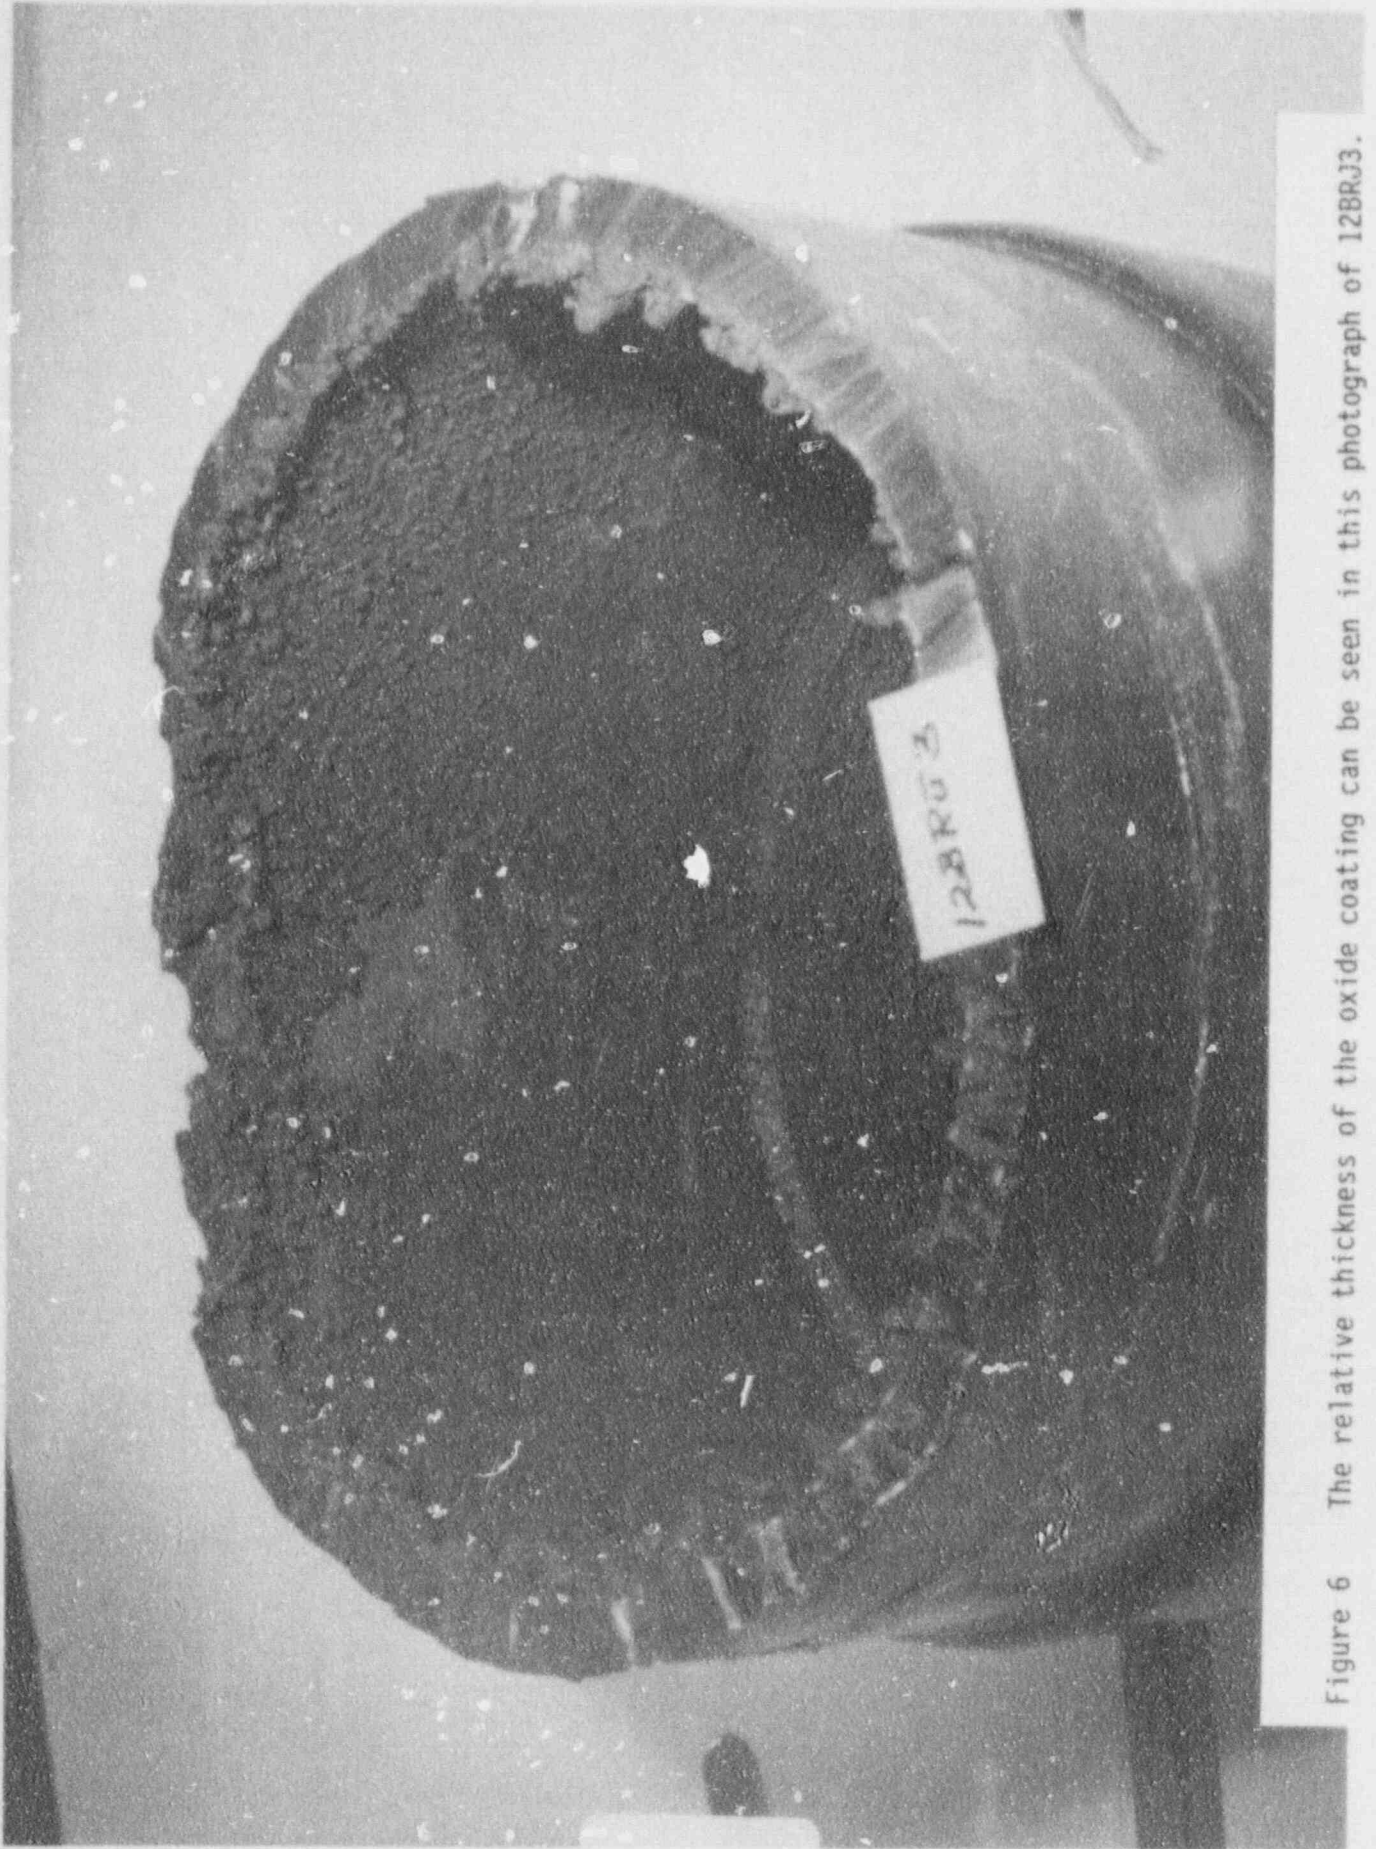
Figure 6 The relative thickness of the oxide coating can be seen in this photograph of 12BRJ3.

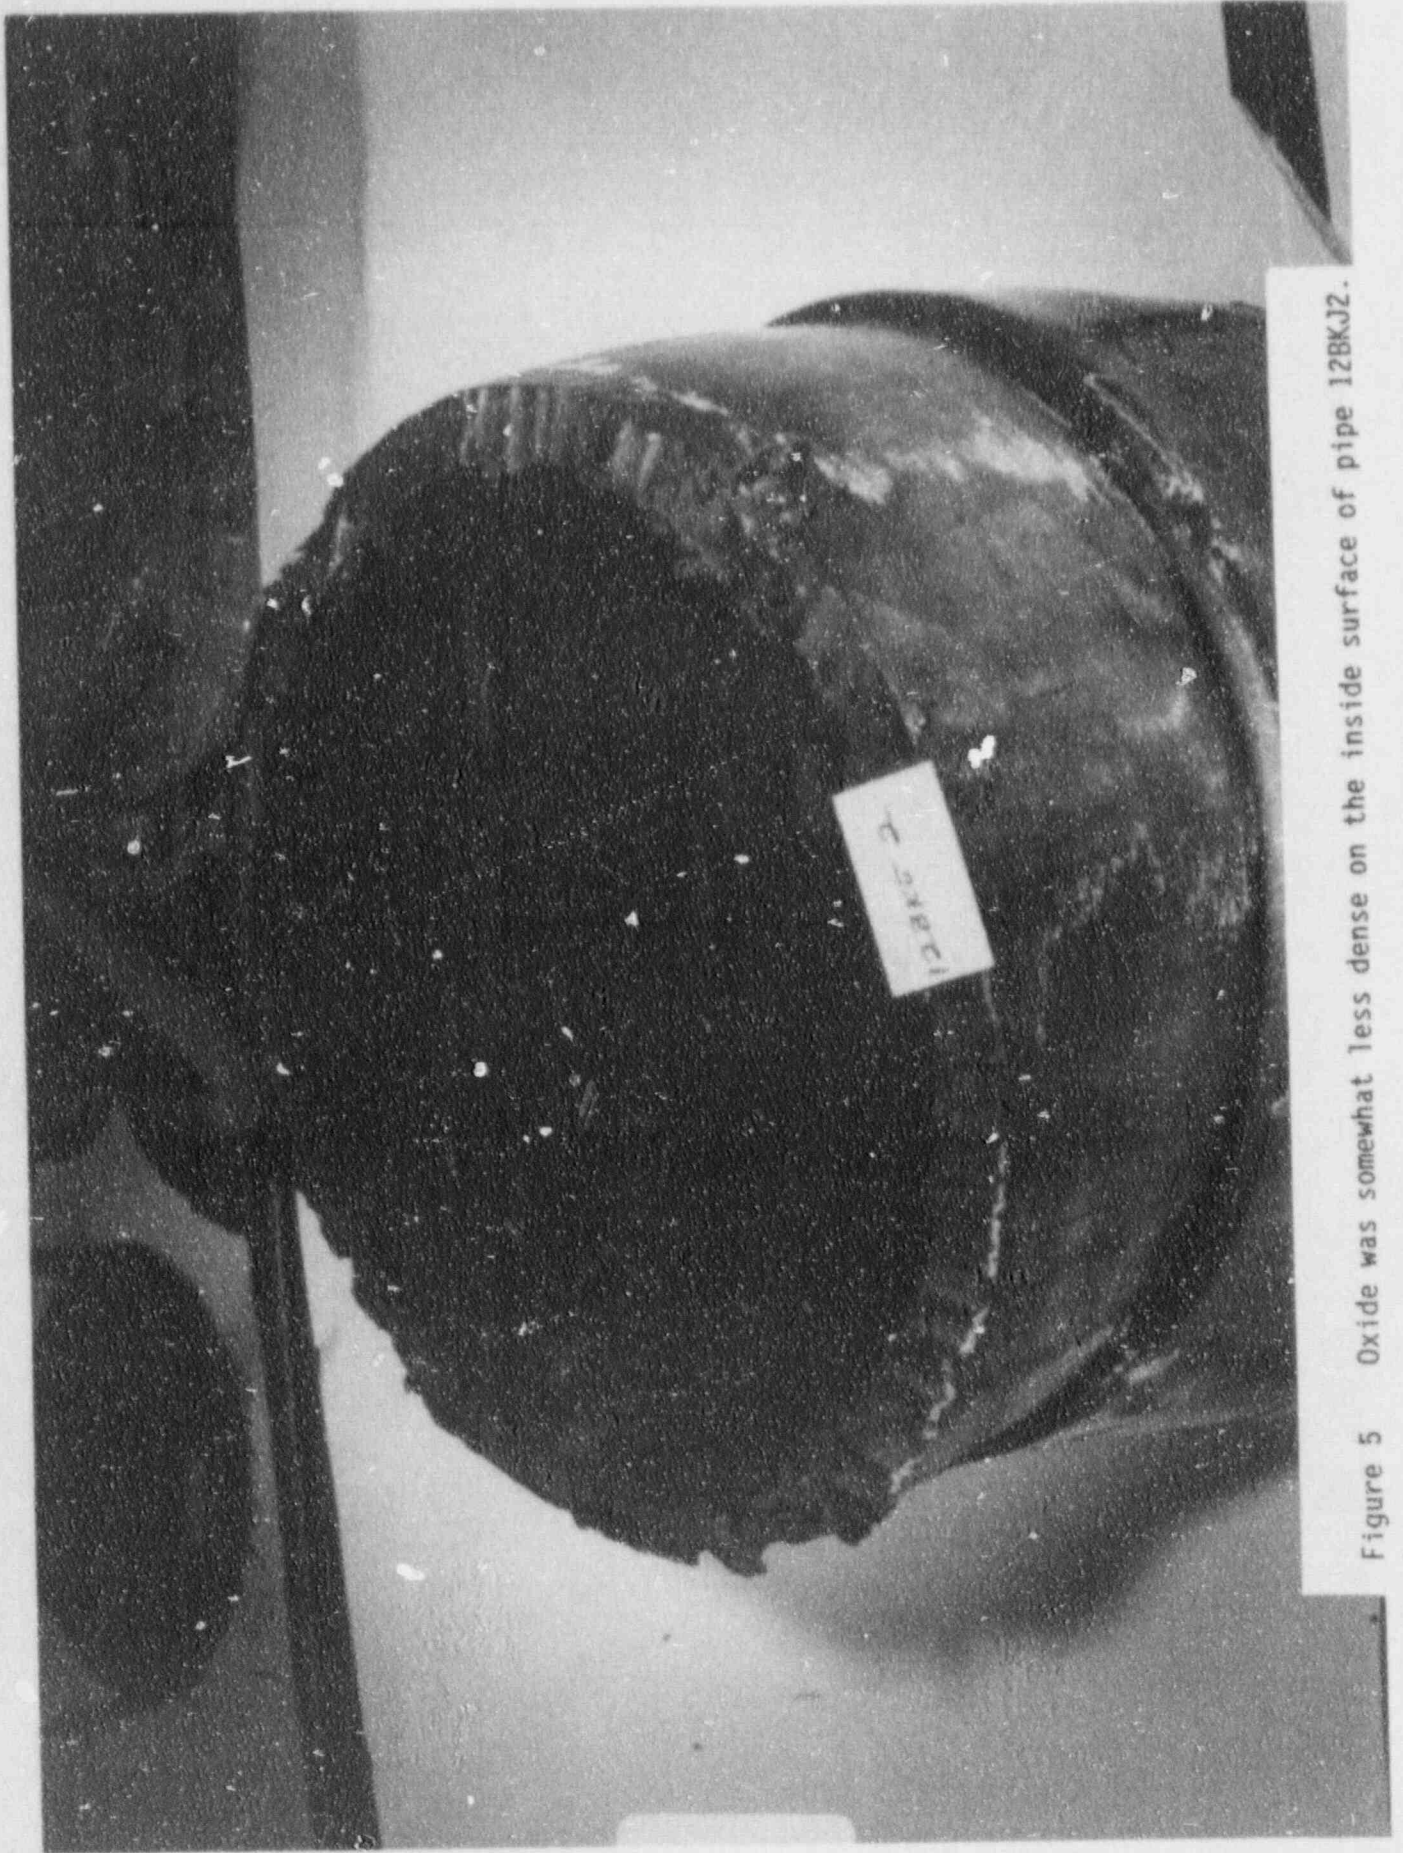
Figure 5 Oxide was somewhat less dense on the inside surface of pipe 12BKJ2.

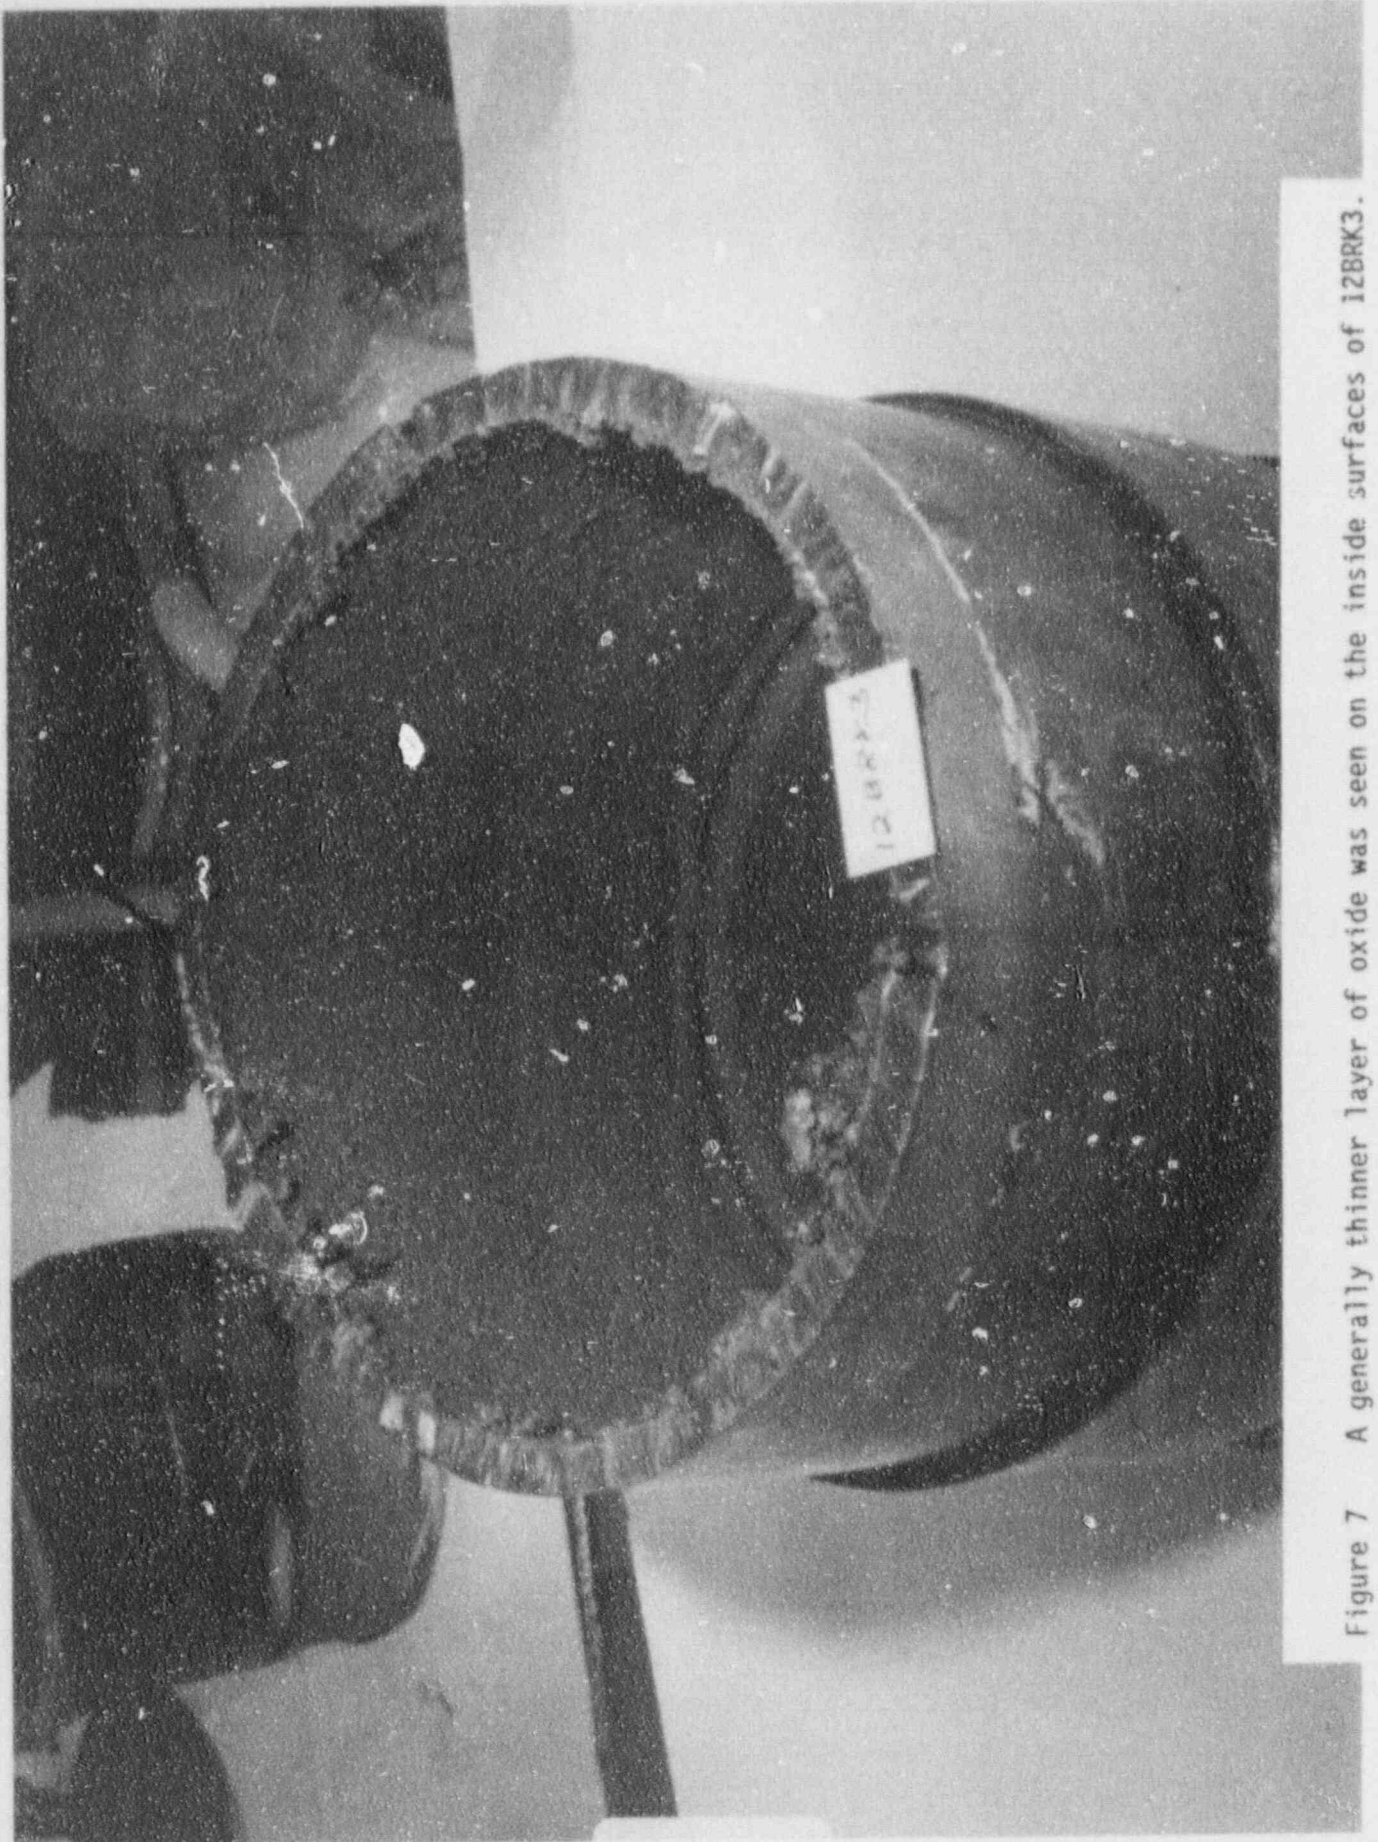
Figure 7 A generally thinner layer of oxide was seen on the inside surfaces of 12BRK3.

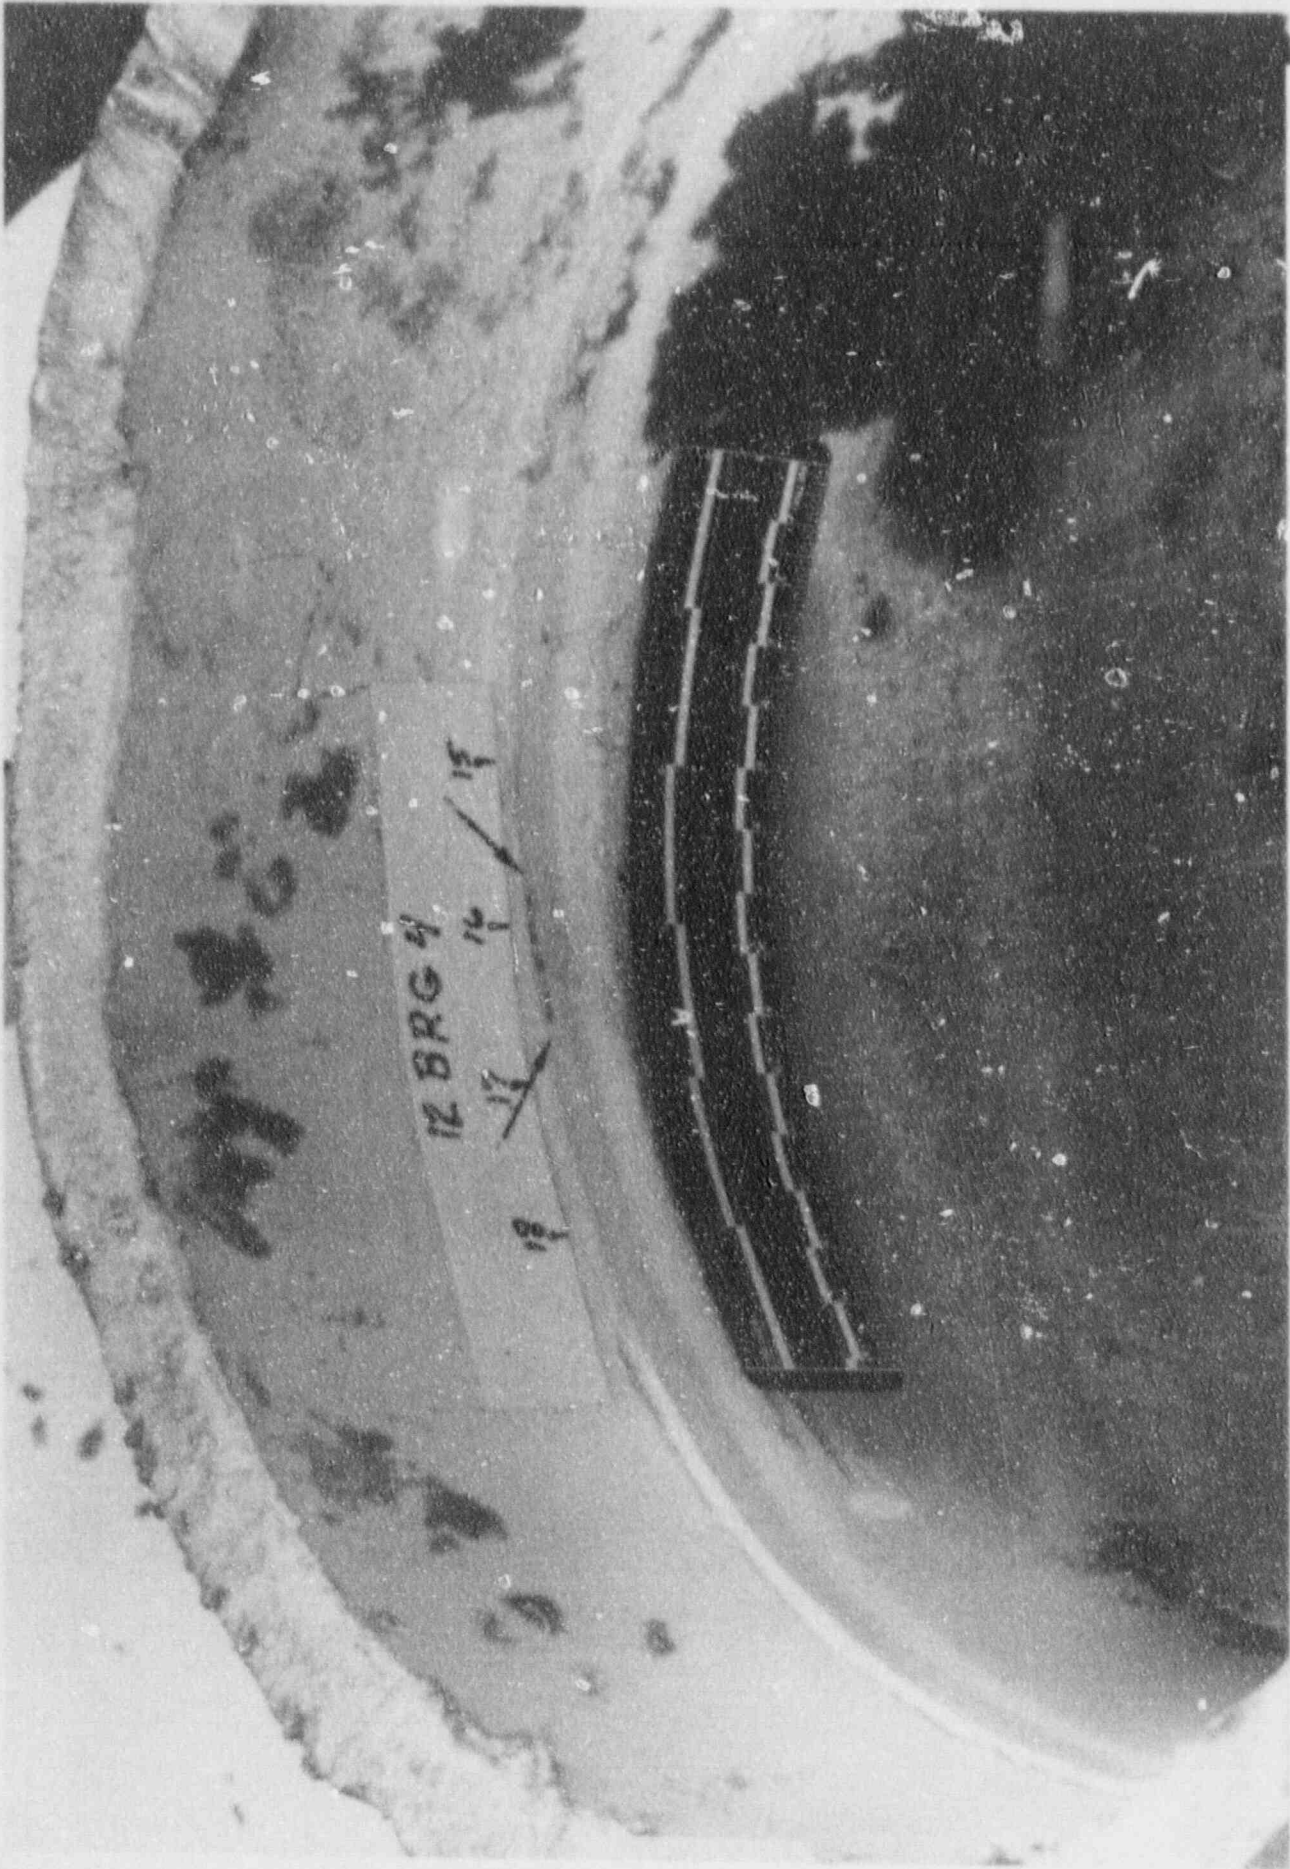
An approximately one inch long indication was noted between station markers 16-17 (Figure 8). A second indication approximately 7½" in length was located between stations 34 and 25 (Figure 9). A third indication (Figure 10) approximately 1½" long was located between stations 38 and 36.

Figure 8 A linear indication (~1 inch long) is seen at stations 17-16 after dye penetrant examination of 12BRG4 (arrows).

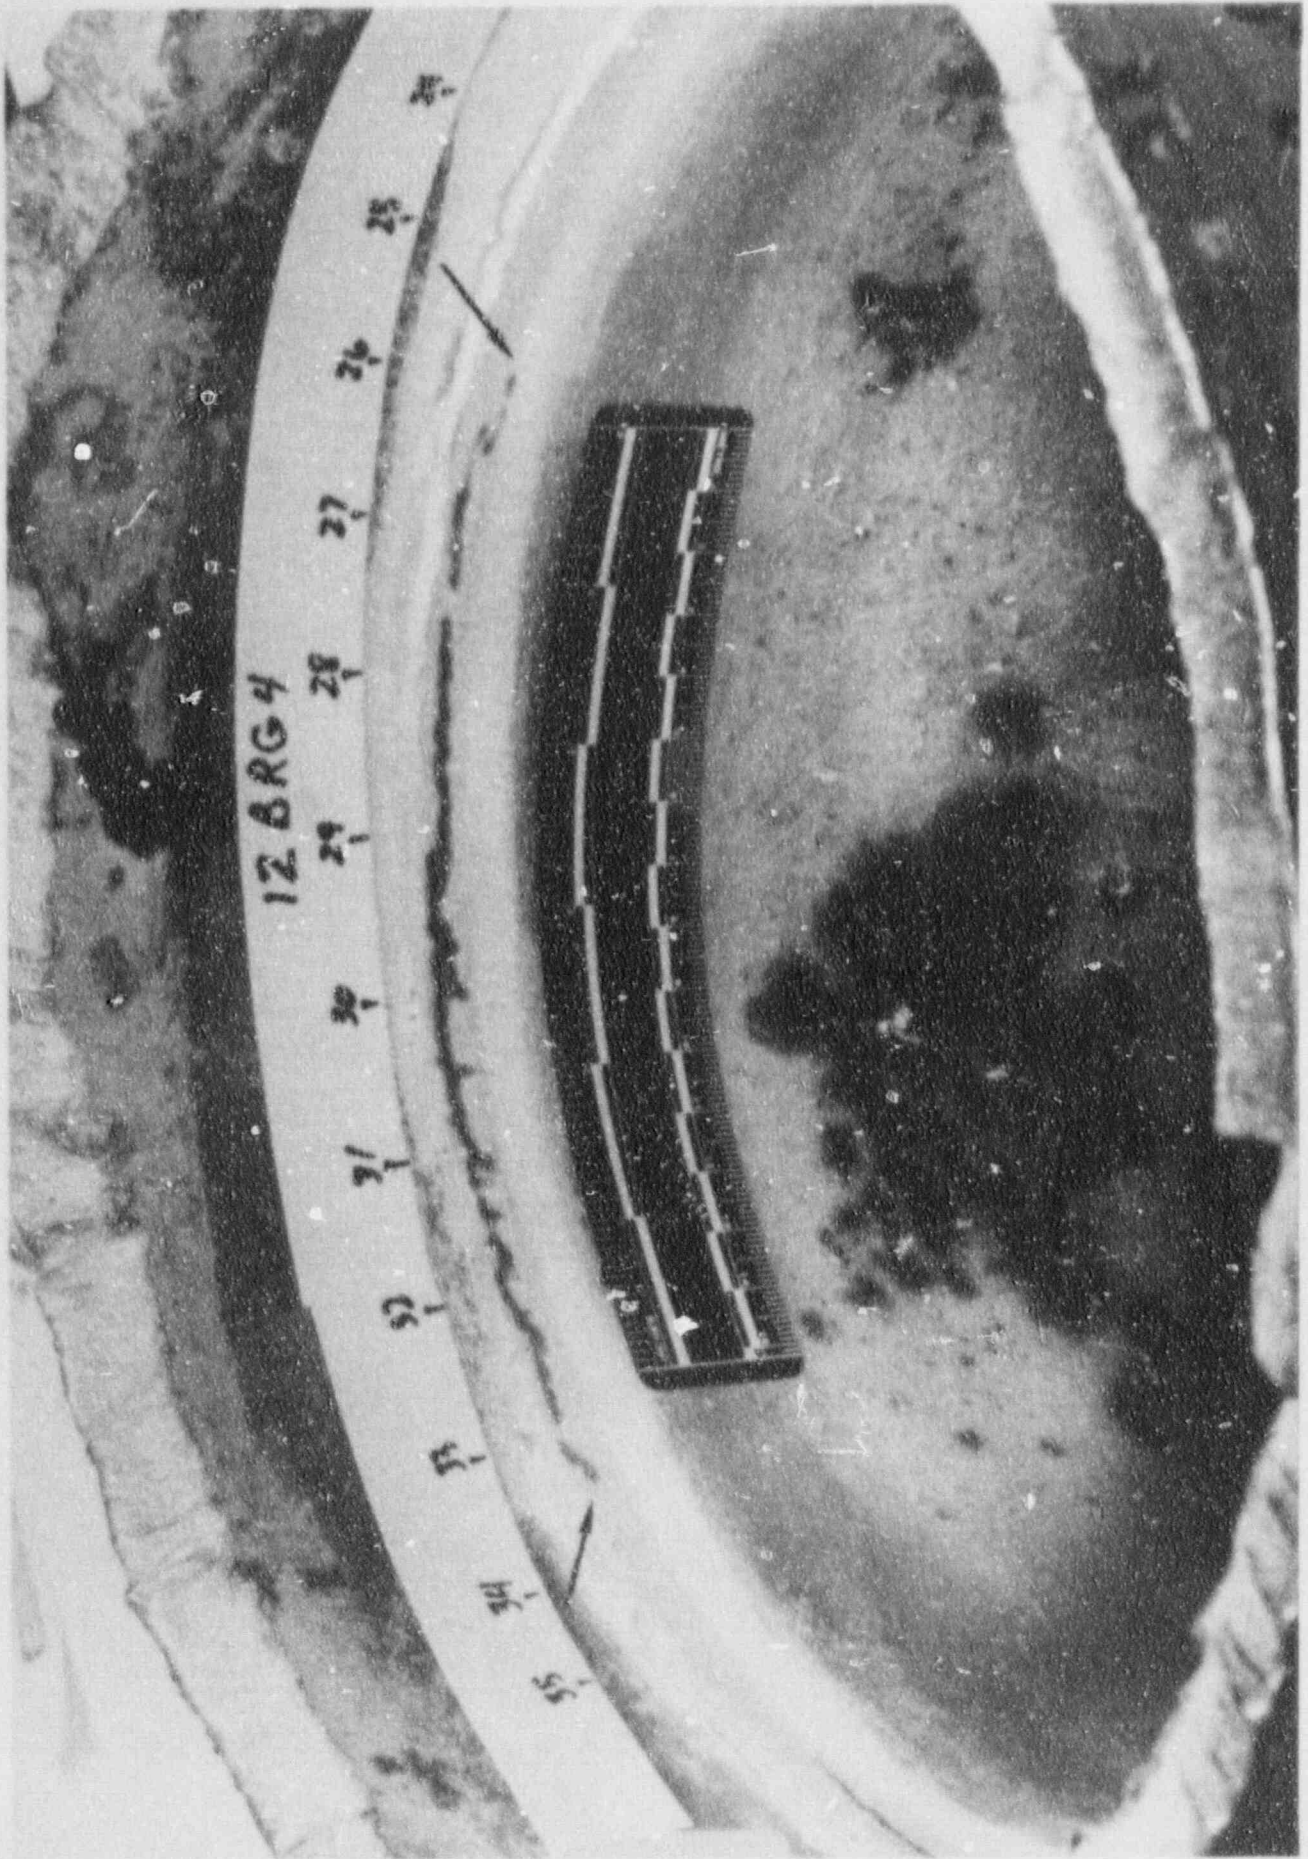
Optical microscopy revealed that all of the cracks were intergranular in nature. The large crack (7.5 inches long) in 12BRG4 was essentially "through wall" (original pipe) for approximately 30% of its length. This is in distinct contrast to the original inspection data which showed a two inch long 14% through wall crack and a second crack 1.25 inches and 7% through wall.

Figure 9 A 7 1/2" long indication was noted on 12BRG4 after dye penetrant was applied (stations 34-25) (arrows).

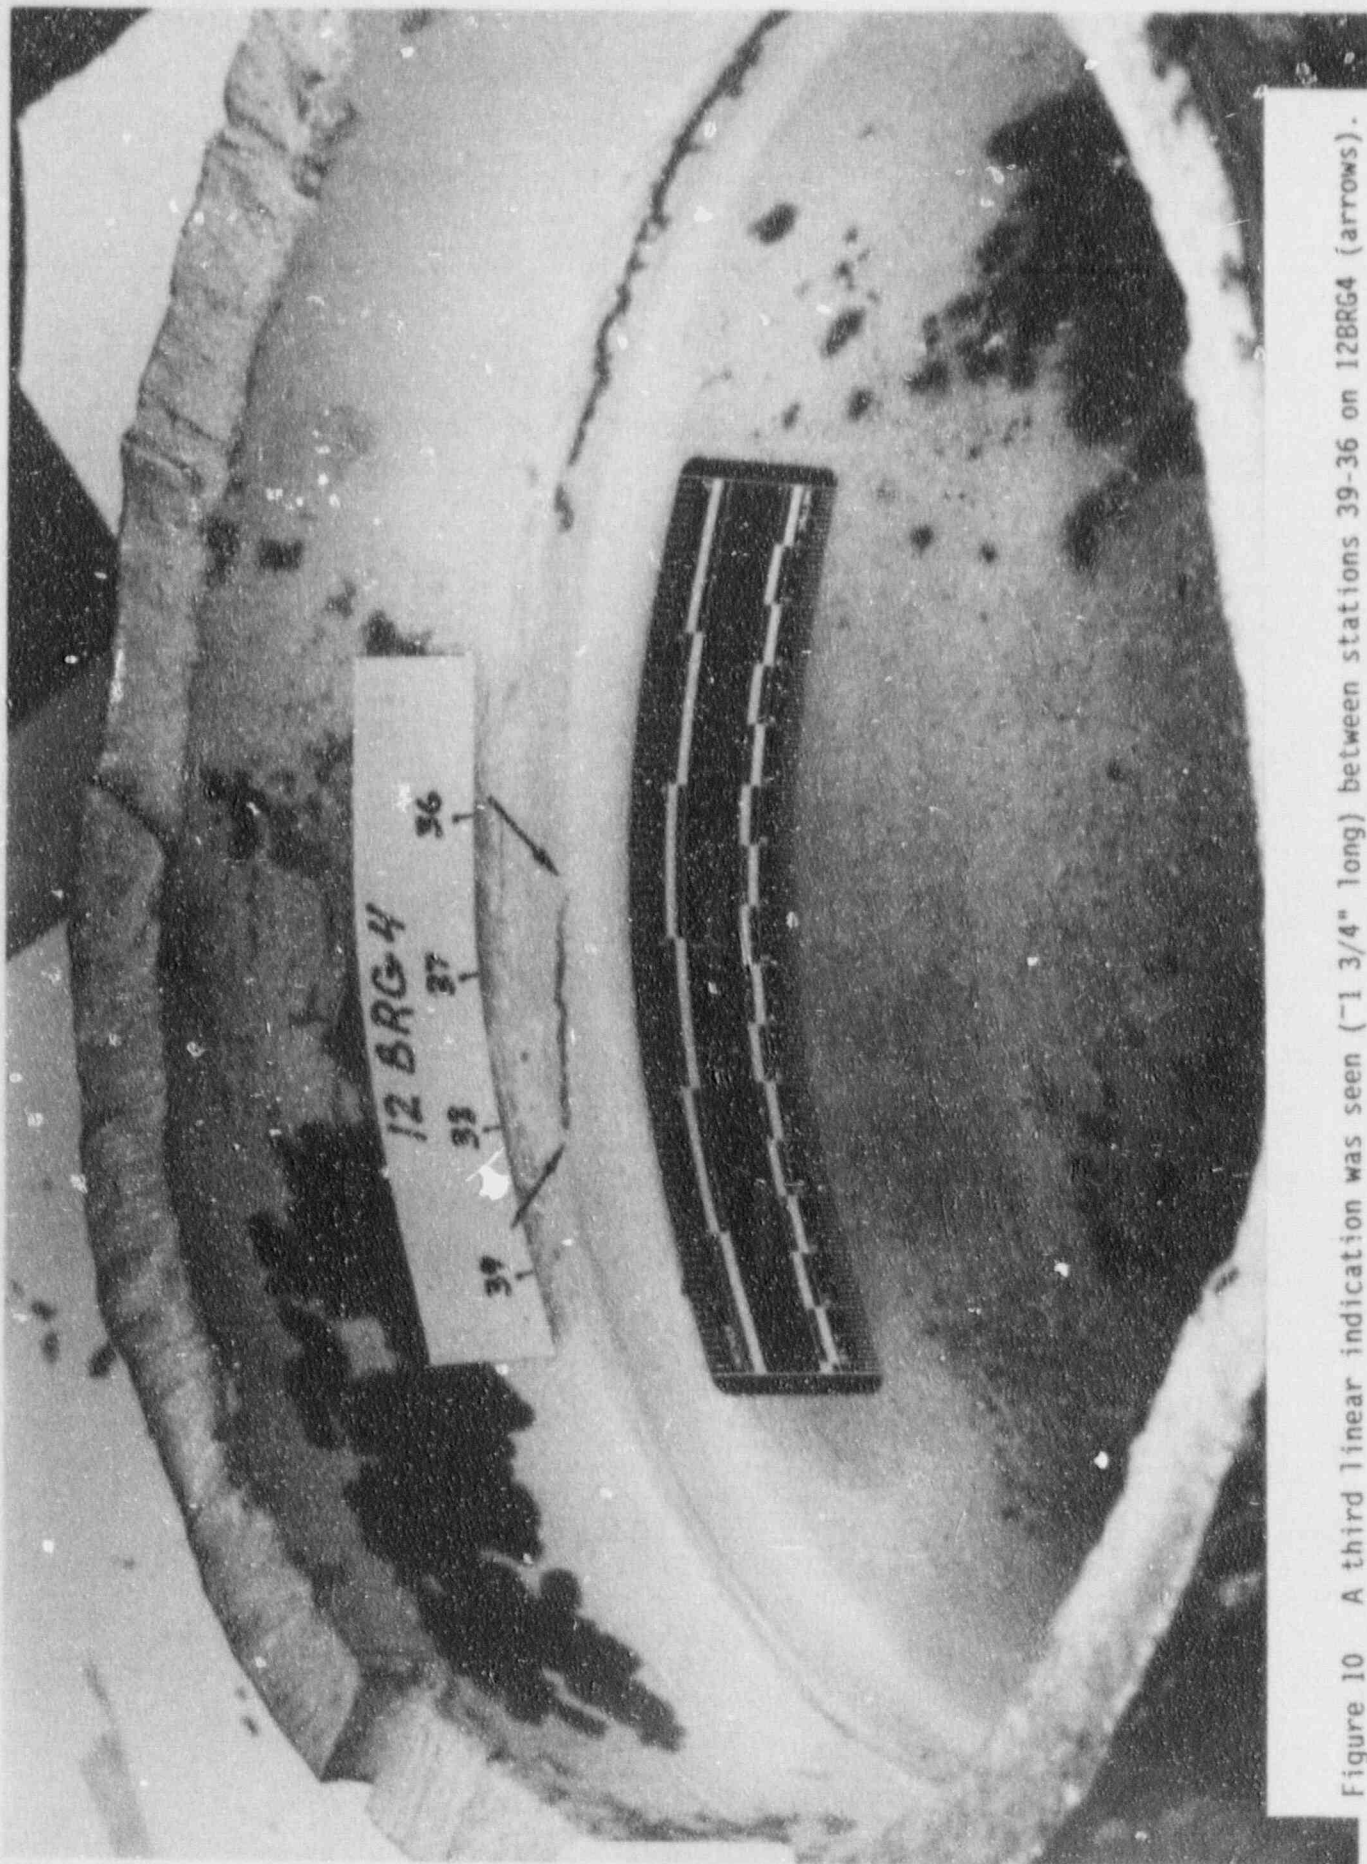
Figure 10 A third linear indication was seen ($\sim 1 \frac{3}{4}$ " long) between stations 39-36 on 12BRG4 (arrows).

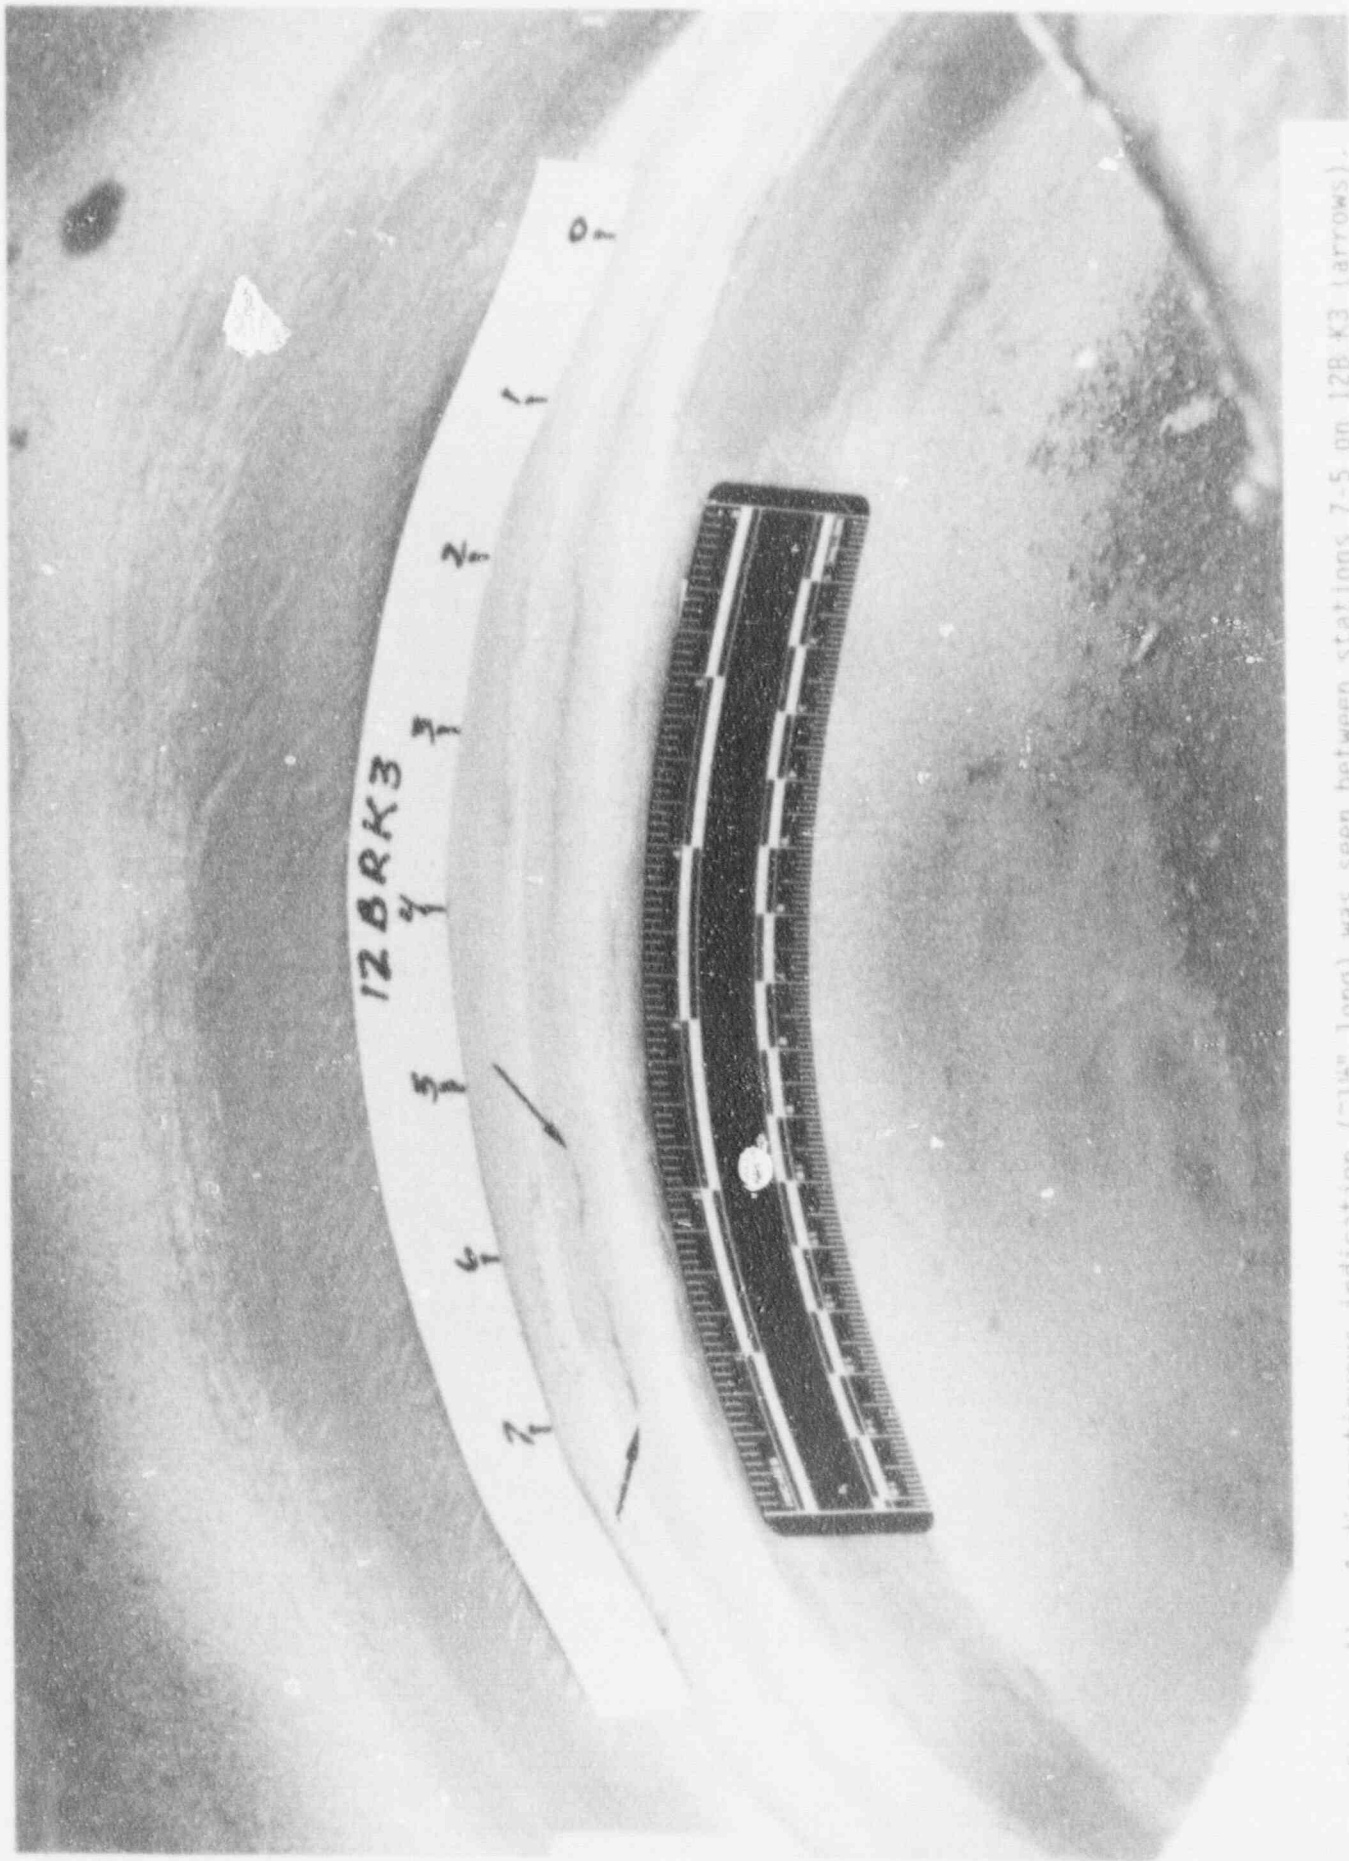
Figure 11 A discontinuous indication (~1 1/2" long) was seen between stations 7-5 on 12B-K3 (arrows).

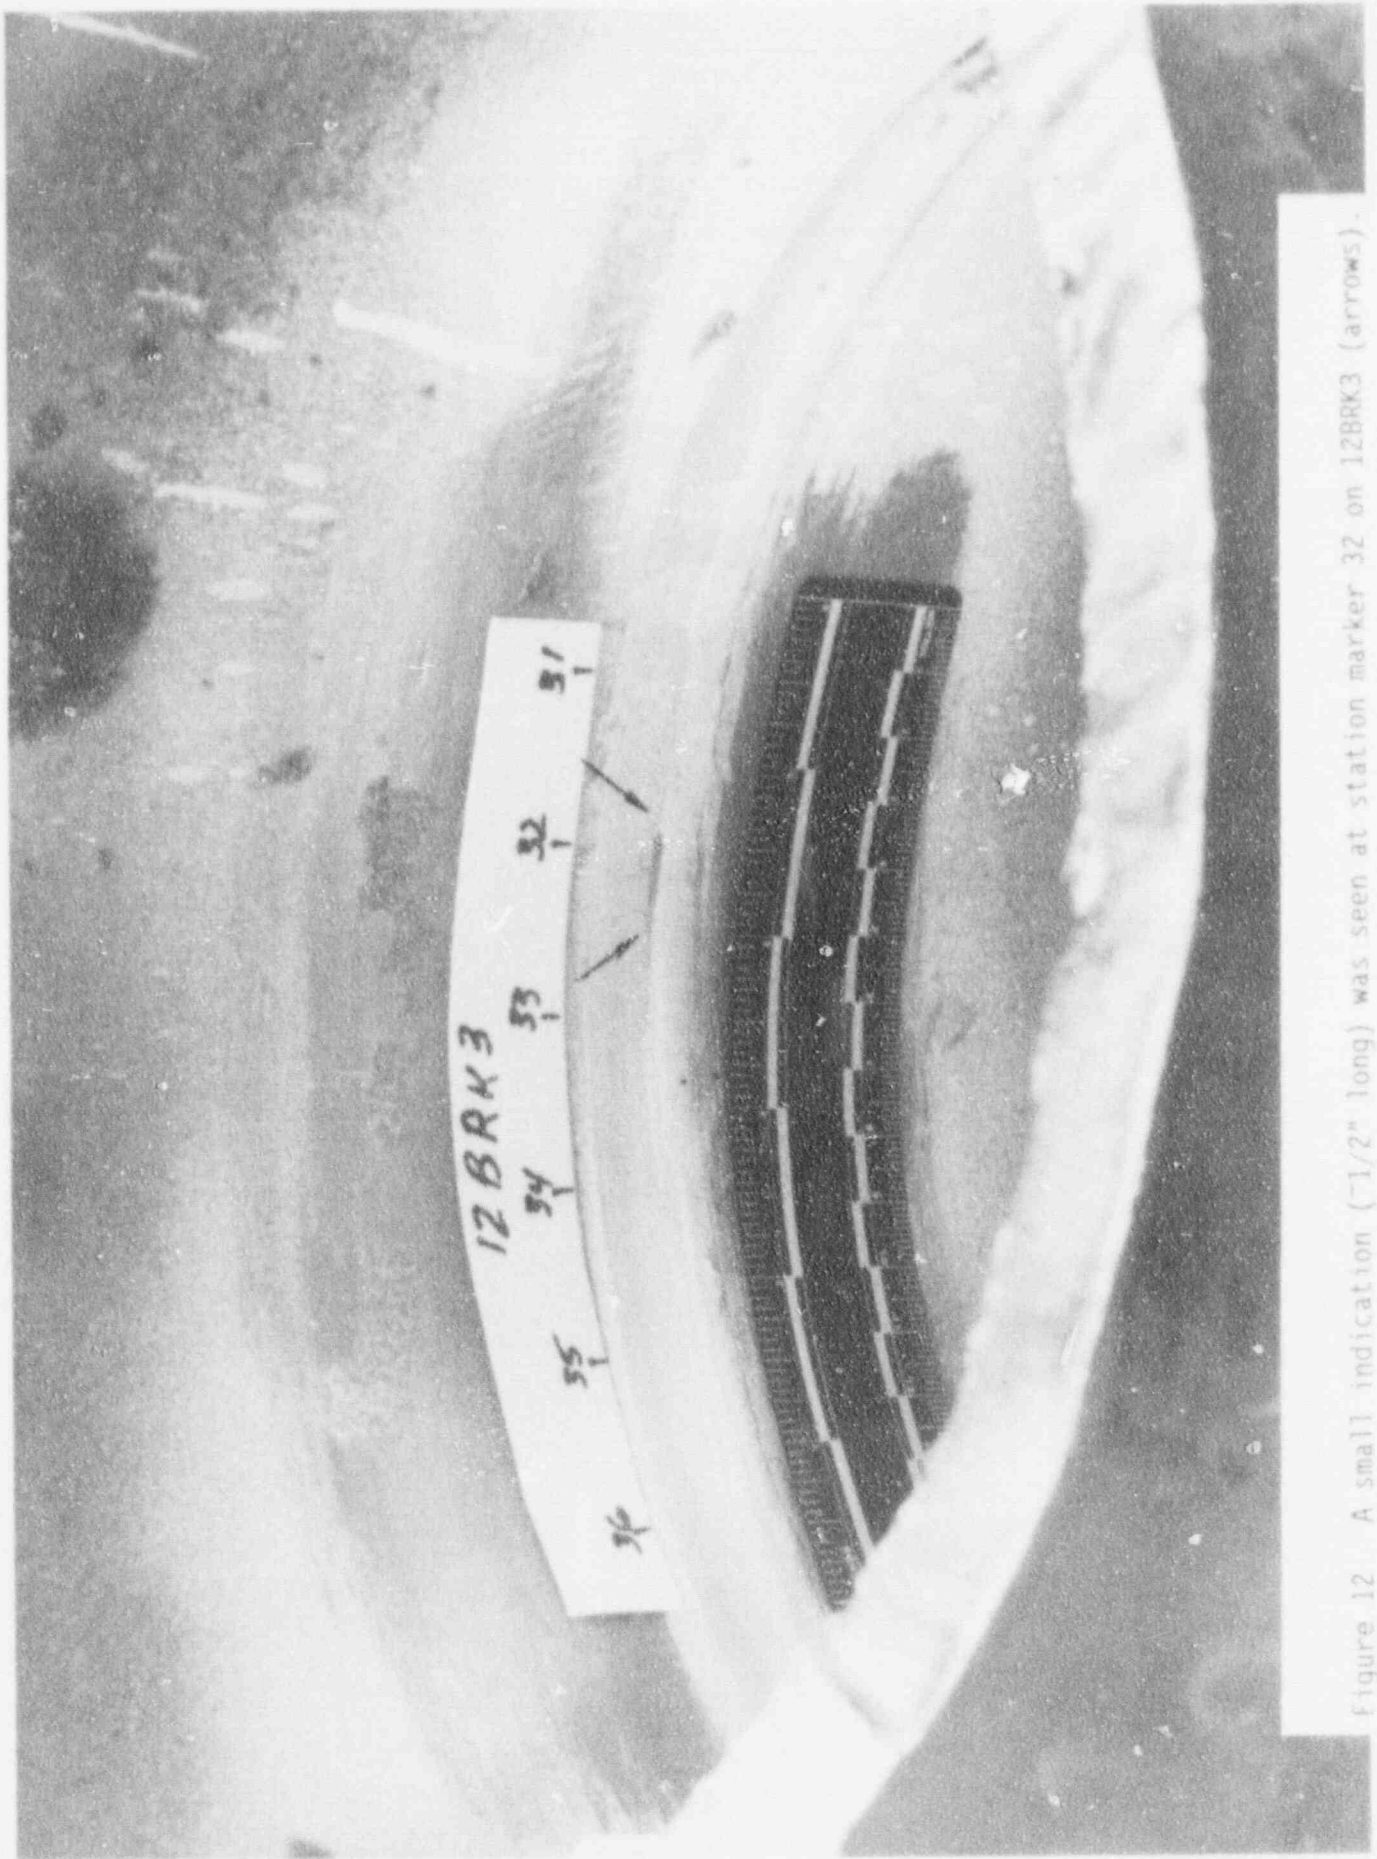
Figure 12. A small indication ($\sim 1/2''$ long) was seen at station marker 32 on 12BRK3 (arrows).
