NUREG/CR-5885
BNL-NUREG-52331

Metallurgical Evaluation of Weld Overlaid Pipe Sections From Brunswick Unit 2 Nuclear Power Station

Brookhaven National Laboratory

Prepared for
U.S. Nuclear Regulatory Commission

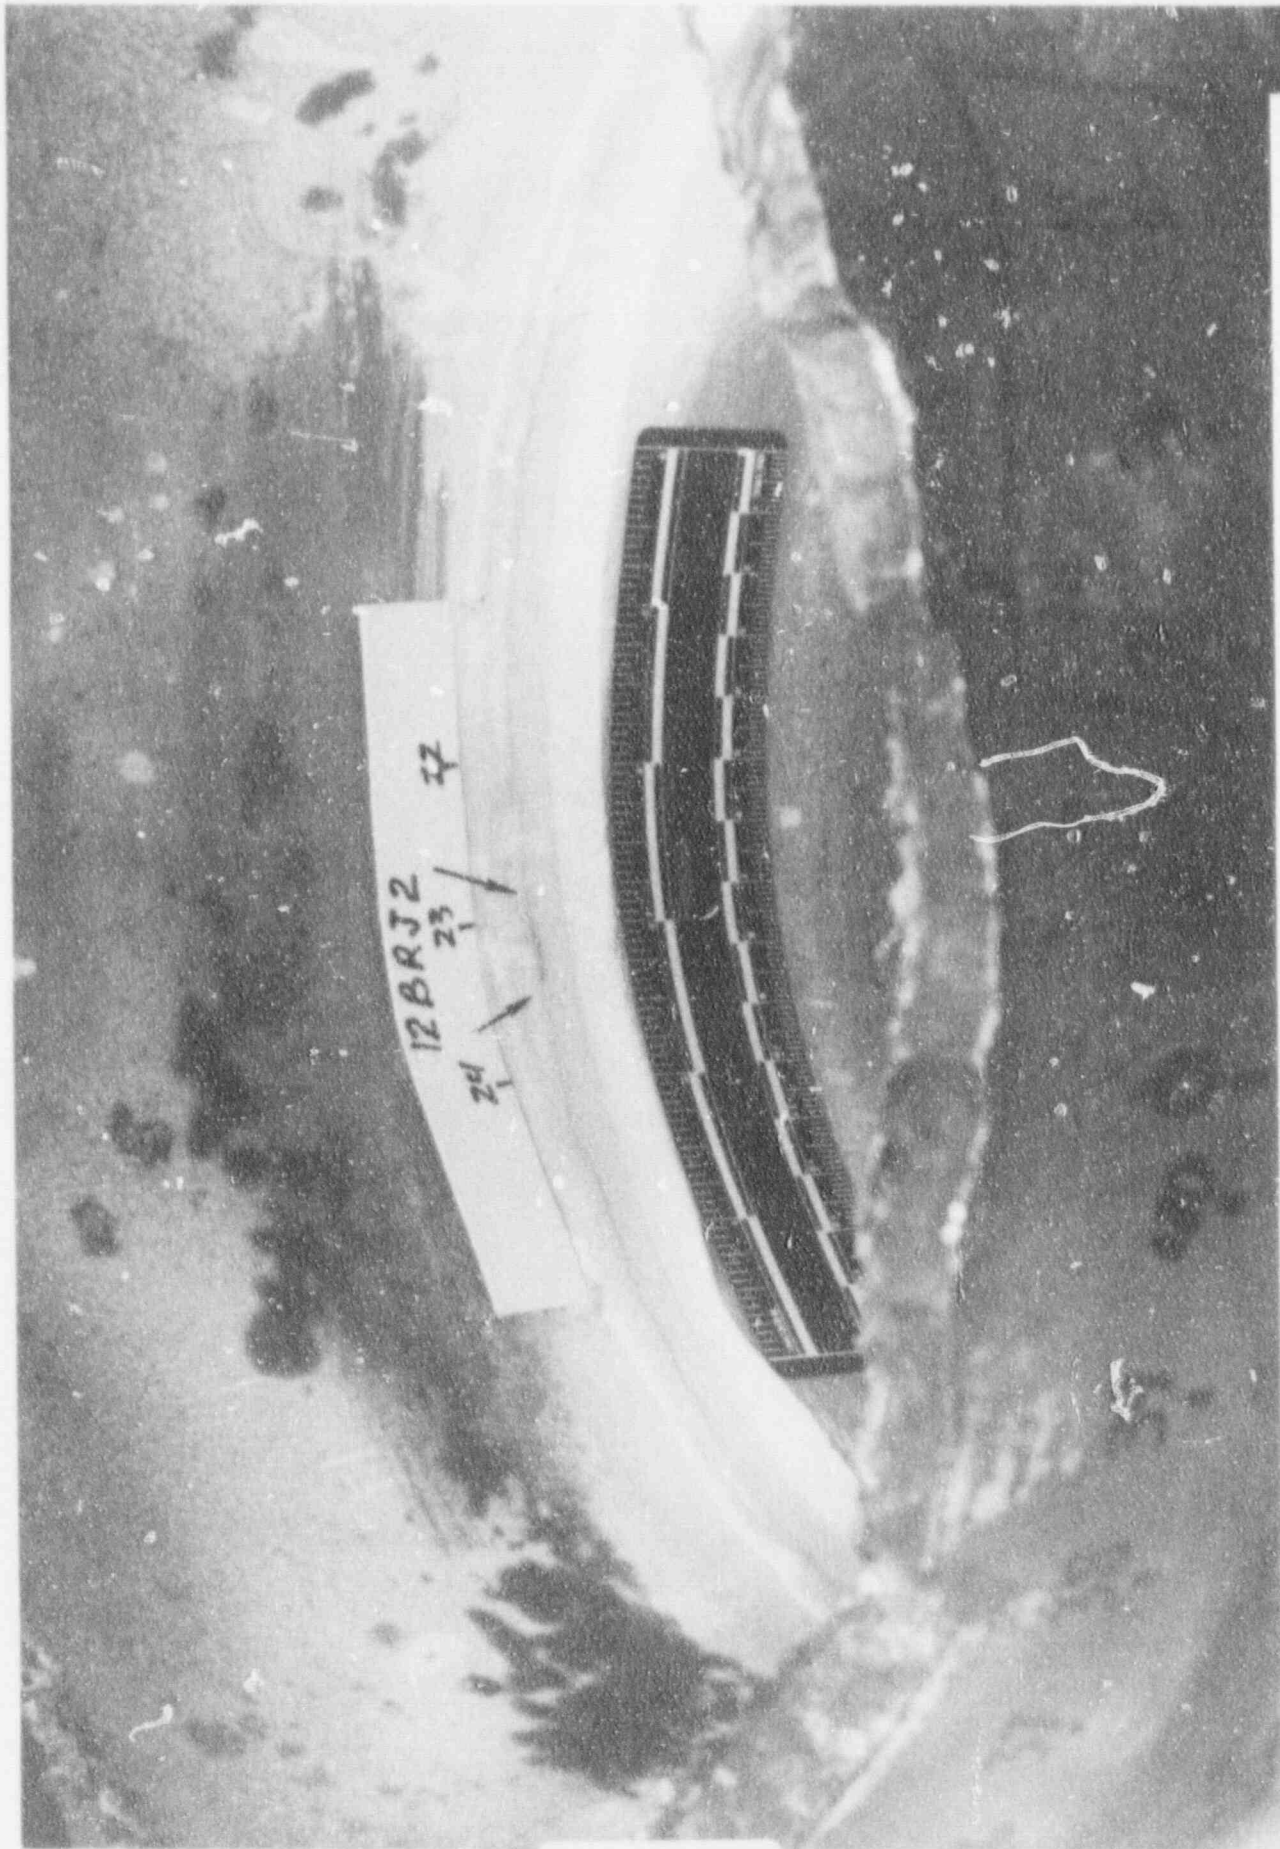
Figure 13 Pipe 12BRJ2 had one small indication (~1/2" long) located between markers 24-23 (arrows).

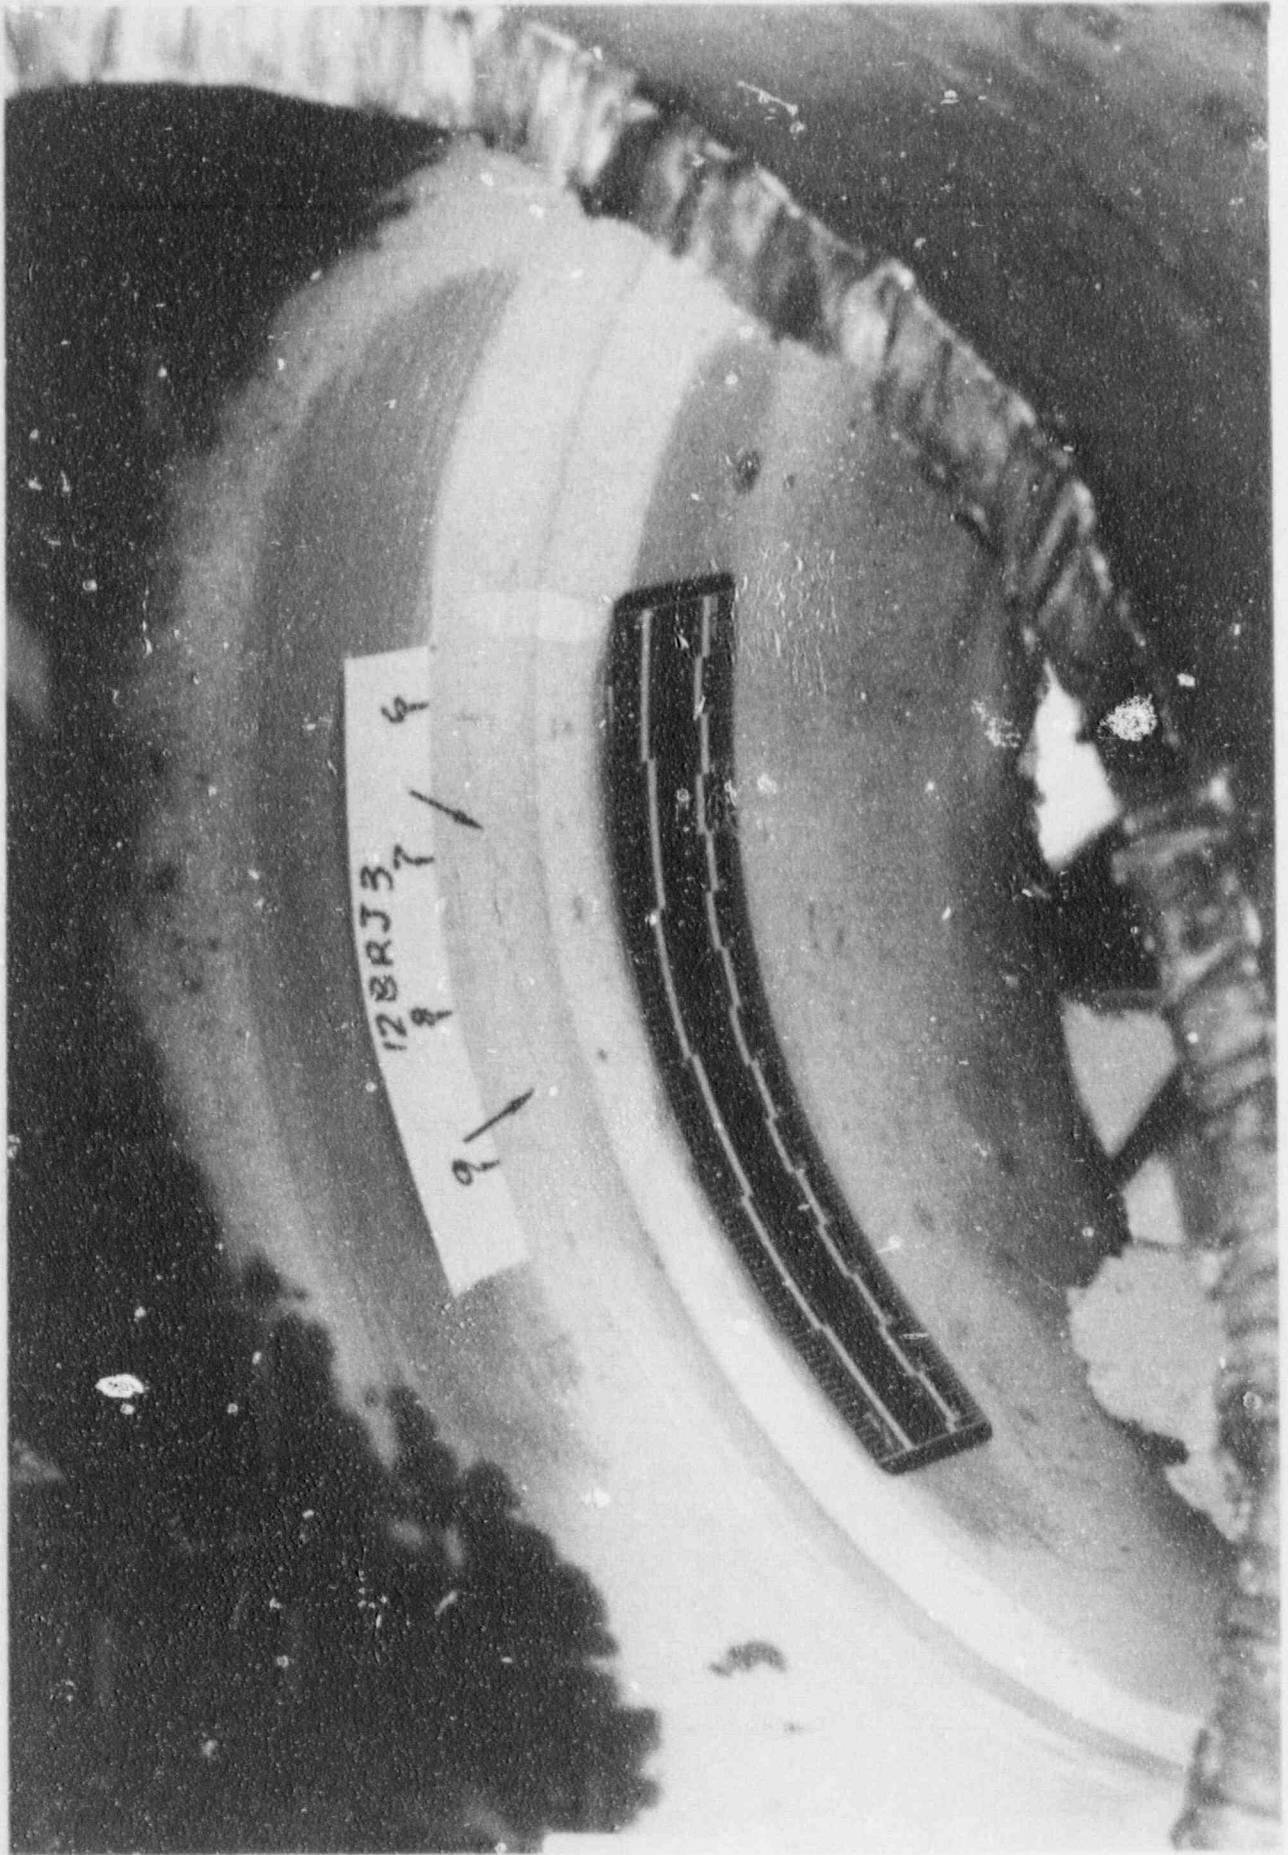
Figure 14 A "crazed" appearing indication was seen between markers 9-7 (~1 1/2" long) on 12BRJ3 (arrows).

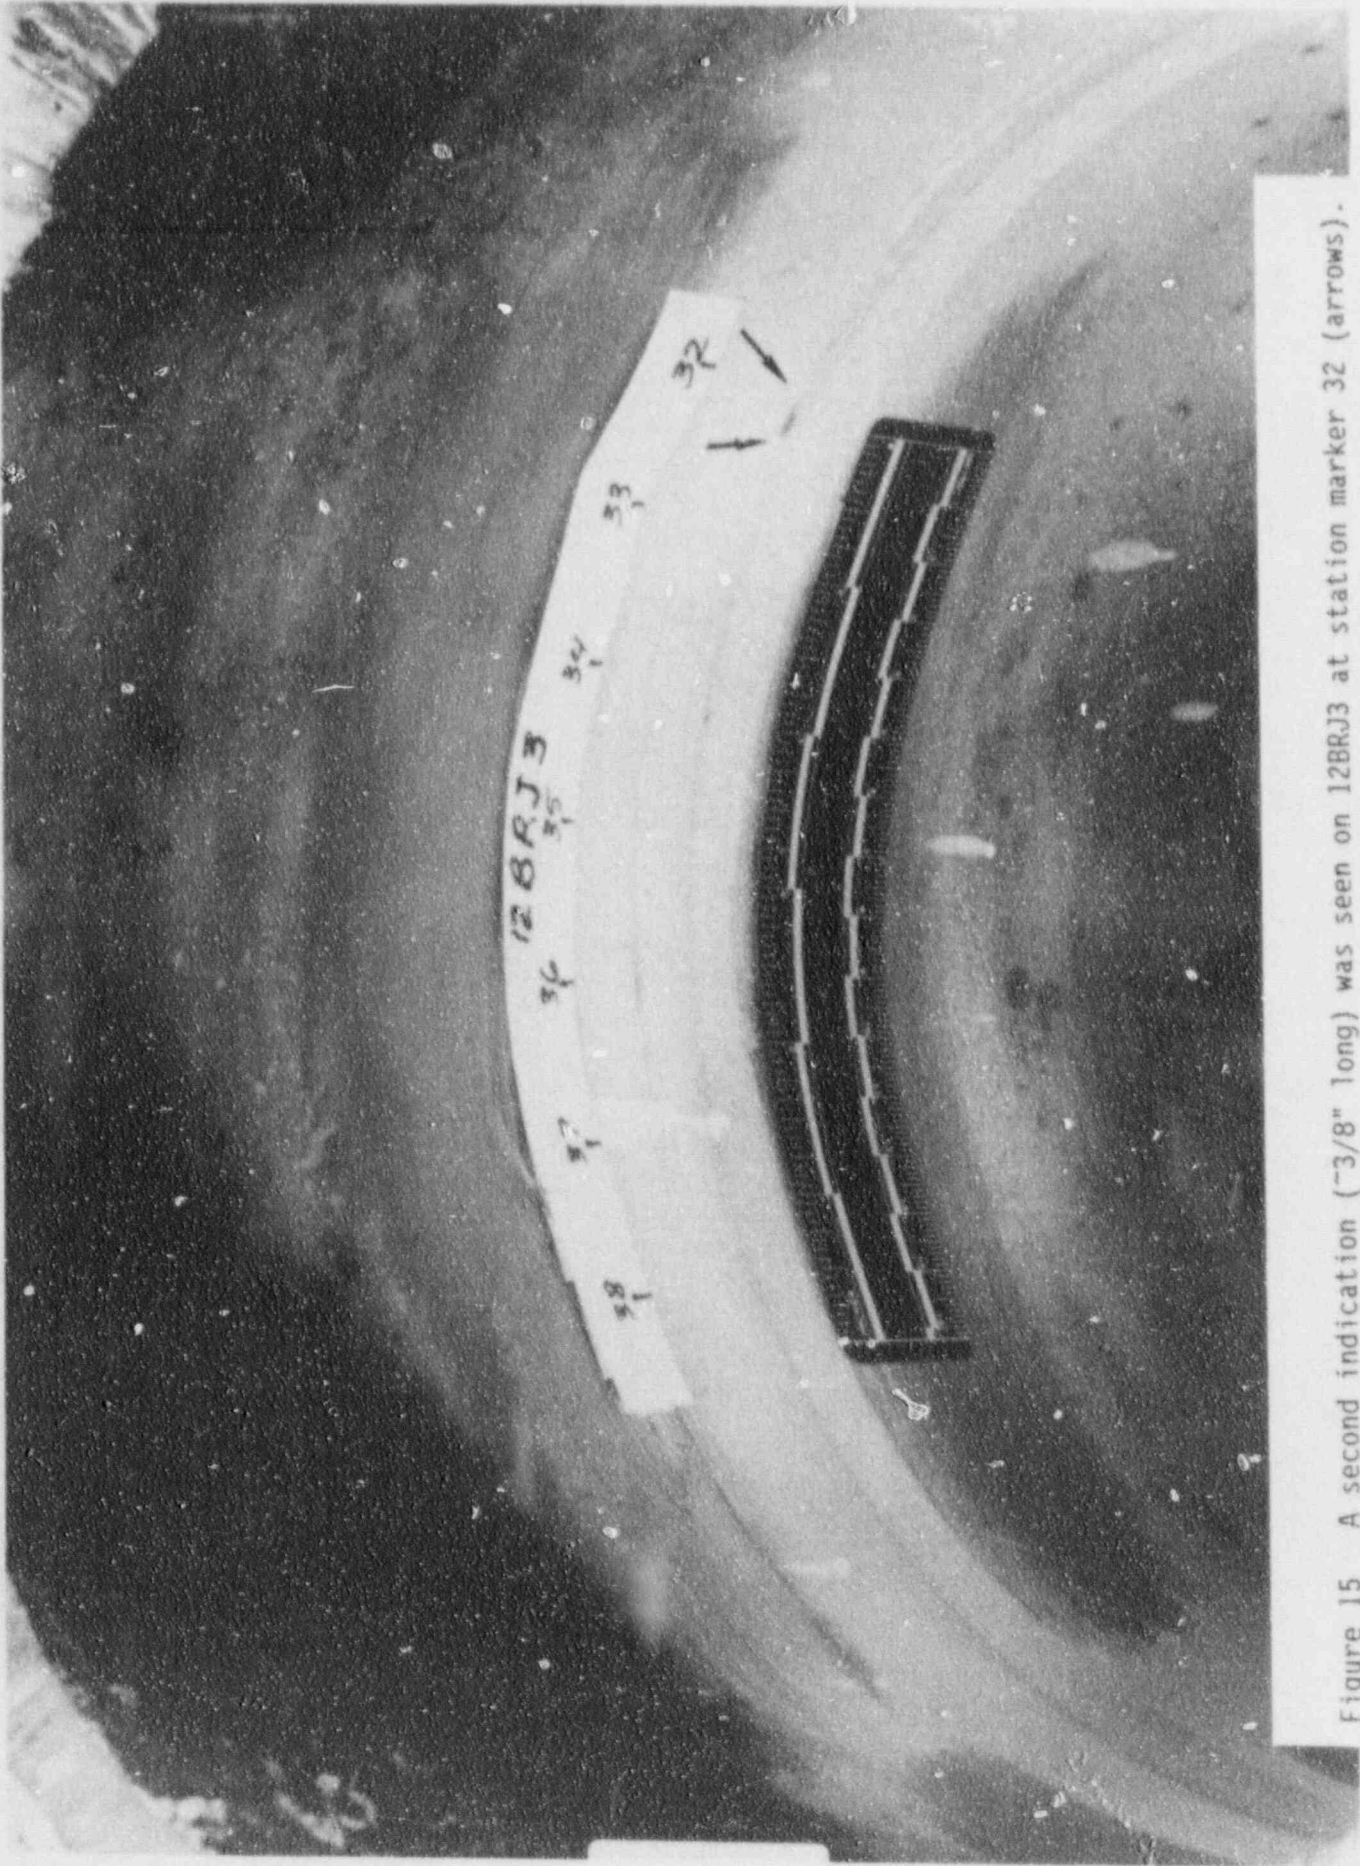
Figure 15 A second indication (~3/8" long) was seen on 12BRJ3 at station marker 32 (arrows).

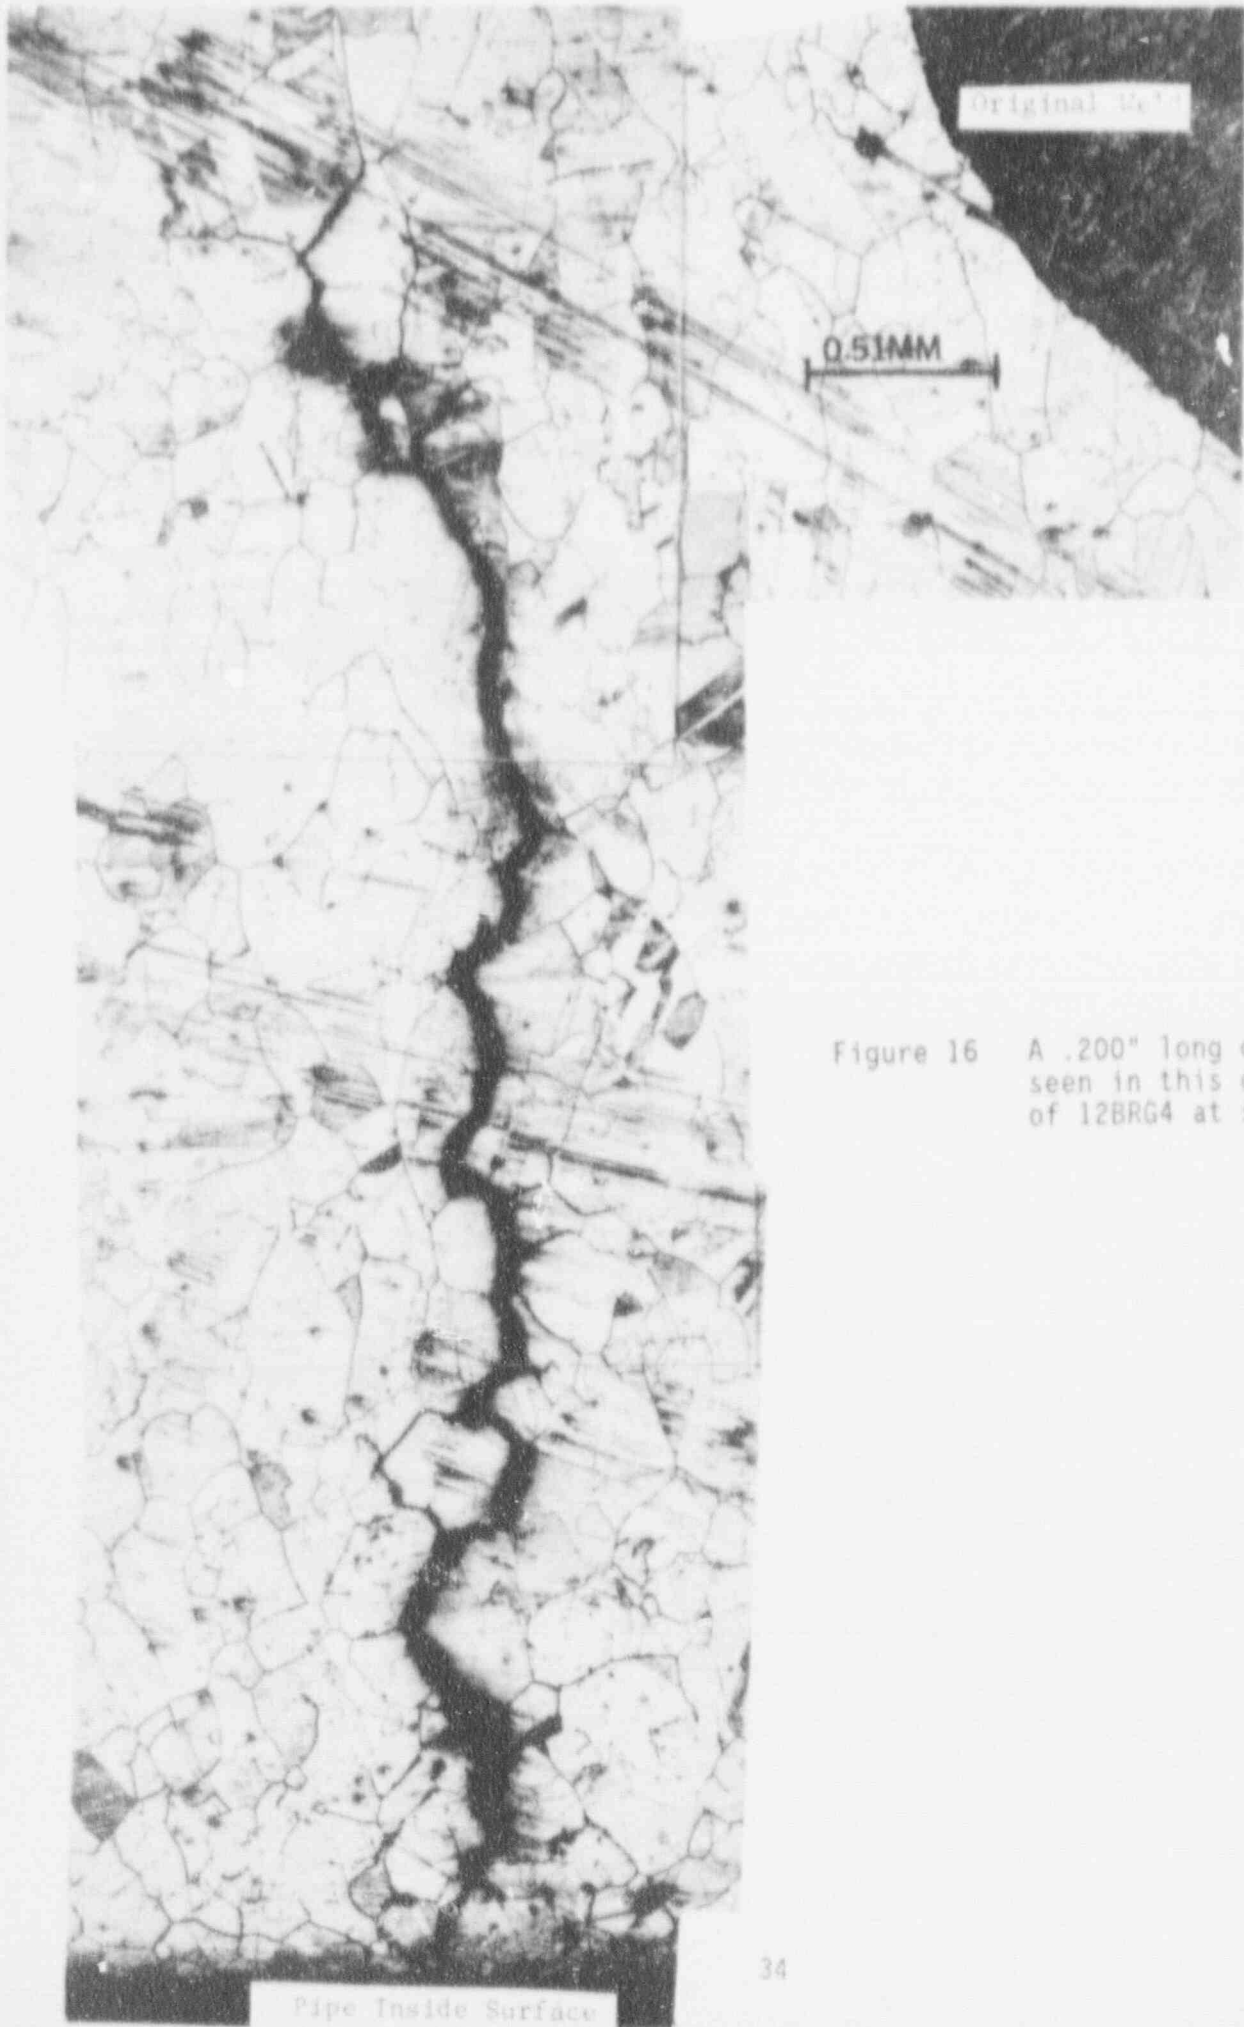
Figure 16 A .200" long crack was seen in this cross section of 12BRG4 at station 16.

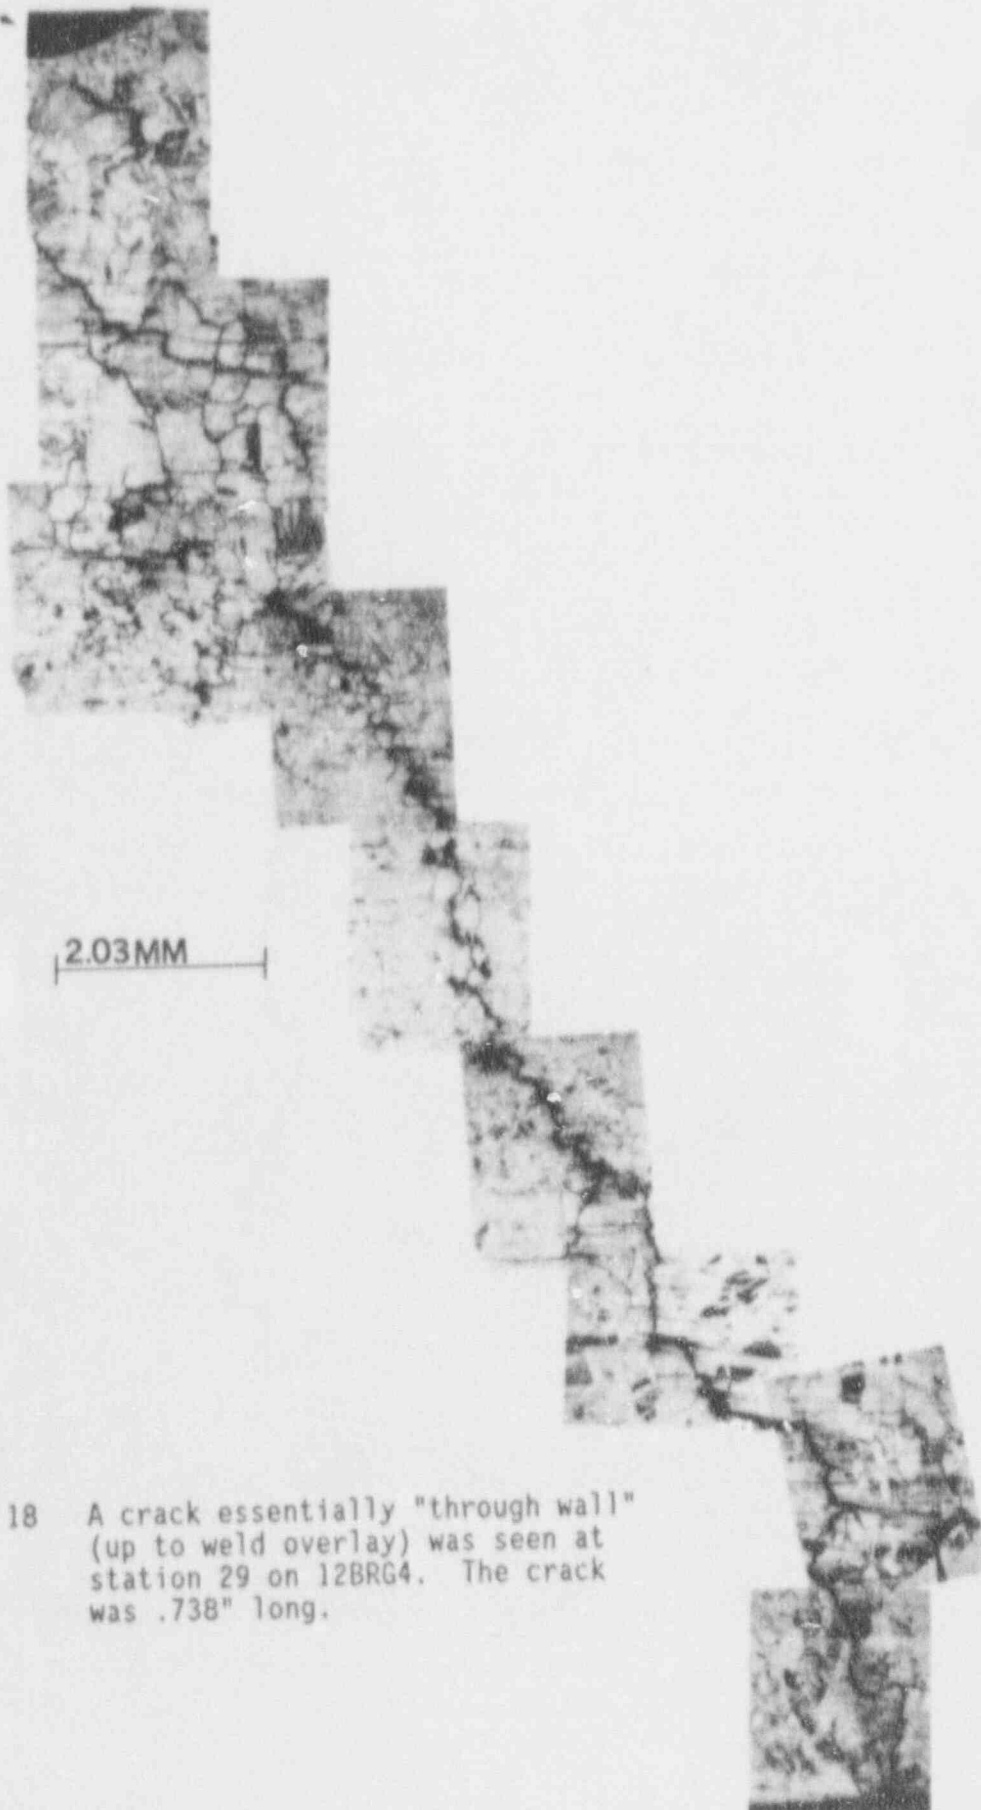
Figure 18 A crack essentially "through wall" (up to weld overlay) was seen at station 29 on 12BRG4. The crack was .738" long.

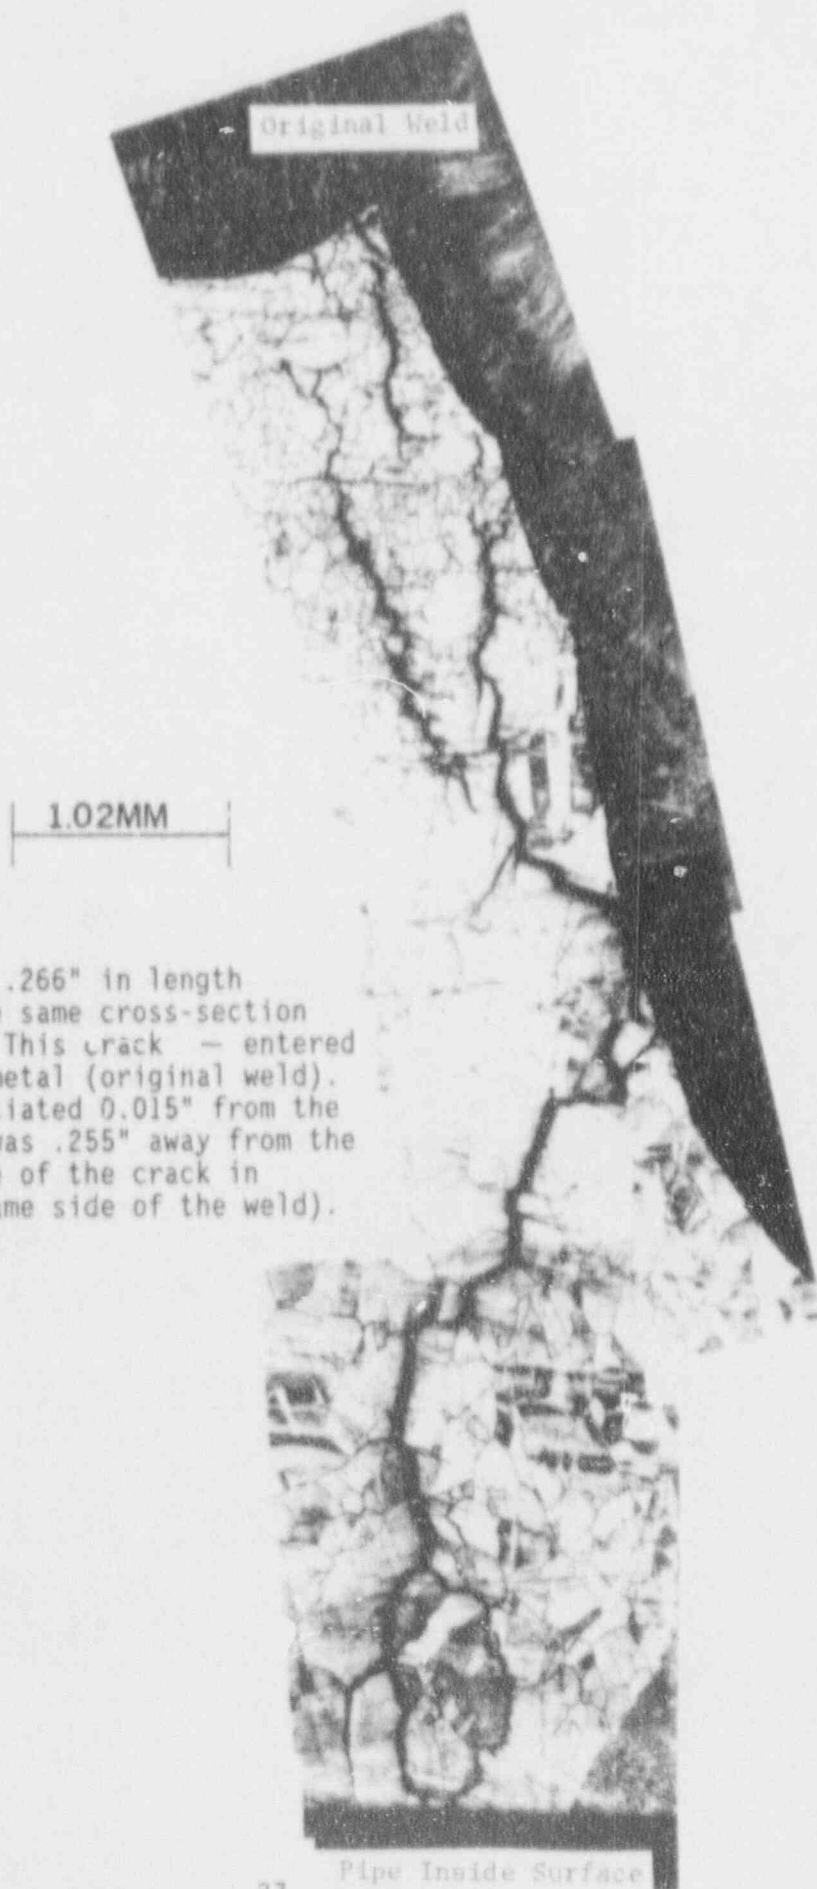
Figure 19 A second crack .266" in length was seen on the same cross-section at marker 29. This crack — entered into the weld metal (original weld). This crack initiated 0.015" from the weld root and was .255" away from the initiation site of the crack in Figure 18. (Same side of the weld).

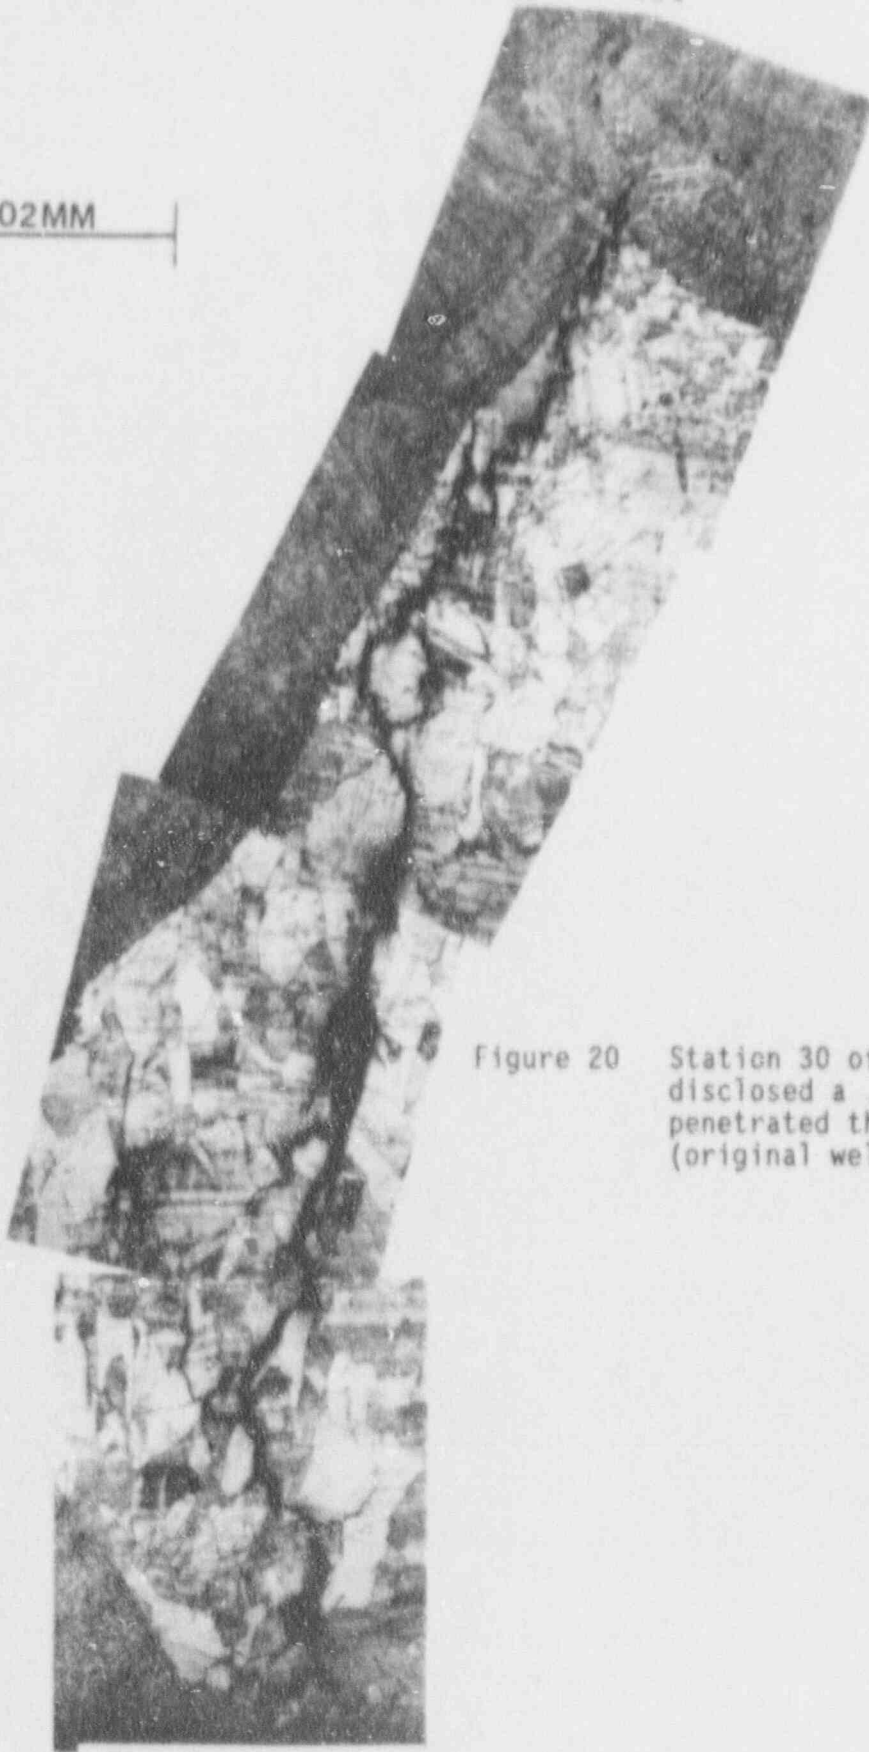
Figure 20 Station 30 of 12BRG4 cross section disclosed a .302" long crack which penetrated the weld metal deposit (original weld).

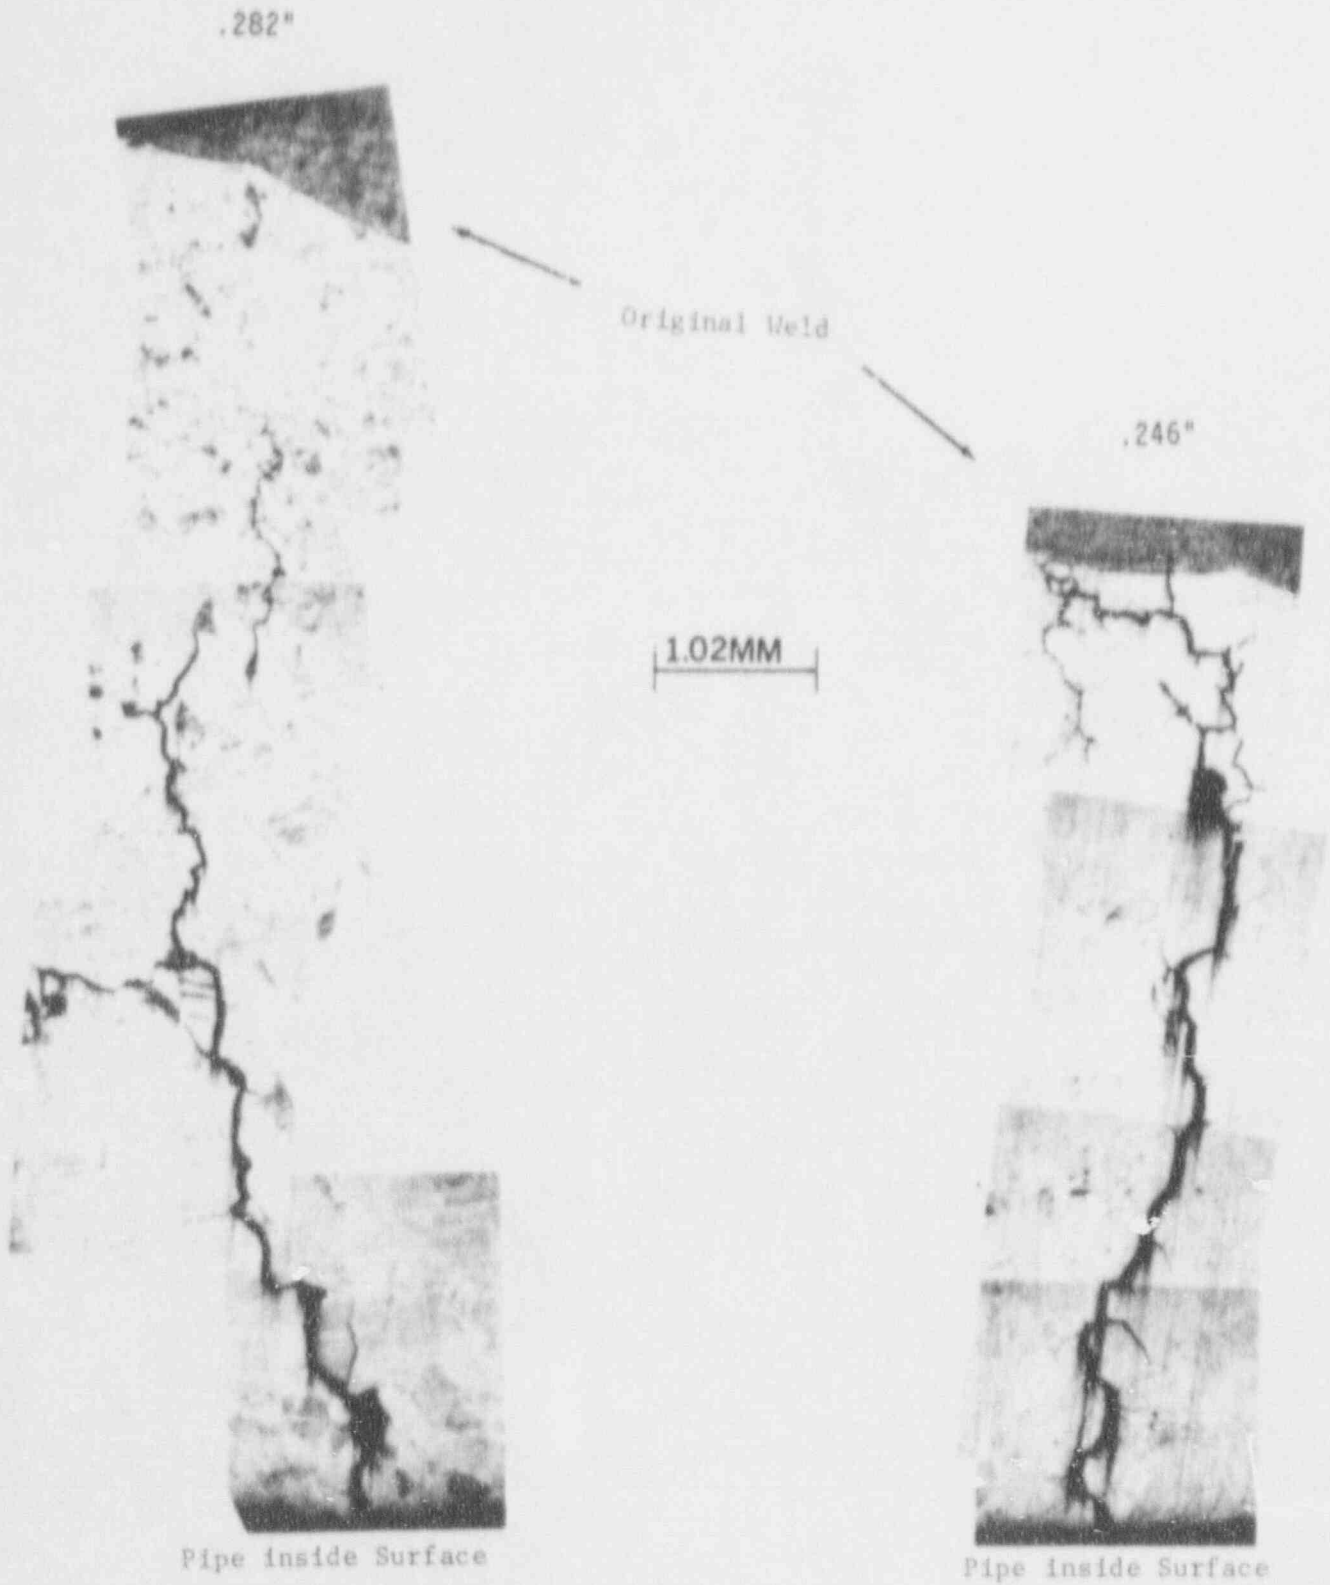
Figure 21 Two axial components were seen on a polished face perpendicular to the crack in Figure 20.

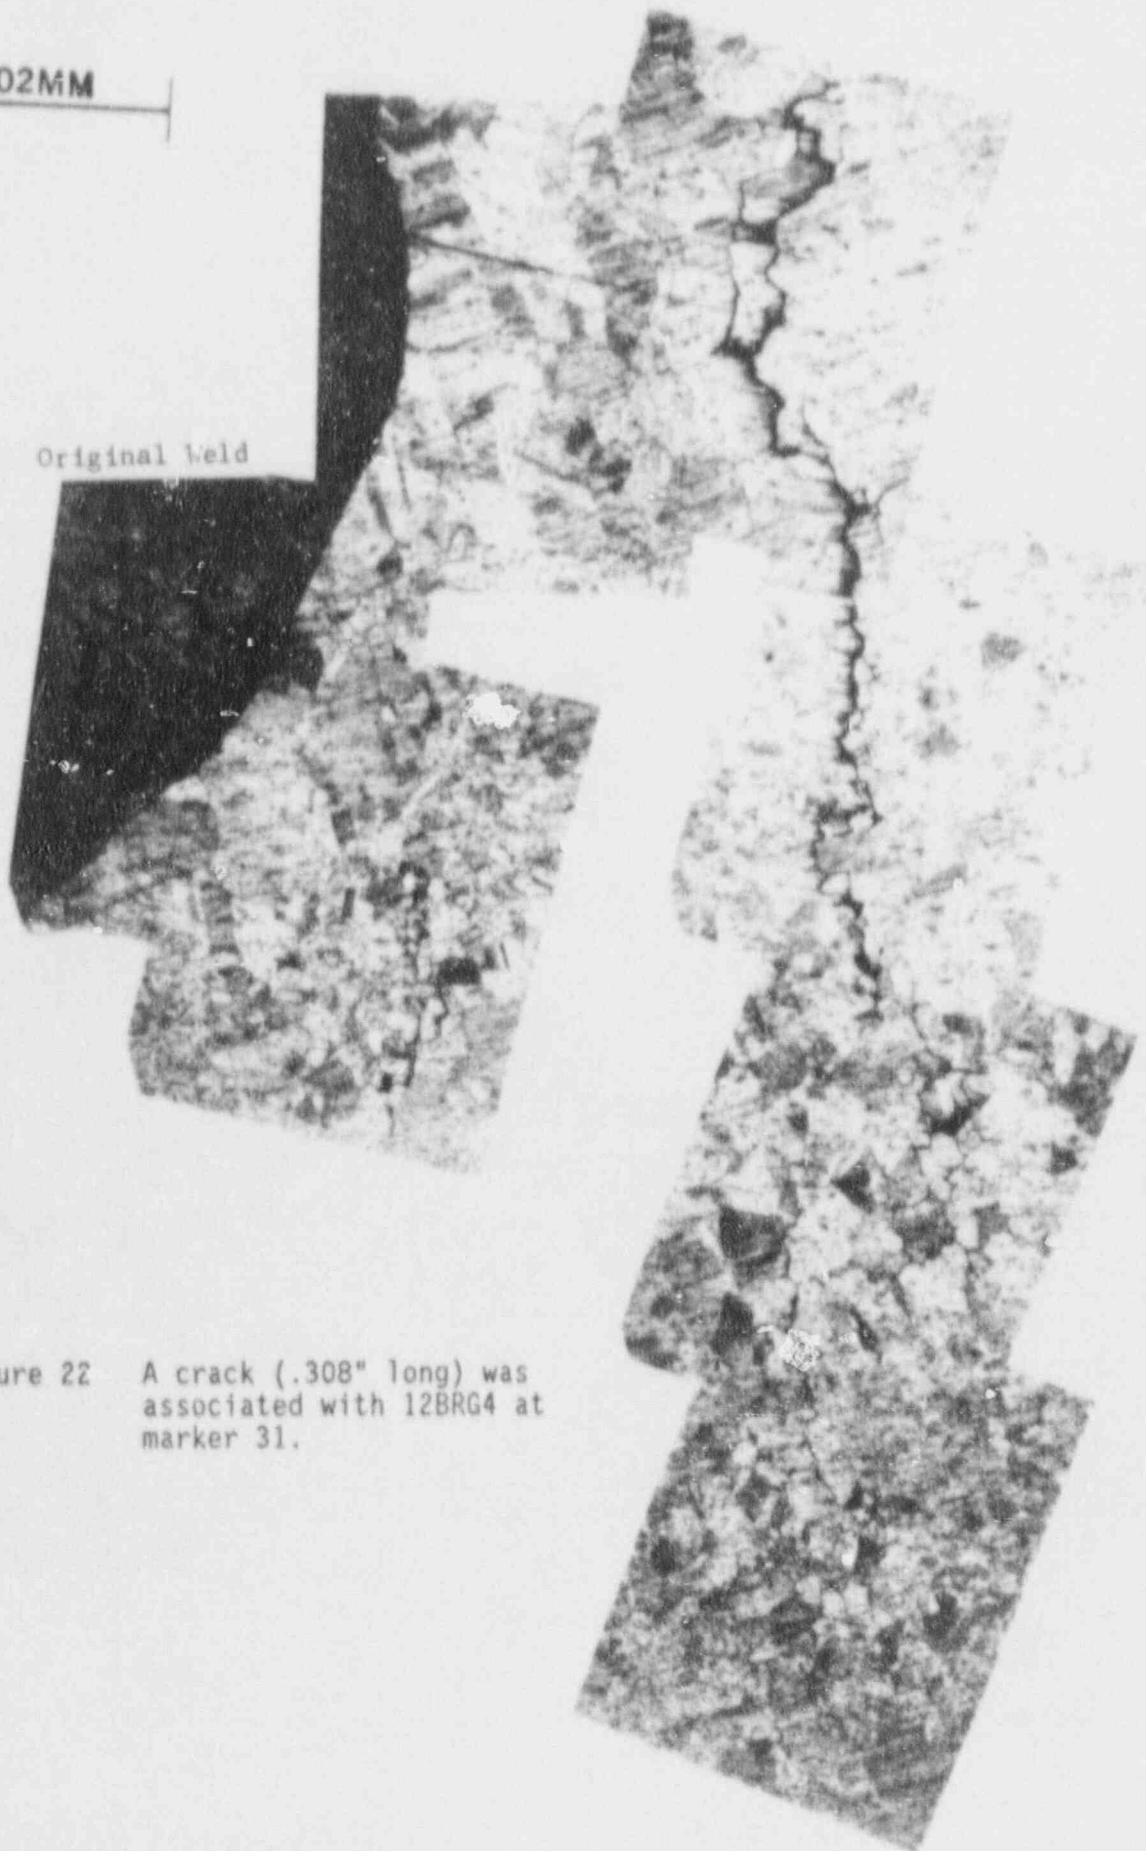
Figure 22 A crack (.308" long) was associated with 12BRG4 at marker 31.

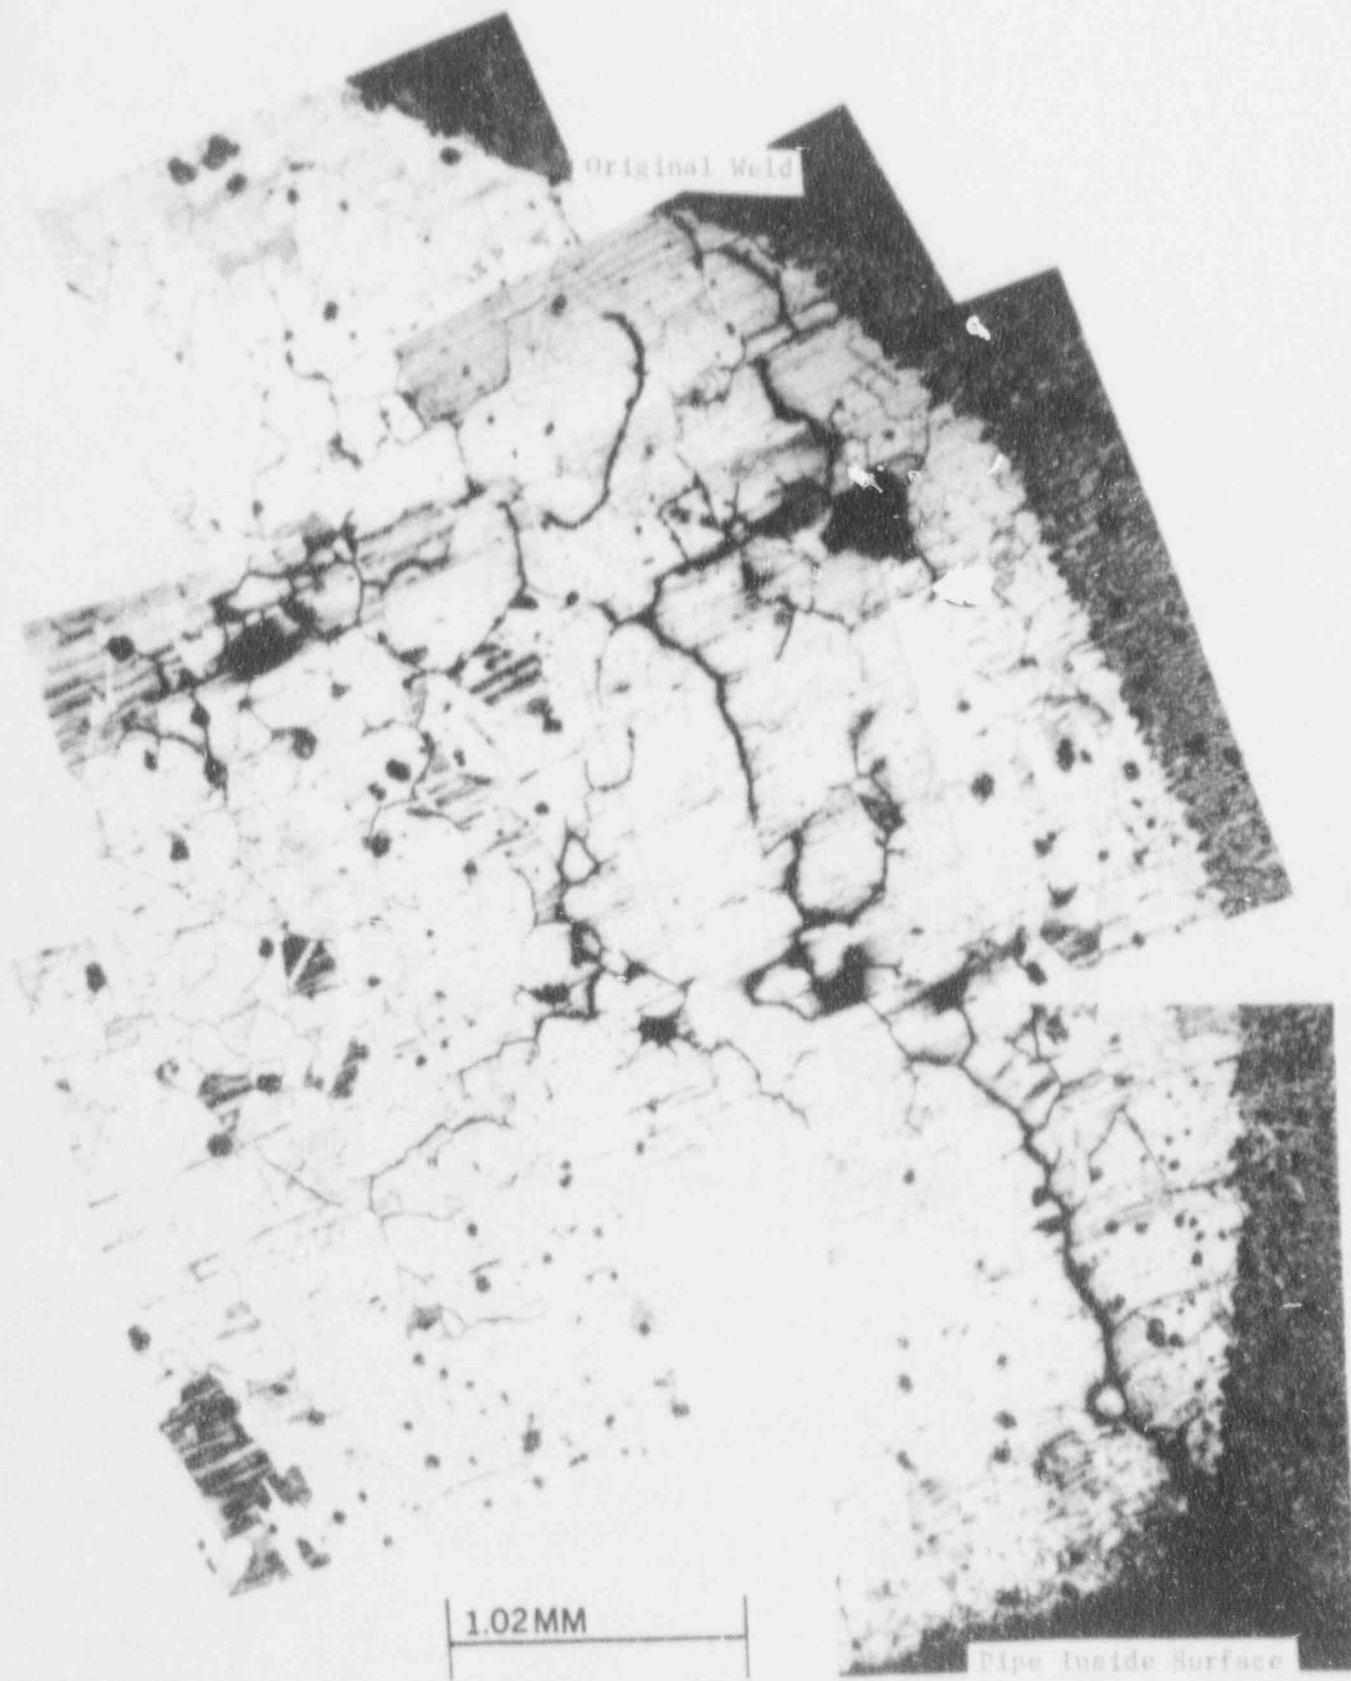
Figure 24 A .200" long array of cracks was seen at marker 22 of pipe 12BRJ2.
