NUREG/CR-5885
BNL-NUREG-52331

Metallurgical Evaluation of Weld Overlaid Pipe Sections From Brunswick Unit 2 Nuclear Power Station

Brookhaven National Laboratory

Prepared for
U.S. Nuclear Regulatory Commission

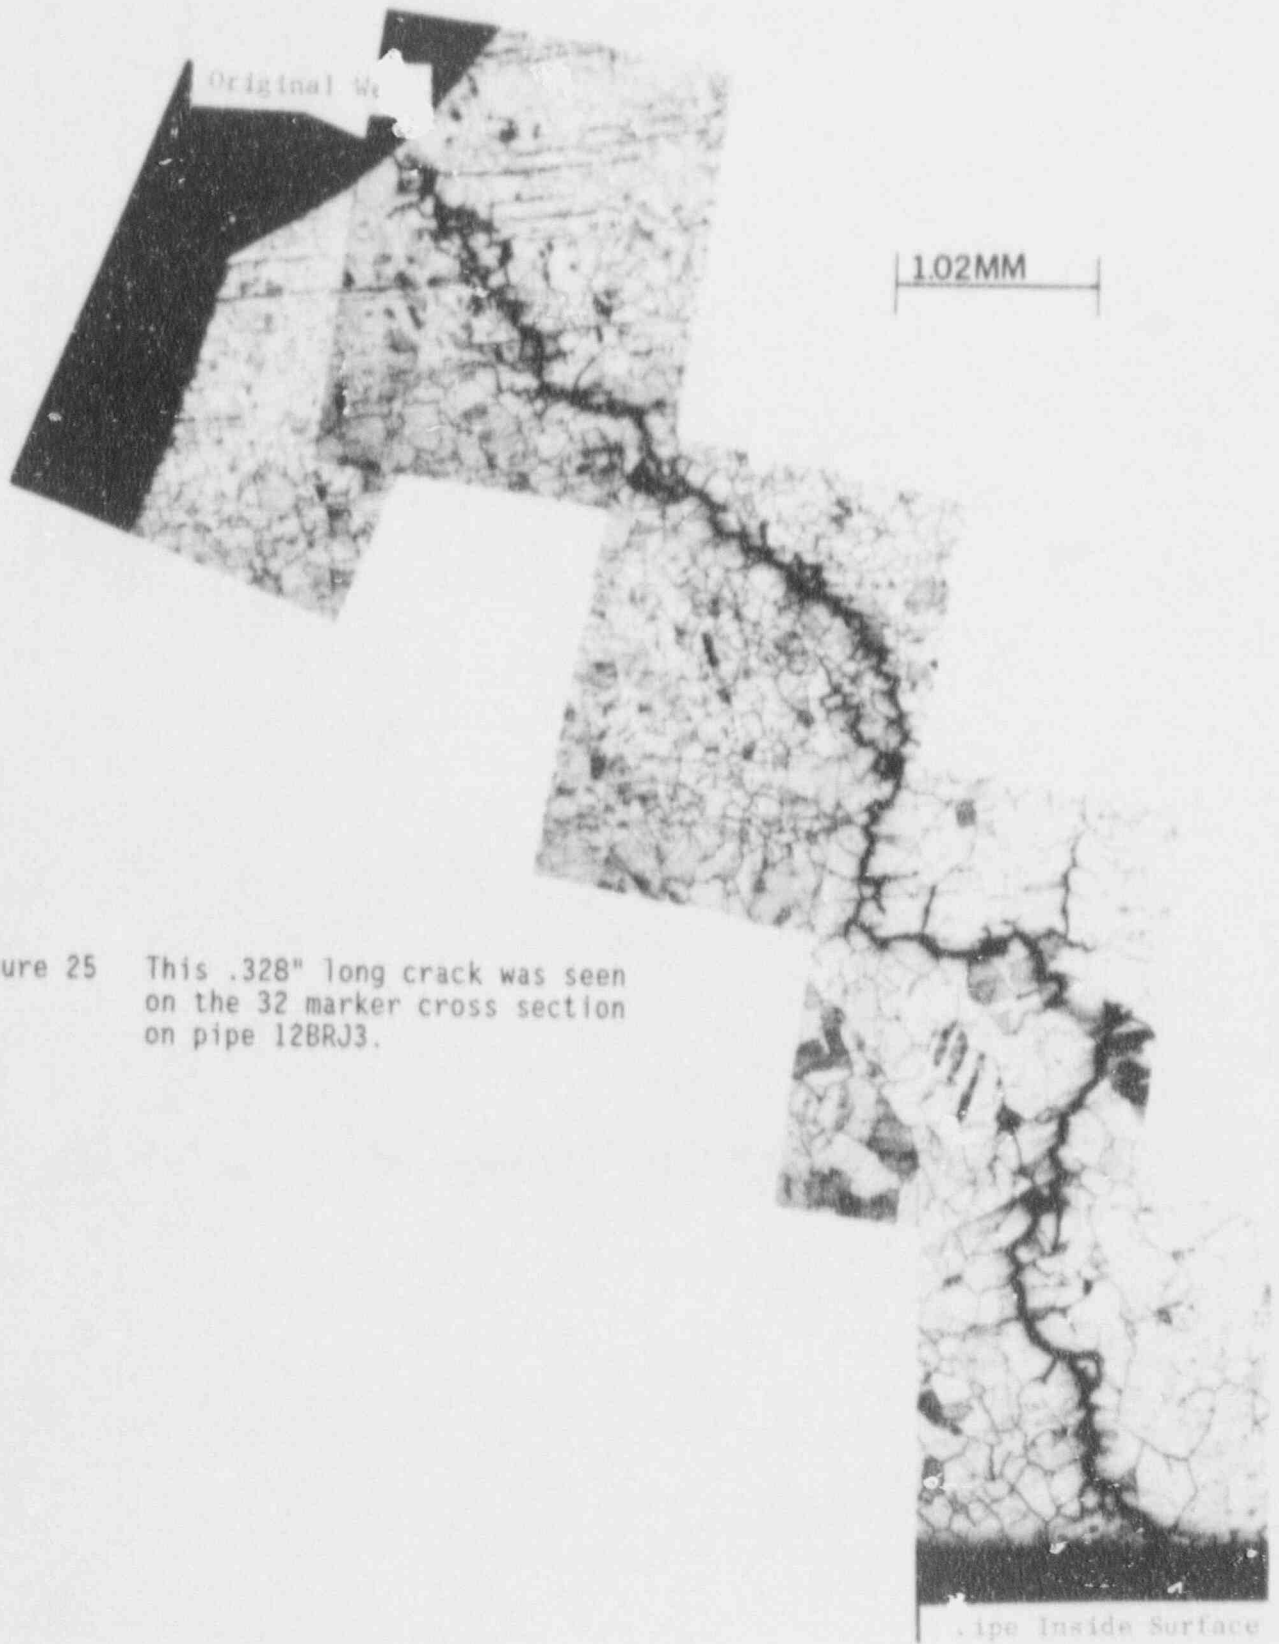
Figure 25 This .328" long crack was seen on the 32 marker cross section on pipe 12BRJ3.

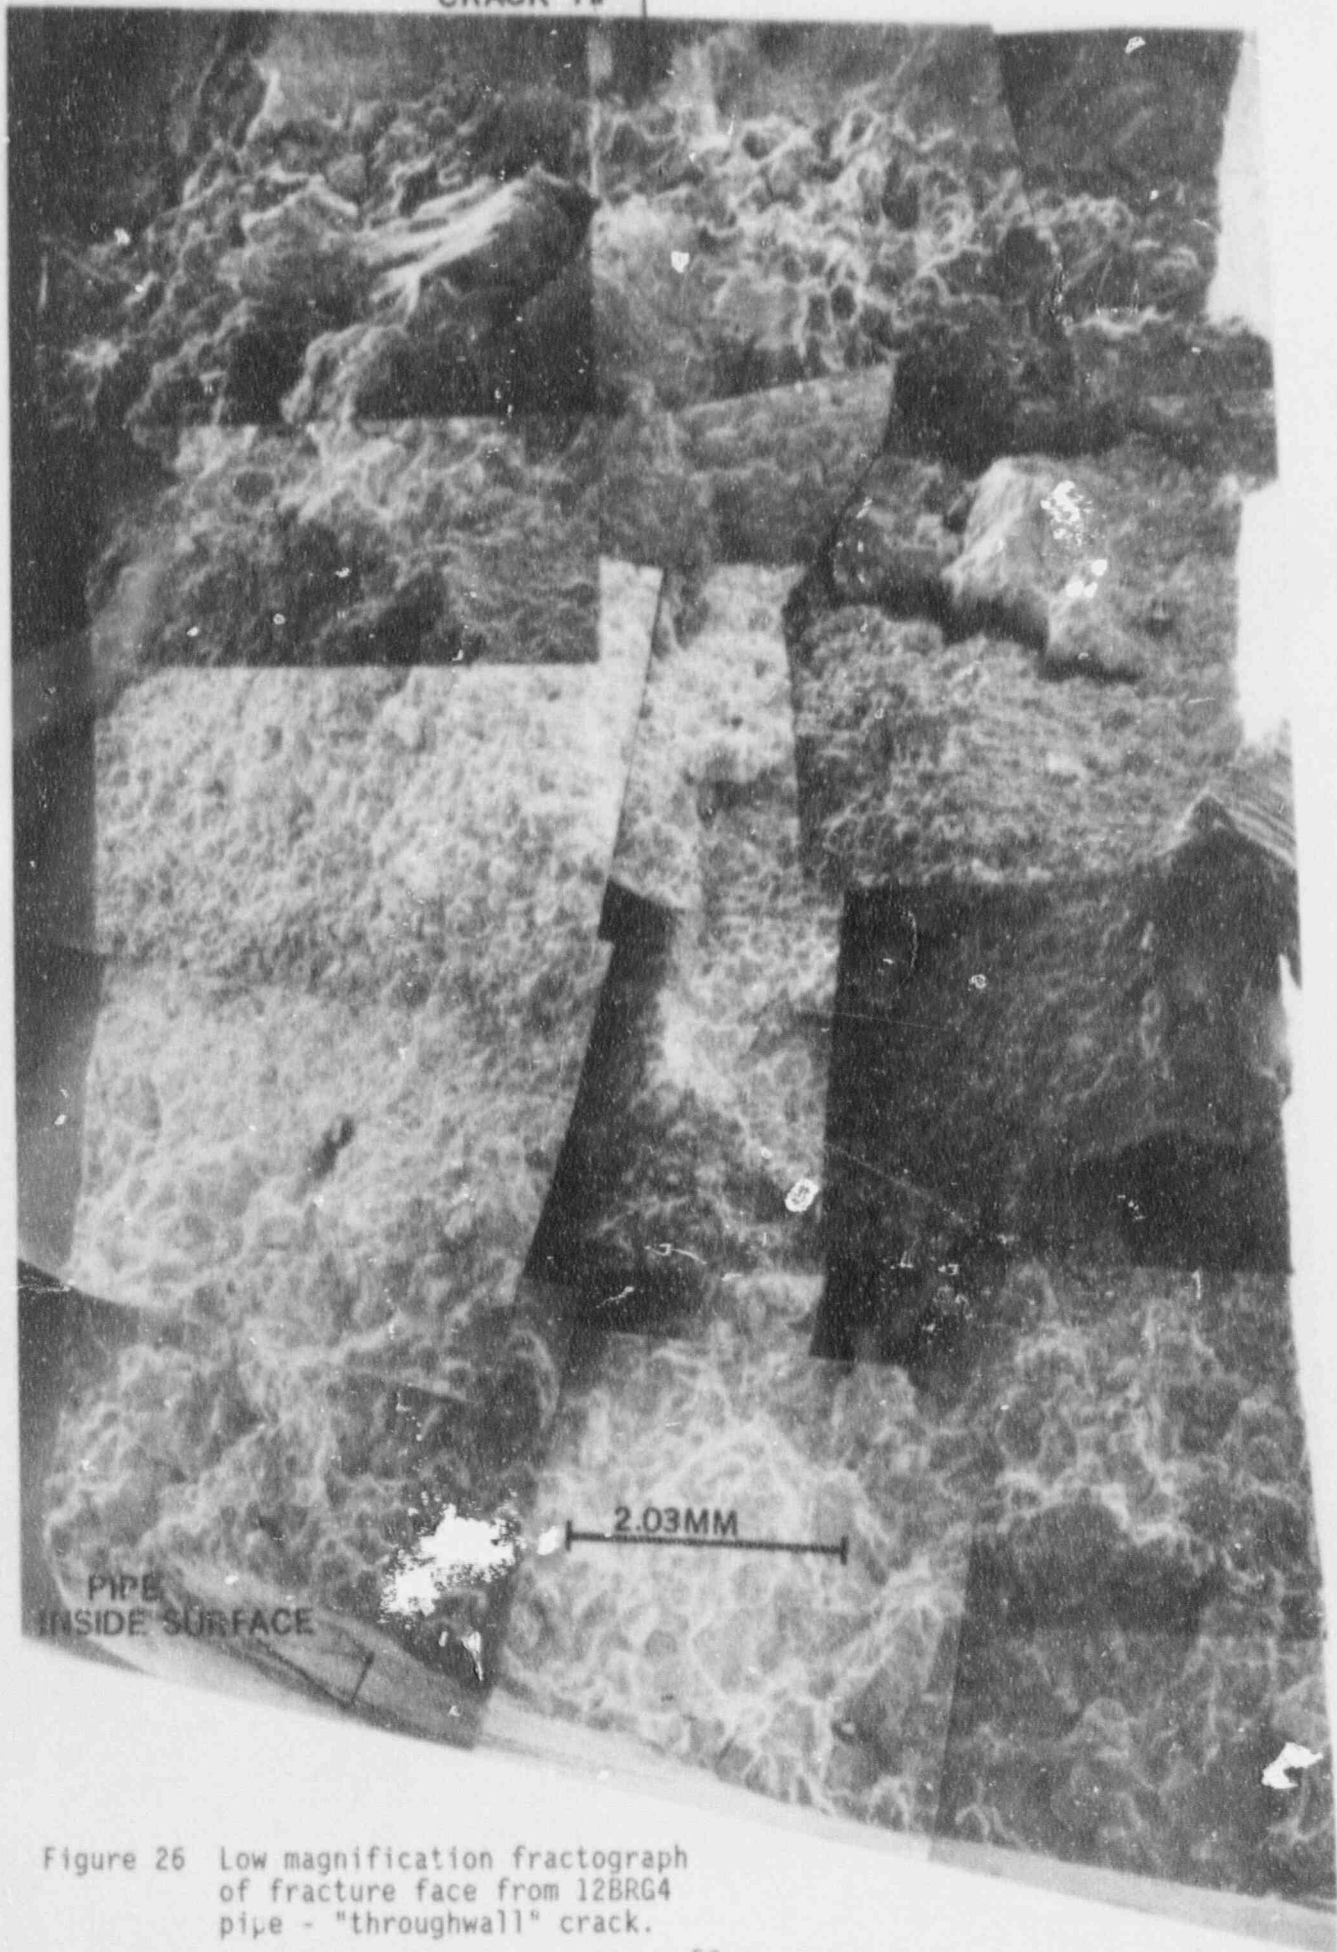
Figure 26 Low magnification fractograph of fracture face from 12BRG4 pipe - "throughwall" crack.

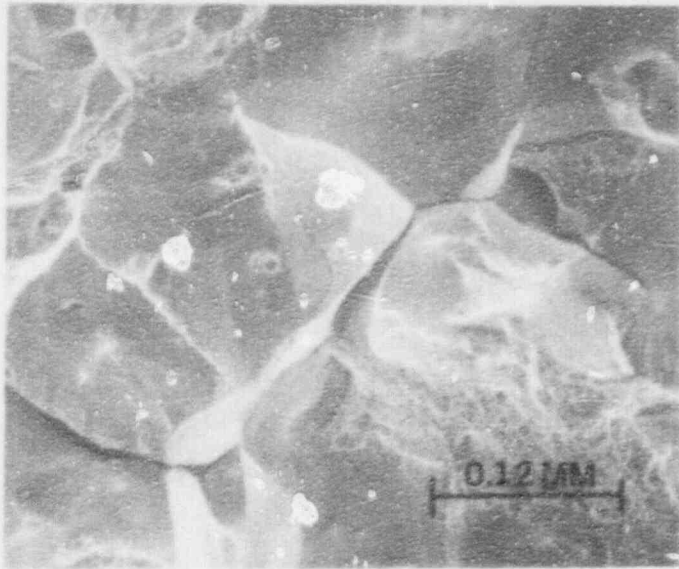
Figure 27 Crack seen in Figure 26 was intergranular in appearance.

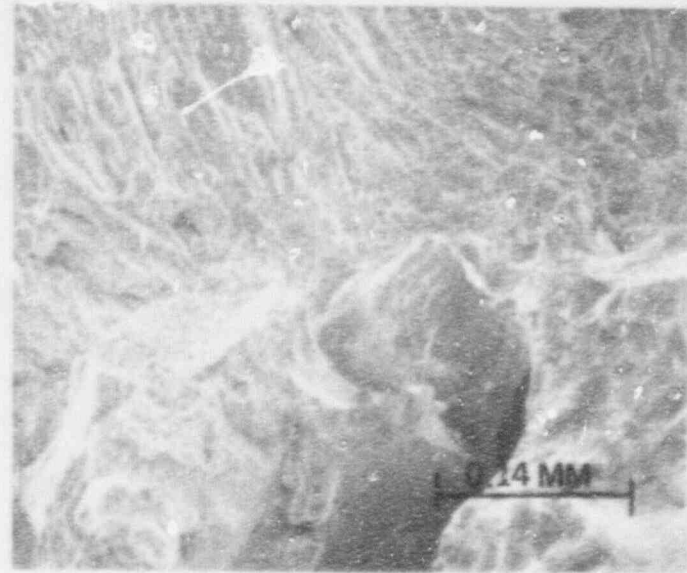
Figure 28a No evidence of crack blunting was seen at the crack/overlay interface.

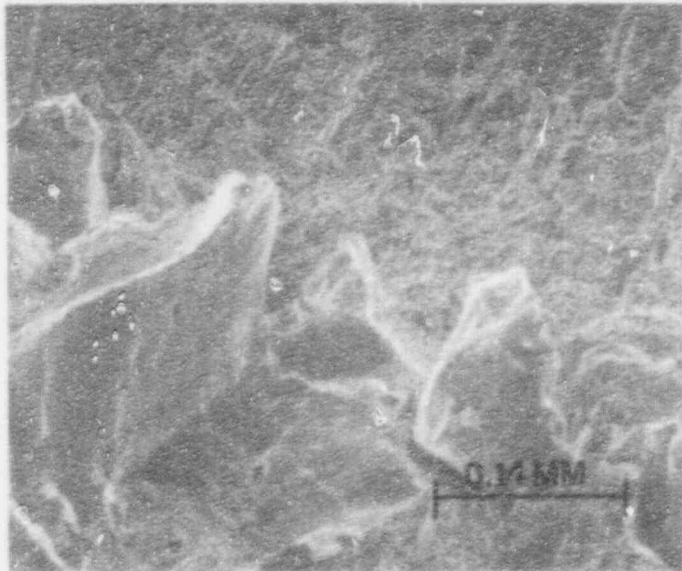
Figure 28b Sharp intergranular facets are evident in the same interface.

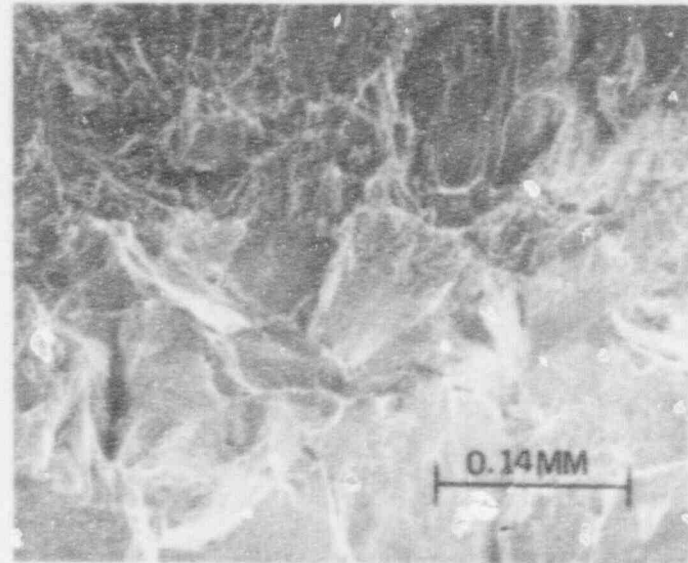
Figure 28c A third area showing no definite crack blunting.

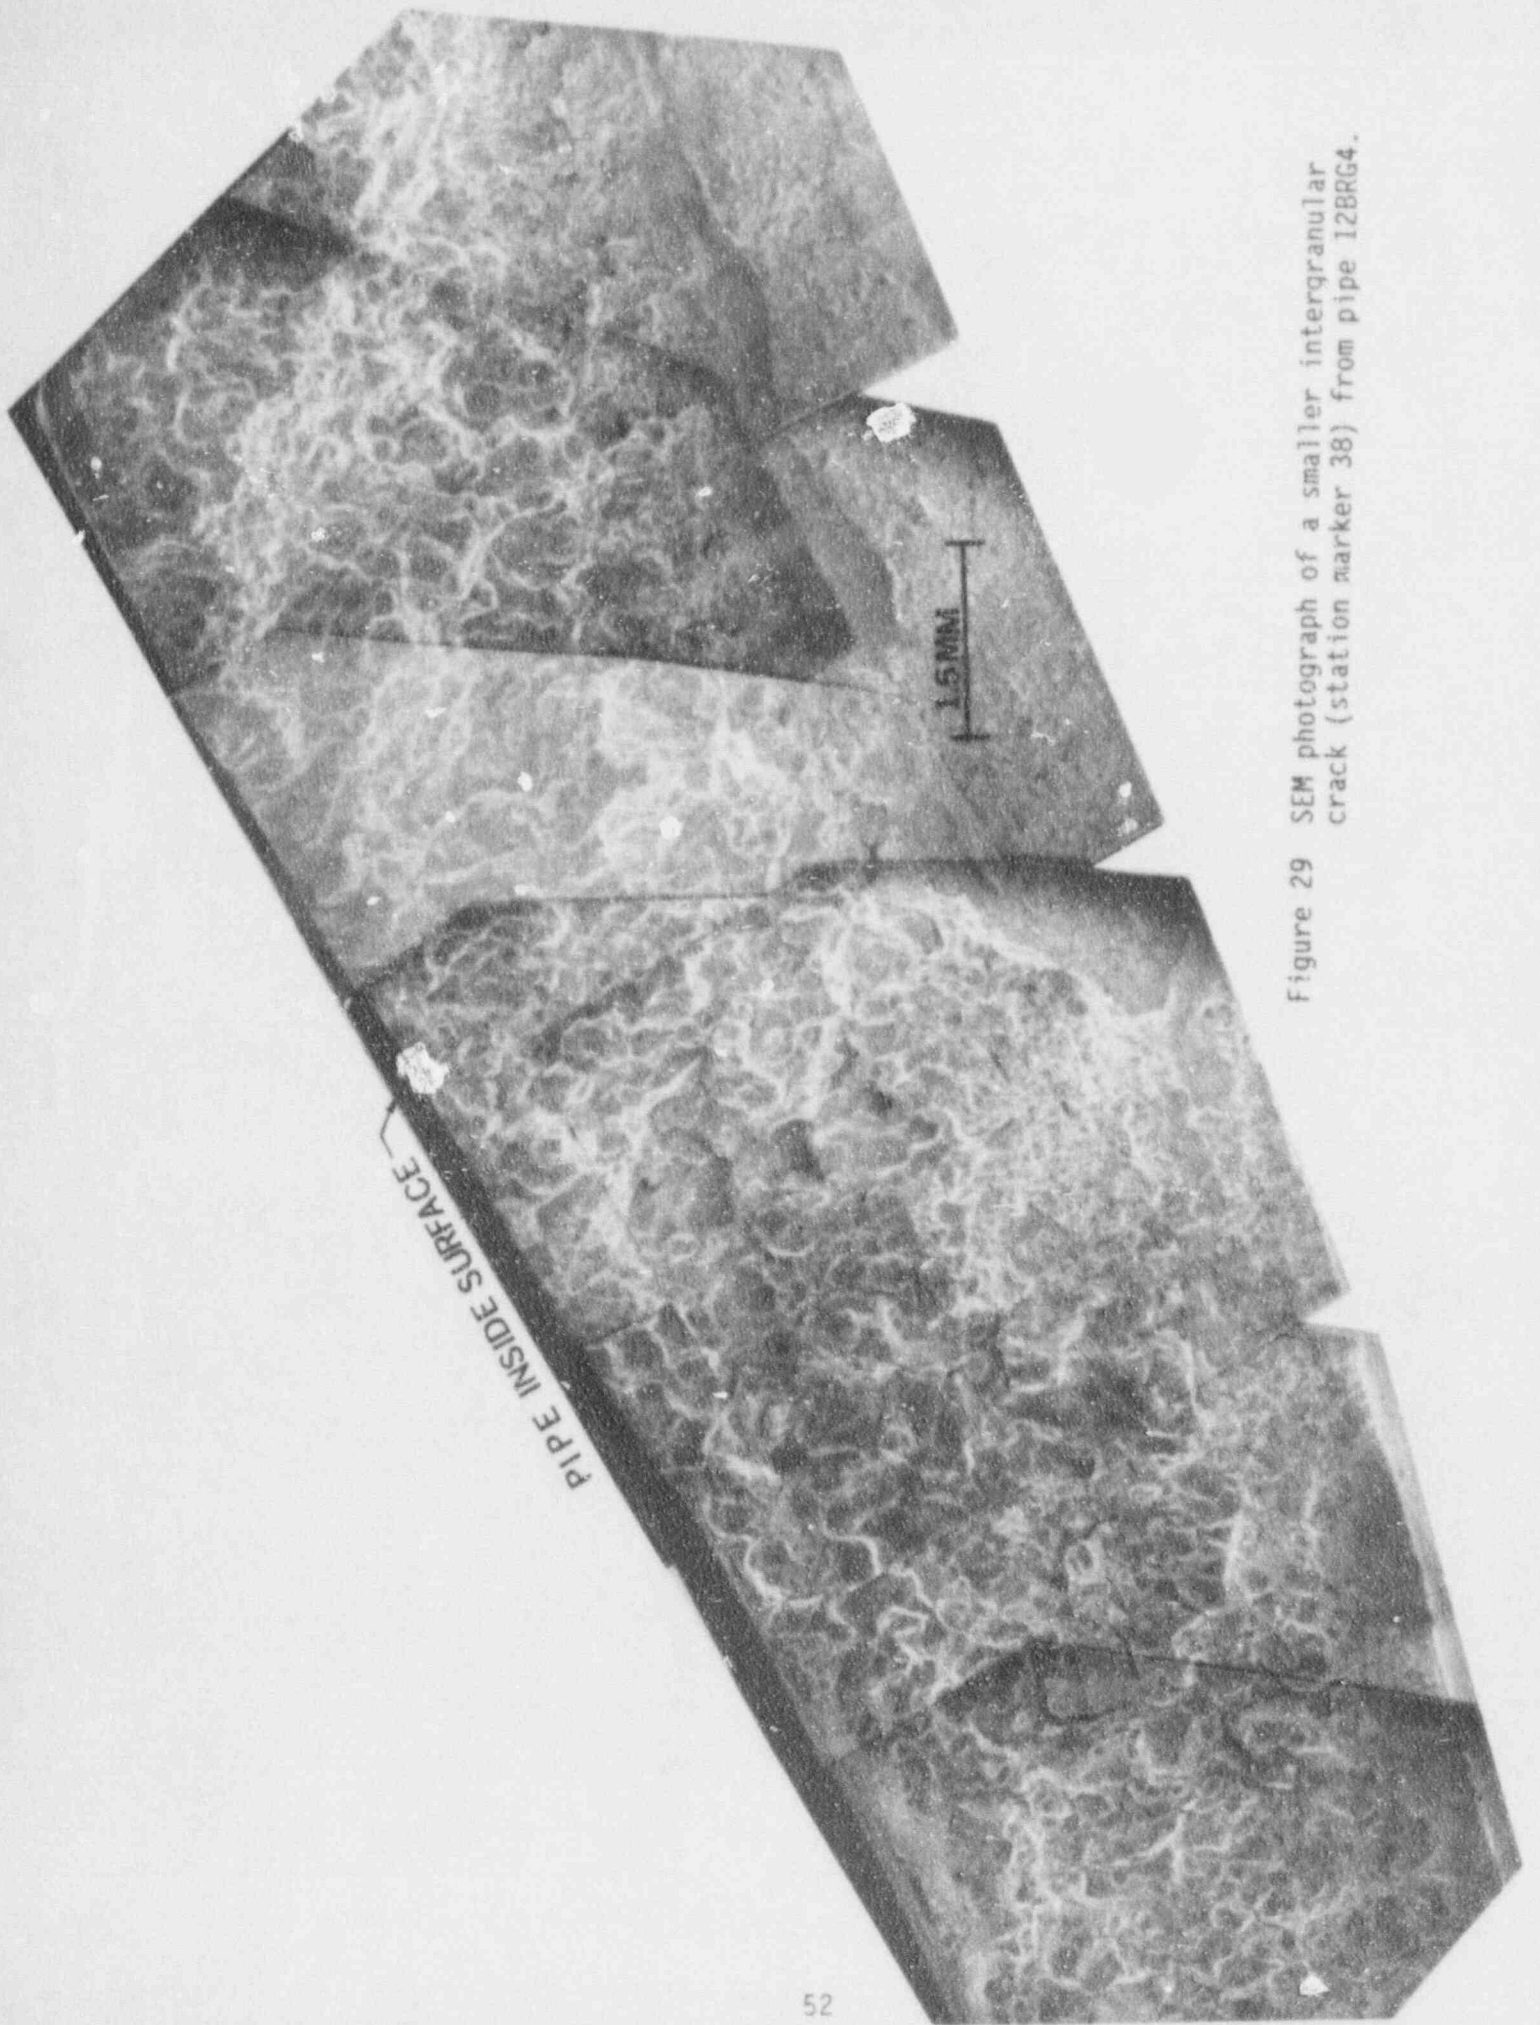
One of the smaller cracks on 12BRG4 was also examined (Figure 29). This crack was also entirely intergranular with no evidence of beach marks, etc.

Figure 29 SEM photograph of a smaller intergranular crack (station marker 38) from pipe I2BRG4.

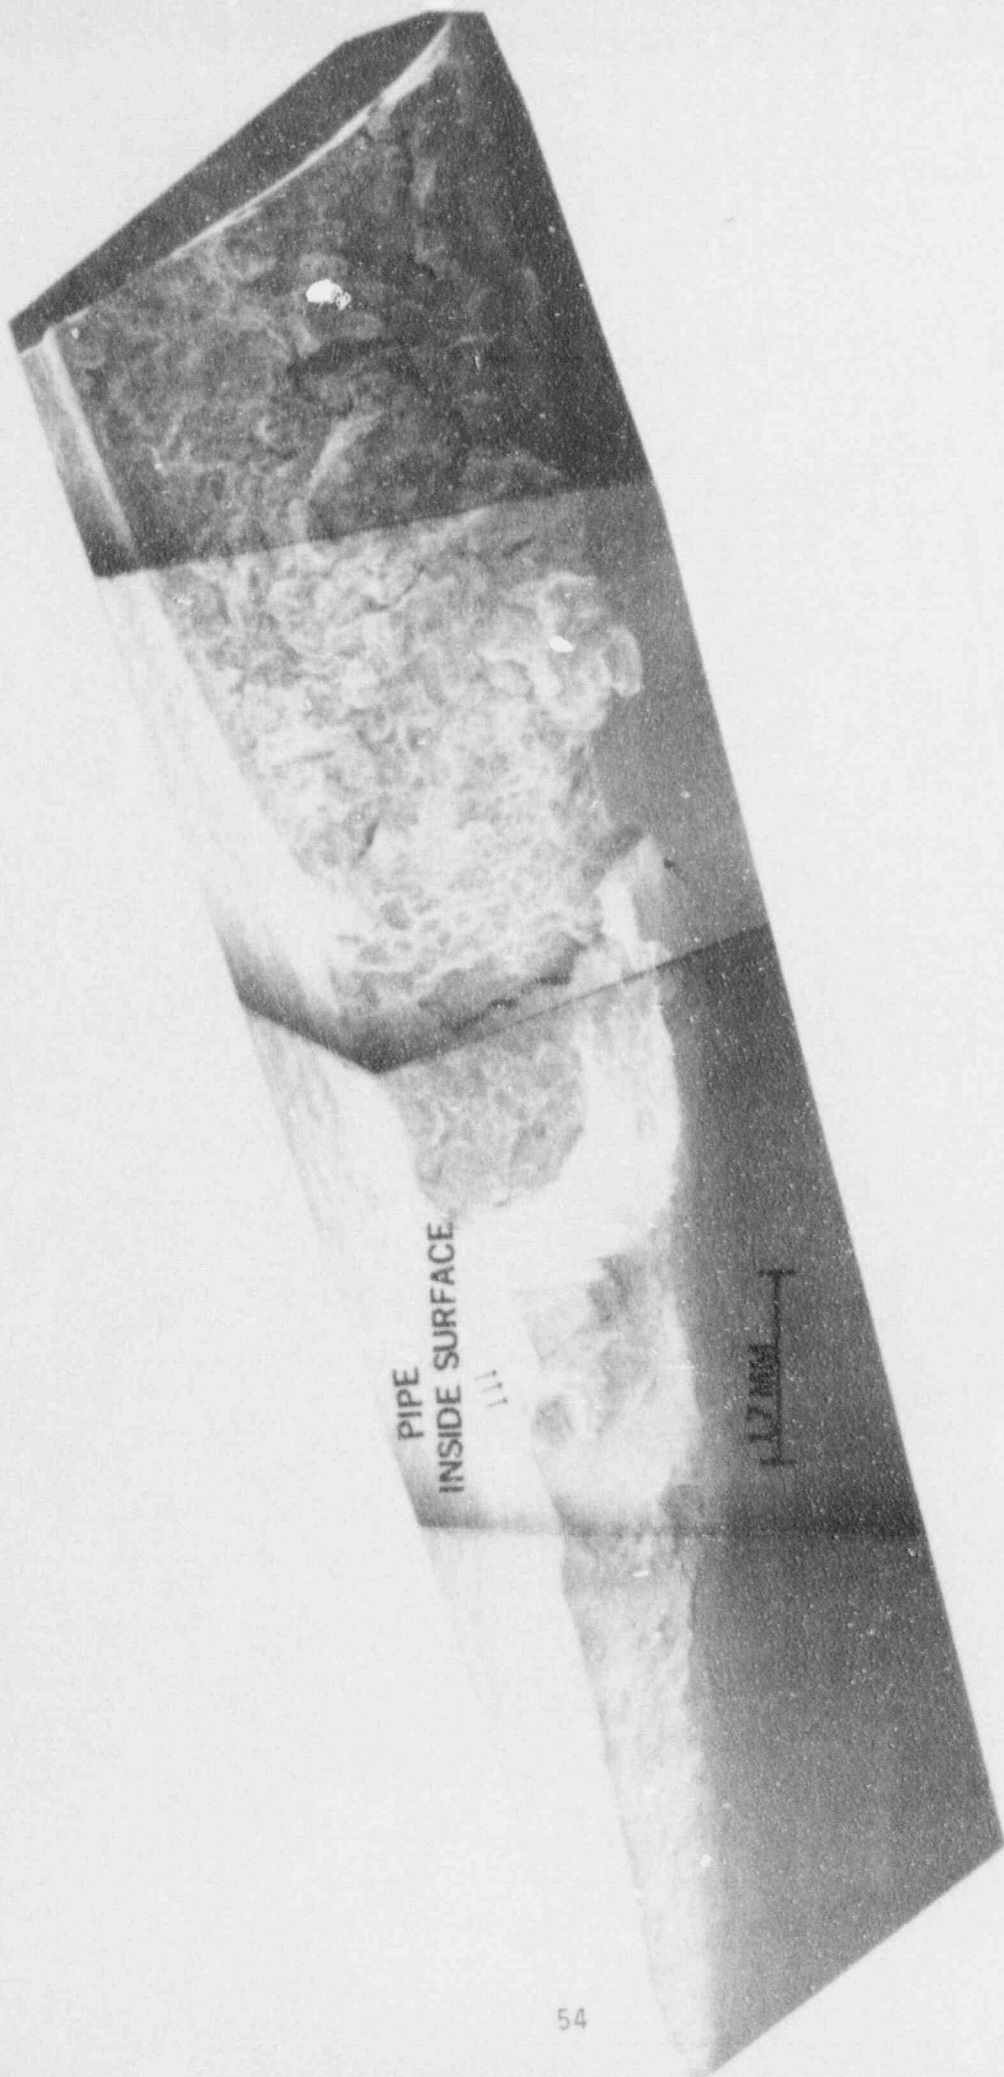
A fracture face from BRJ2 pipe (typical of other cracks examined) is shown in Figure 30. This crack was entirely intergranular (Figure 31a and 31b) with no evidence of beach marks or discontinuous crack growth.

Figure 30 Low Magnification fractograph of intergranular crack from BRJ2 station marker 22.

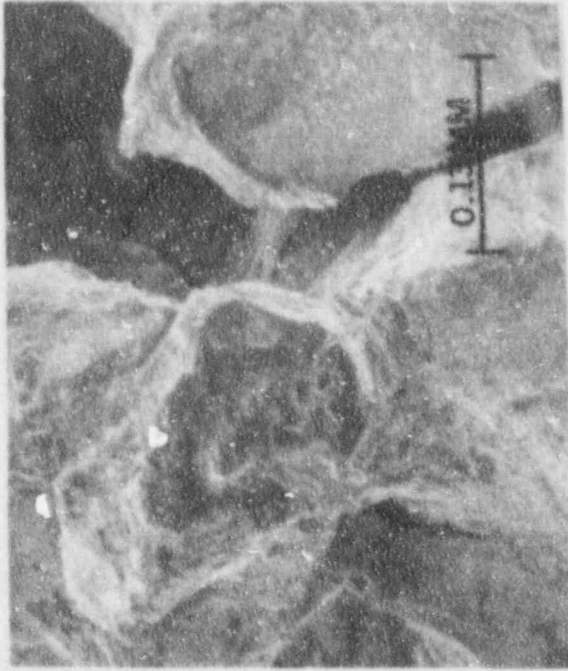
Figure 31b Second intergranular area (typical) seen on BRJ2 (station marker 22).

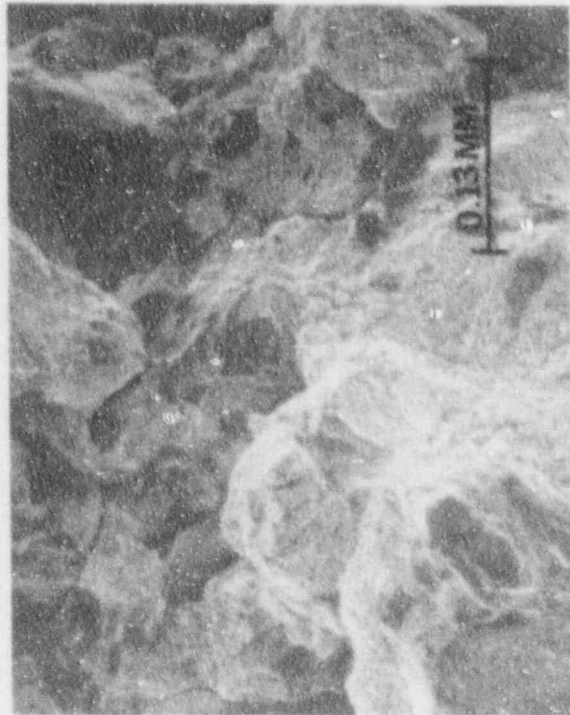
Figure 31a Higher magnification SEM photo of fracture face on BRJ2 (station marker 22).
