NUCLEAR REGULATORY COMMISSION

SUBJECT: PREDECISIONAL ENFORCEMENT CONFERENCE TO DISCUSS APPARENT VIOLATIONS

NEBRASKA PUBLIC POWER DISTRICT

PREDECISIONAL ENFORCEMENT CONFERENCE

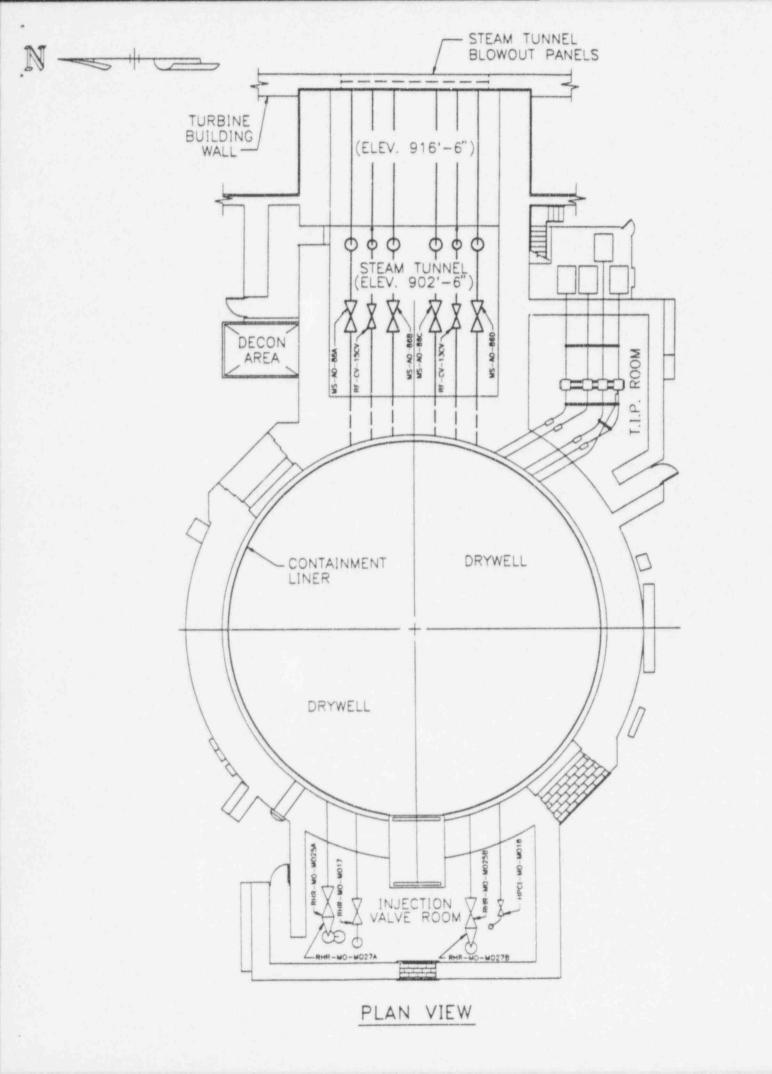
- A modification was performed in 1985 without an evaluation to determine if it constituted a change to the facility or the technical specifications or constituted an unreviewed safety question
 - Fiberglass applied to panels prevented blowout at the required pressure and raised the steam tunnel peak pressure

- Panels are secondary containment boundary
 - Made of 3-inch thick cellular concrete
 - Designed to mitigate effects of a HELB in steam tunnel
 - Panels sealed with fiberglass material in 1985 to prevent secondary containment leakage - MWR used - no 50.59 evaluation
- Fiberglass material strengthened panels elevated rupture pressure

Immediate Corrective Actions:

- Restored design basis function of panels
- Inspected other blowout panels minor discrepancy found
- Performed safety consequences evaluation
- Determined unreviewed safety question existed prior to restoring design basis function of panels

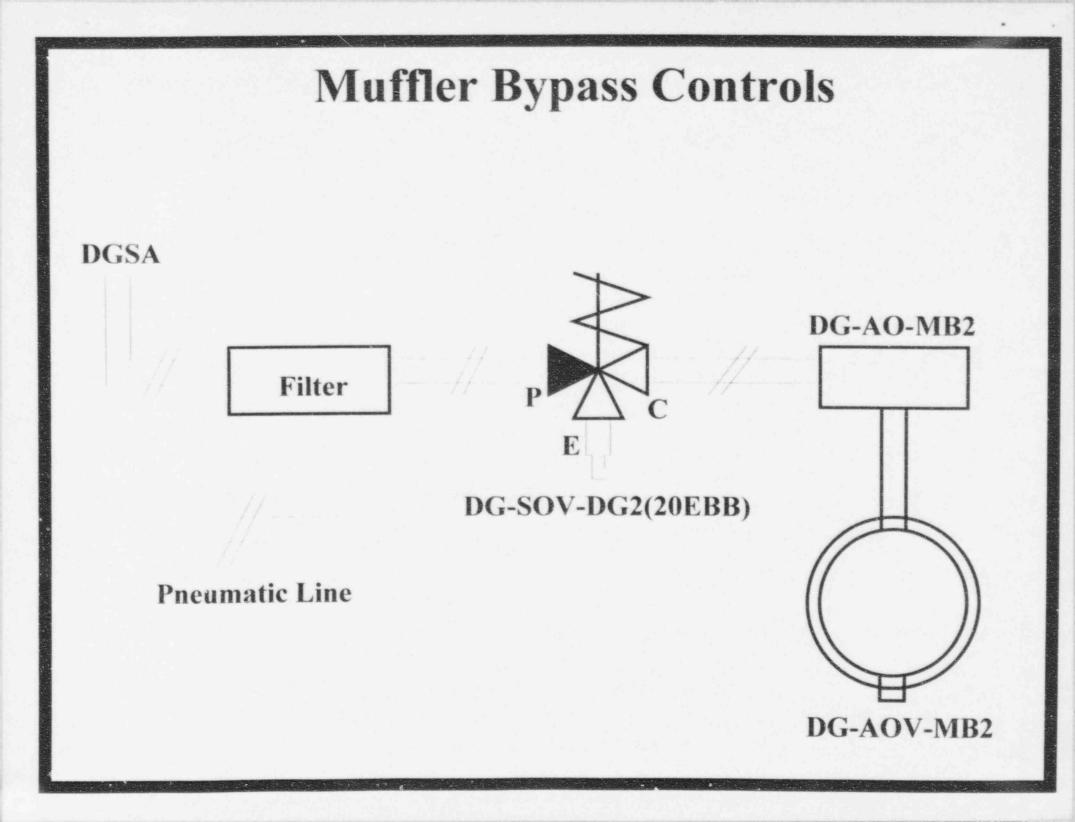
Diesel Generator #1 Timeline

Contrary to 10 CFR Part 50, Appendix B, Criterion III, an unauthorized modification was installed on both Diesel Generator muffler bypass systems.

- Failure to communicate what constitutes a change to the Plant
 - Installation of Exhaust Tube not recognized as an Unauthorized Modification
 - Inadequate training of Craft and Field Engineer

- Replaced DG-SOV-DG2(20EBB)
- Increased testing frequency to semi-monthly
- Sent SOV to ASCO for Failure Analysis
- Tested DG #1 MBV upon failure of DG #2 MBV
- Failed DG #2 MBV to safe position
- Removed Exhaust Tubes
