SUBJECT: SUMMARY OF THE OPERATING REACTOR EVENTS  
 MEETING ON JANUARY 17, 1985

# OPERATING REACTOR EVENTS BRIEFING

JANUARY 17, 1985

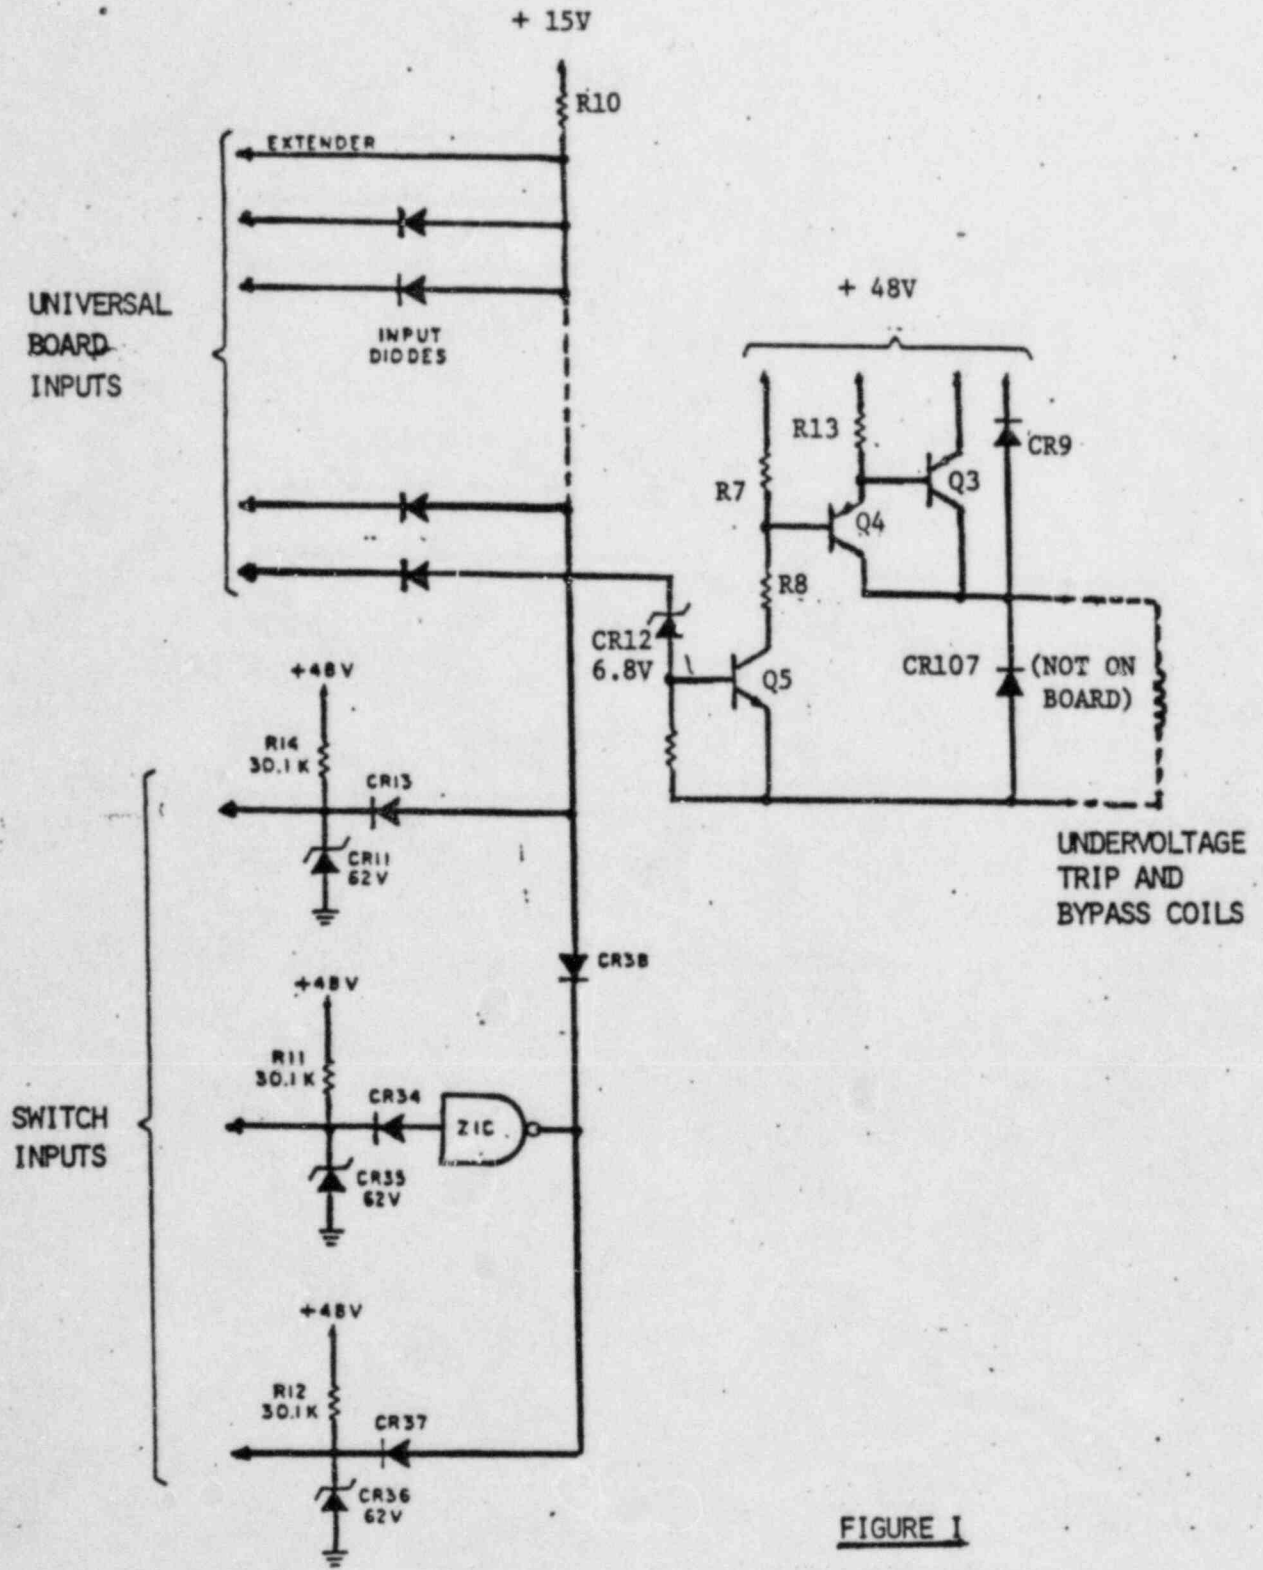
FIGURE I  
UV OUTPUT CIRCUIT

- SHORTED TRANSISTOR (Q-3) IN WESTINGHOUSE SOLID STATE PROTECTION SYSTEM (SSPS)

- NONE IN THIS CASE (I.E., THE REDUNDANT UV OUTPUT CIRCUIT FUNCTIONED PROPERLY AND SCRAMMED THE REACTOR BY OPENING RTB "B"). HOWEVER, SHORT CIRCUIT FAILURES OF BOTH REDUNDANT Q-3 TRANSISTORS COULD LEAD TO AN ATWS BY INHIBITING THE AUTOMATIC TRIPPING FEATURE (I.E., BOTH THE UV AND SHUNT TRIP FEATURES) OF BOTH RTB'S. SINCE SUCH FAILURES ARE NOT ROUTINELY MONITORED, THEY WOULD NOT BE ANNUNCIATED

- TESTING - EXTENSIVE SURVEILLANCE TESTING OF THE RPS WAS PERFORMED, INCLUDING RESPONSE TIME TESTING OF THE RTB'S AFTER THE DEFECTIVE CARD WAS REPLACED. IN ADDITION, THE FAILED CIRCUIT CARD WAS INSPECTED AND TESTED AT WHICH TIME IT WAS DETERMINED THAT THE FAILURE WAS A SHORT CIRCUIT OF TRANSISTOR Q-3. ALL OTHER COMPONENTS WITHIN THE UV OUTPUT CIRCUIT TESTED OK

- RTB "A" MANUALLY TRIPPED - UPON NOTICING THAT RTB "A" HAD NOT TRIPPED, THE OPERATOR MANUALLY TRIPPED THE BREAKER, THEREBY ASSURING A REACTOR SCRAM
- POST-TRIP REVIEW - DURING THE POST-TRIP REVIEW, THE LICENSEE DIAGNOSED THE FAILURE AS BEING IN THE UV OUTPUT CIRCUIT OF THE SSPS. THUS, THE OUTPUT CIRCUIT CARD ON THE AFFECTED SSPS TRAIN WAS REPLACED, AFTER WHICH THE TRIP FUNCTION OPERATED PROPERLY

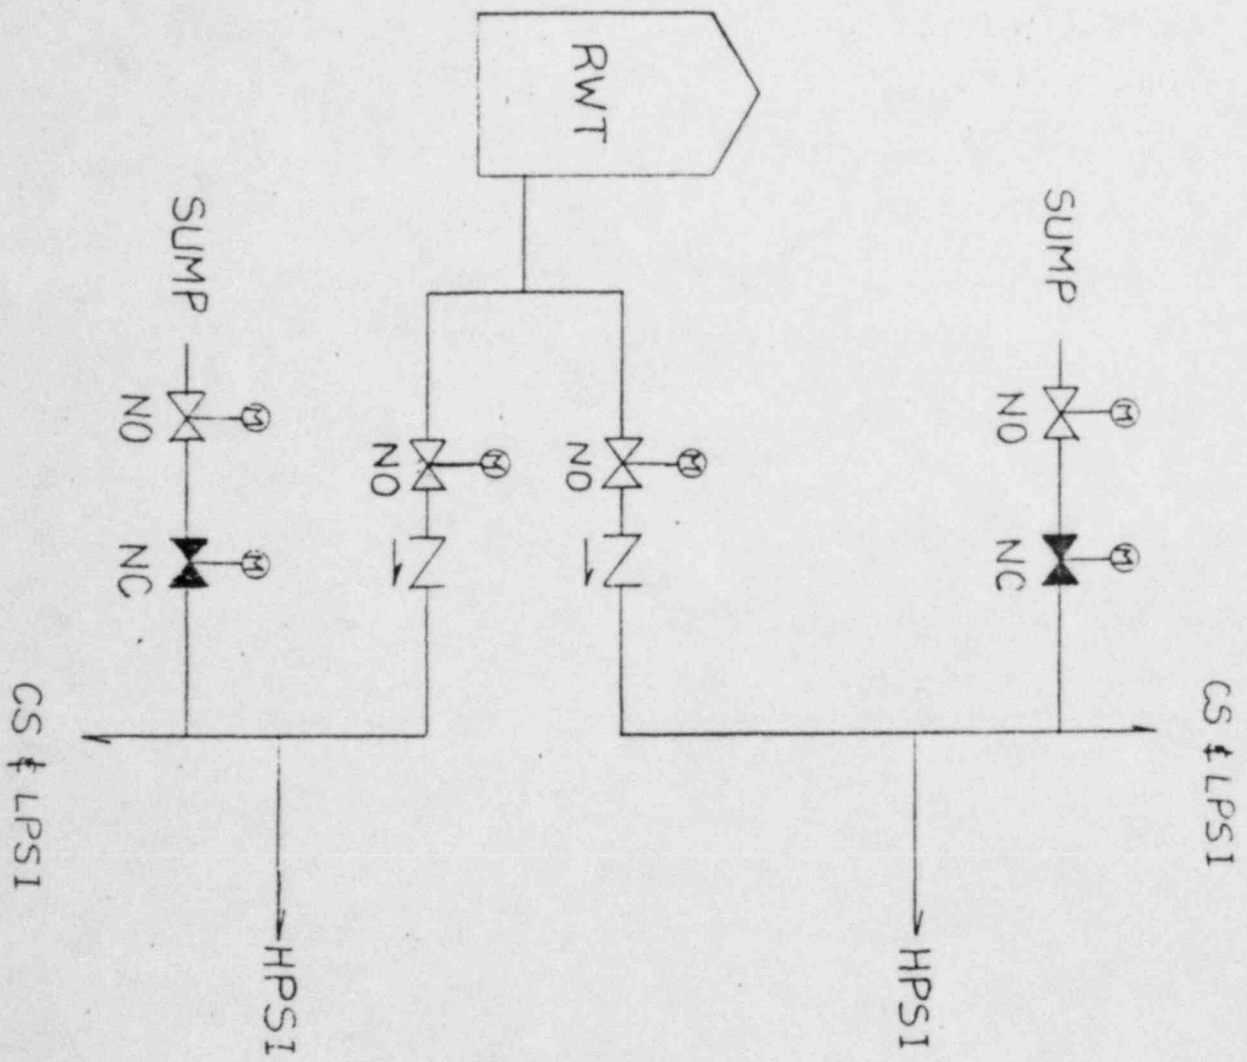
- PLANT PROTECTION SYSTEM BEING TESTED (PLANT AT FULL POWER)
- CHANNEL "A" OF RECIRCULATION ACTUATION SYSTEM (RAS) TRIPPED WHILE "B" OUT OF SERVICE FOR TESTING
- TWO-OUT-OF-FOUR LOGIC NECESSARY TO GENERATE RAS SATISFIED
- CONTAINMENT SUMP RECIRCULATION ISOLATION VALVES OPEN (✓ 22 SECONDS NEEDED TO FULLY OPEN)
- REFUELING WATER TANK DISCHARGE VALVES CLOSE (✓ 80 SECONDS NEEDED TO FULLY CLOSE)
- ABOUT 50,000 GALLONS OF RWT WATER FLOWED INTO CONTAINMENT
- CAUSE OF SPURIOUS ACTUATION BEING INVESTIGATED

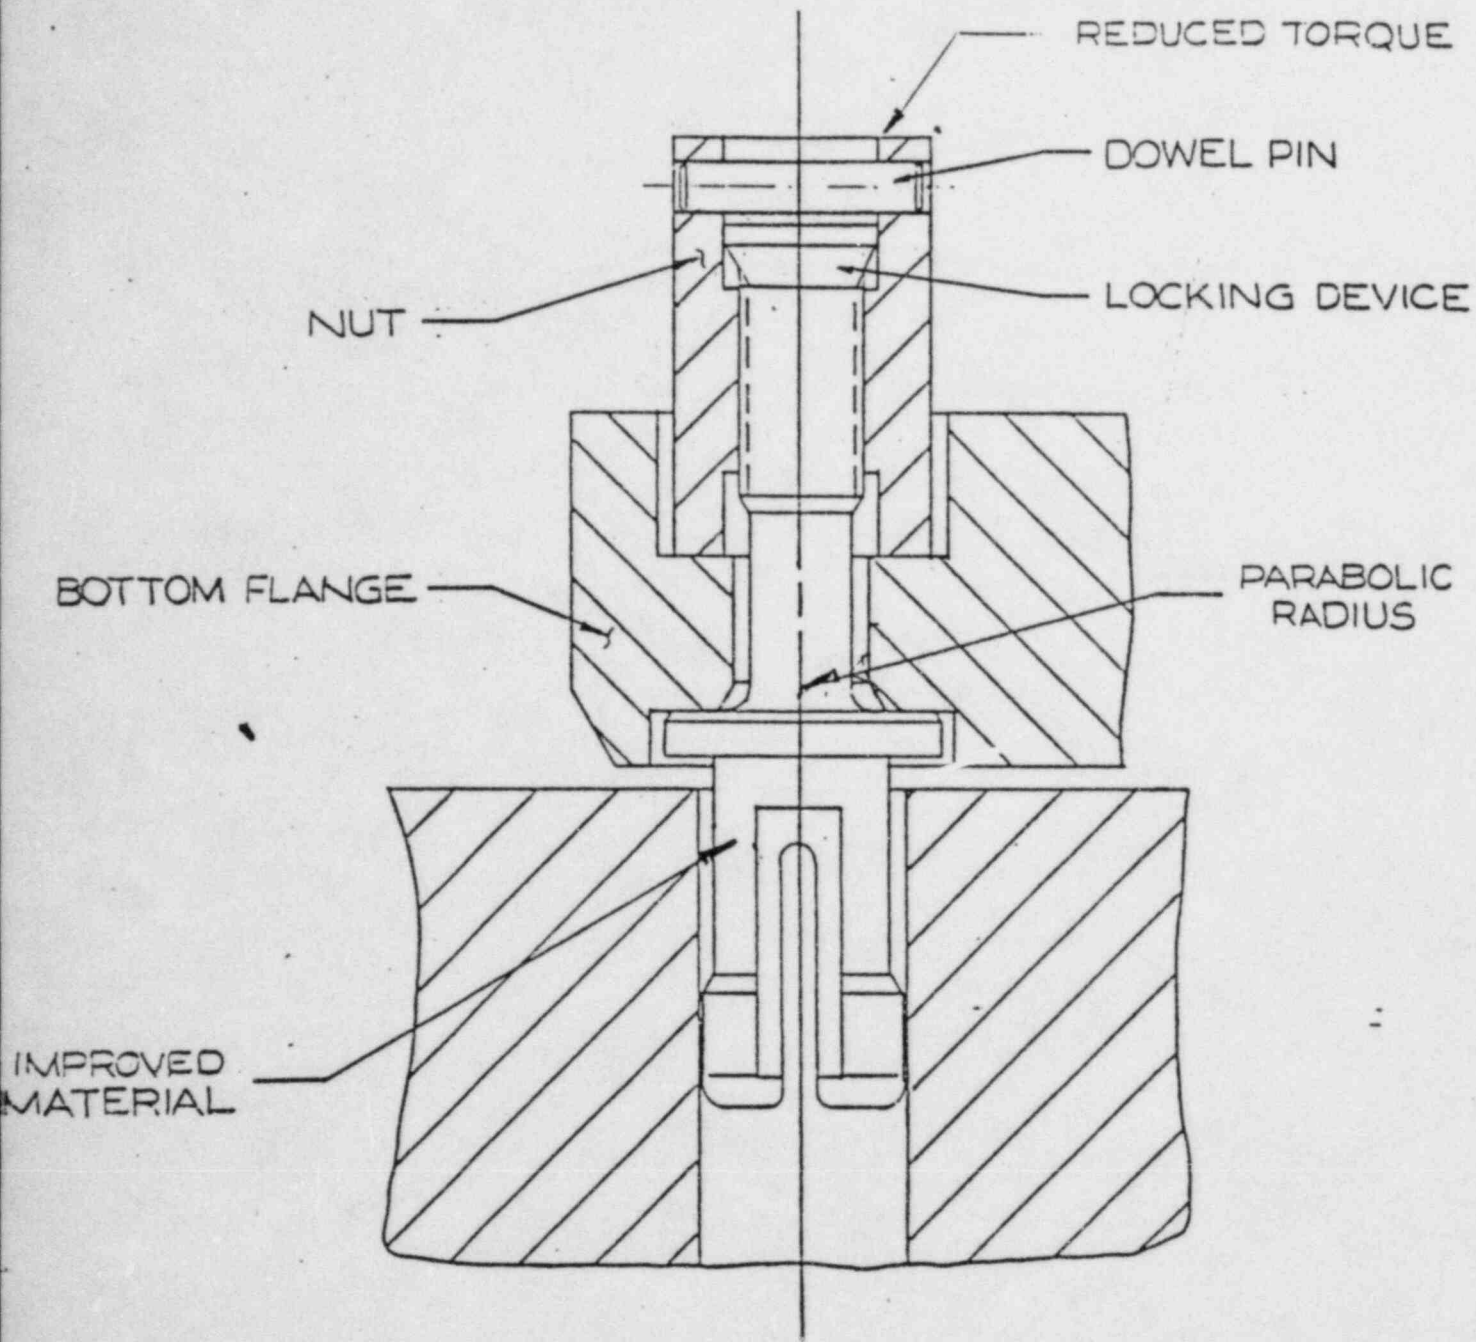
# GUIDE TUBE SUPPORT PIN ASSEMBLY

- LOOSE PARTS INDICATIONS DETECTED IN TWO STEAM GENERATORS (SG) WHILE STARTING UP FROM OUTAGE
- WESTINGHOUSE NOISE ANALYSIS INDICATES CRDM GUIDE TUBE SUPPORT PINS
- PLANT COOLED DOWN AND SGs INSPECTED
- NUT, DOWEL PIN, LOCKING PIN AND BROKEN PIECE OF SHANK FOUND IN No. 2 SG
- NUT, LOCKING DEVICE AND DOWEL PIN FOUND IN No. 3 SG
- TUBE ENDS INSPECTED; MINOR PEENING DAMAGE
- UNIT 1 PINS TO BE REPLACED AT A 10-YEAR OUTAGE (APRIL 1985)
- REPLACEMENT OF UNIT 2 PINS AT NEXT REFUELING OUTAGE BEING CONSIDERED

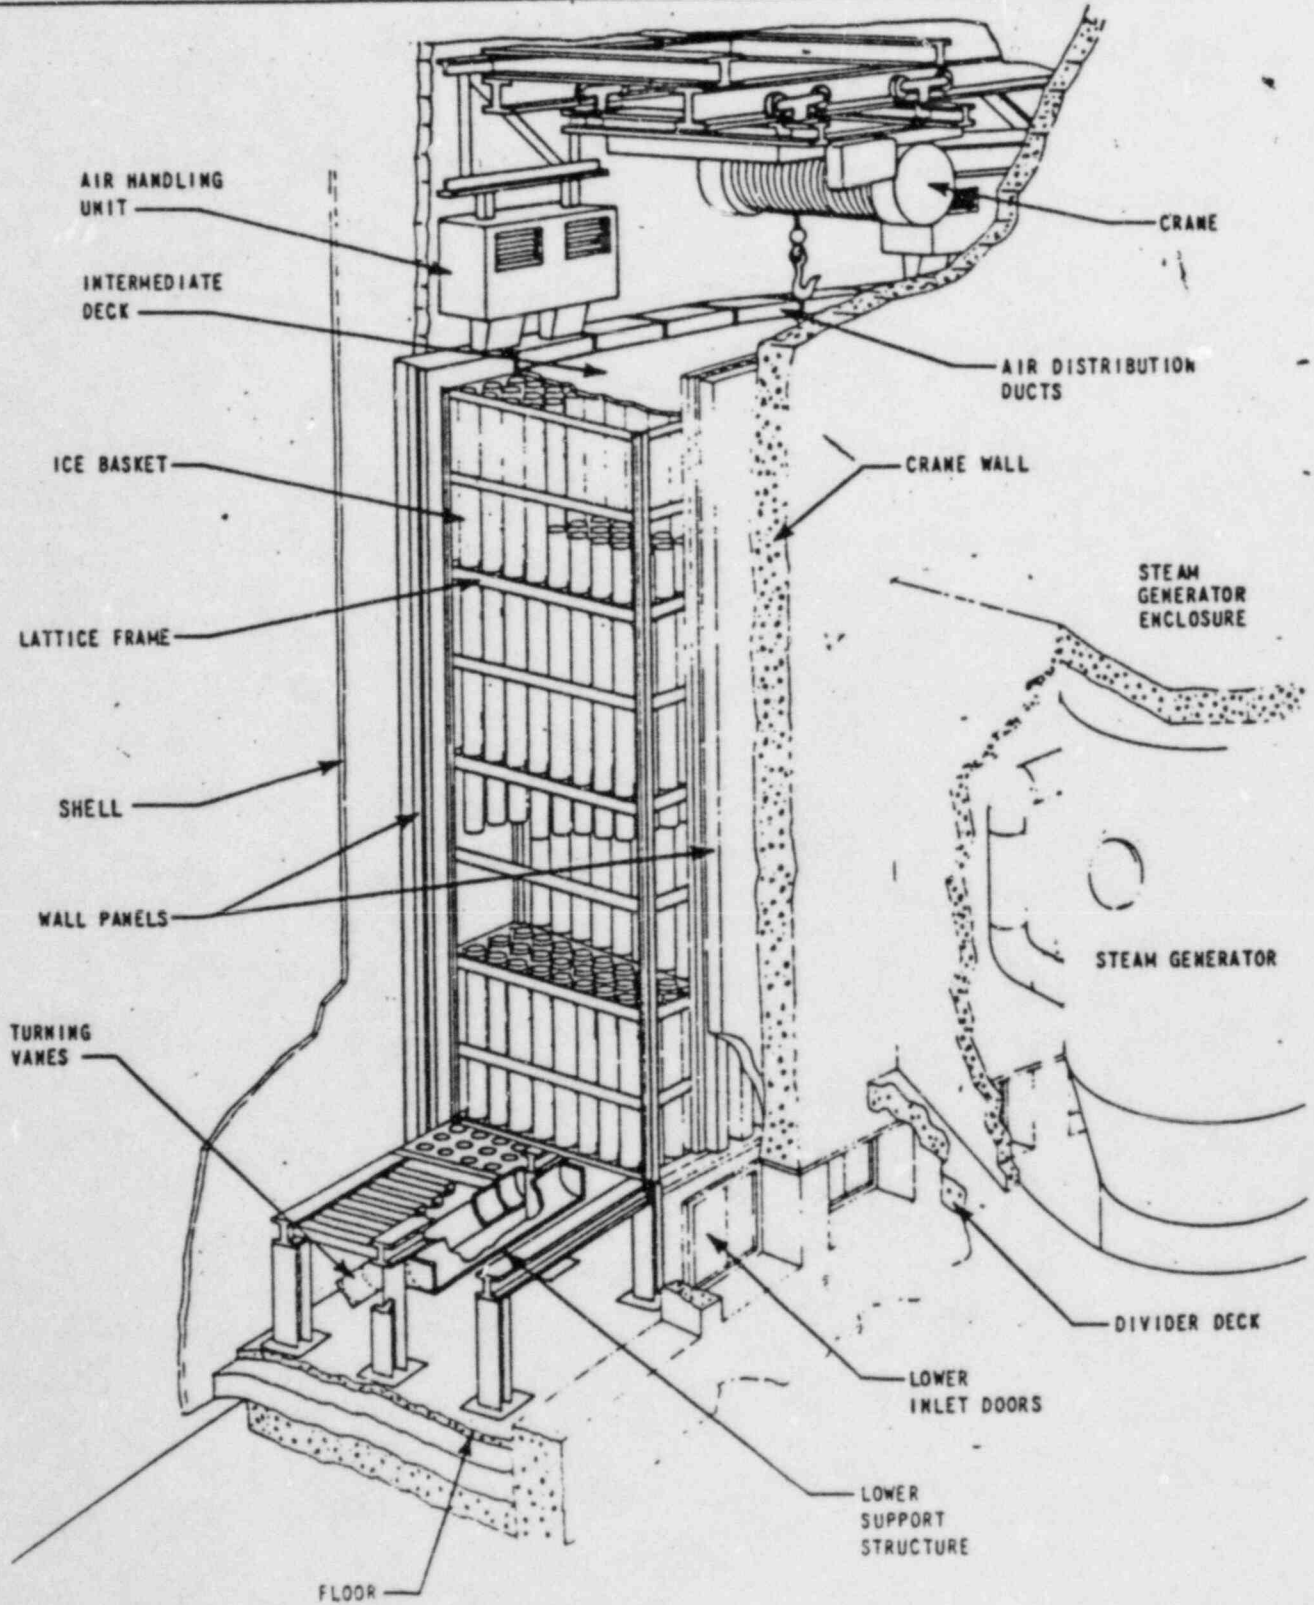
ISOMETRIC OF ICE CONDENSER.

- 23 OF 24 ICE CONDENSER INLET DOORS FOUND BLOCKED CLOSED WITH PLANT IN MODE 2
- BLOCKED DOORS COULD CUT-OFF COOLING PATH FOR CONTAINMENT ATMOSPHERE FOLLOWING LOCA OR MSLB

- NO IMMEDIATE HAZARD SINCE PLANT IS IN INITIAL STARTUP PHASE WITH INSIGNIFICANT LEVELS OF DECAY HEAT
- DOORS WERE BLOCKED CLOSED TO PREVENT ICE MELT WHILE IN MODES 5 AND 6; SHOULD HAVE BEEN UNBLOCKED CPER T. S. WHEN MODE 3 ENTERED ON 12/31/84

- CAUSE WAS PERSONNEL ERROR IN FAILING TO COMPLETE ACTION REQUIRED BY T.S.; INVESTIGATION IN PROGRESS SINCE ACTION TO UNBLOCK DOORS HAD BEEN SIGNED OFF AS COMPLETE

- CORRECTIVE ACTIONS
  - LICENSEE DETERMINING LEVEL OF DEGRADATION OF DOOR PERFORMANCE DURING ACCIDENT AND POTENTIAL CONSEQUENCES
  - COMPLETION OF ALL ACTIONS REQUIRED BY T.S. ON MODE CHANGE BEING INDEPENDENTLY VERIFIED

- DOOR BLOCKS ARE BEING PAINTED A BRIGHT COLOR; DOOR SIGNS WILL BE USED TO INDICATE BLOCKED DOORS IN FUTURE
