ESK-96-055

April 9, 1996

Subject: Quad Cities Nuclear Station Unit 1, Core Shroud Examination Results  
NRC Docket No. 50-254

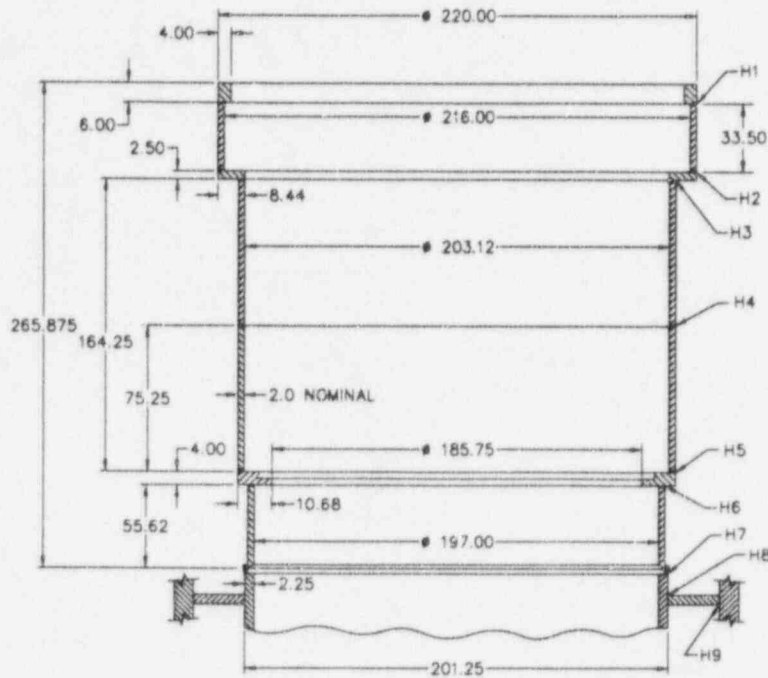
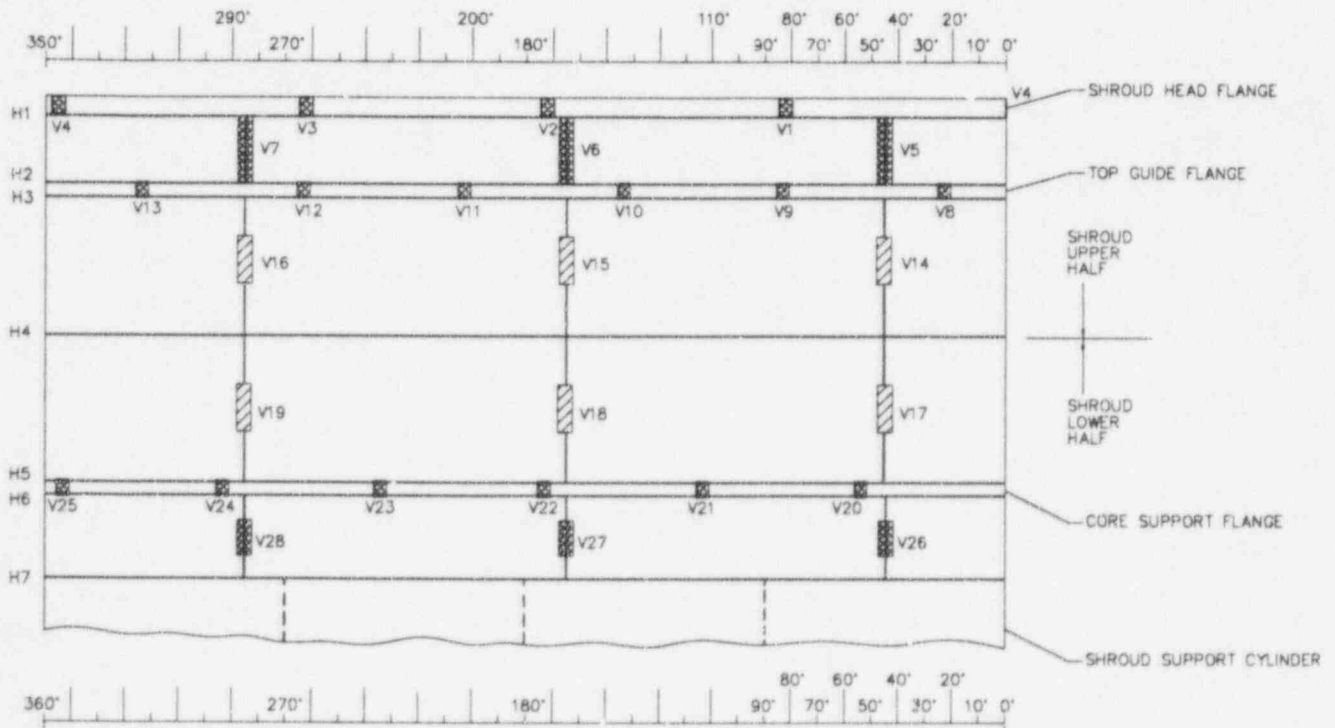
# FIGURE 1

The following is a summary of the core shroud examination scope and results. Details of the specific areas examined and the results of the examinations are presented in the attached Table 1 and Figure 1.

- The ultrasonic examination scope consisted of shroud vertical welds (V14 through V19) located between horizontal welds H3/H4 and H4/H5 (i.e. beltline region). Approximately 27 inches, or between 31% and 36% of the total length of each vertical weld was examined. These examinations resulted in no reportable indications.

- The enhanced visual examination scope consisted of the ring segment welds associated with the shroud head flange ring, top guide support ring, core plate support ring, vertical welds V5-V7 and V26-V28, inclusive; the H8 and H9 horizontal welds at the shroud repair hardware locations; and the shroud repair hardware attachment sites at the shroud head flange ring and the jet pump support plate. These examinations resulted in no reportable indications.
