# WOLF CREEK

Subject: Docket No. 50-482: Licensee Event Report 92-006-00

## LICENSEE EVENT REPORT (LER)

TITLE (4) **Binding And Slippage Between Reactor Coolant System Crossover Leg Saddles And Thrust Block Causes Unusual Noise**

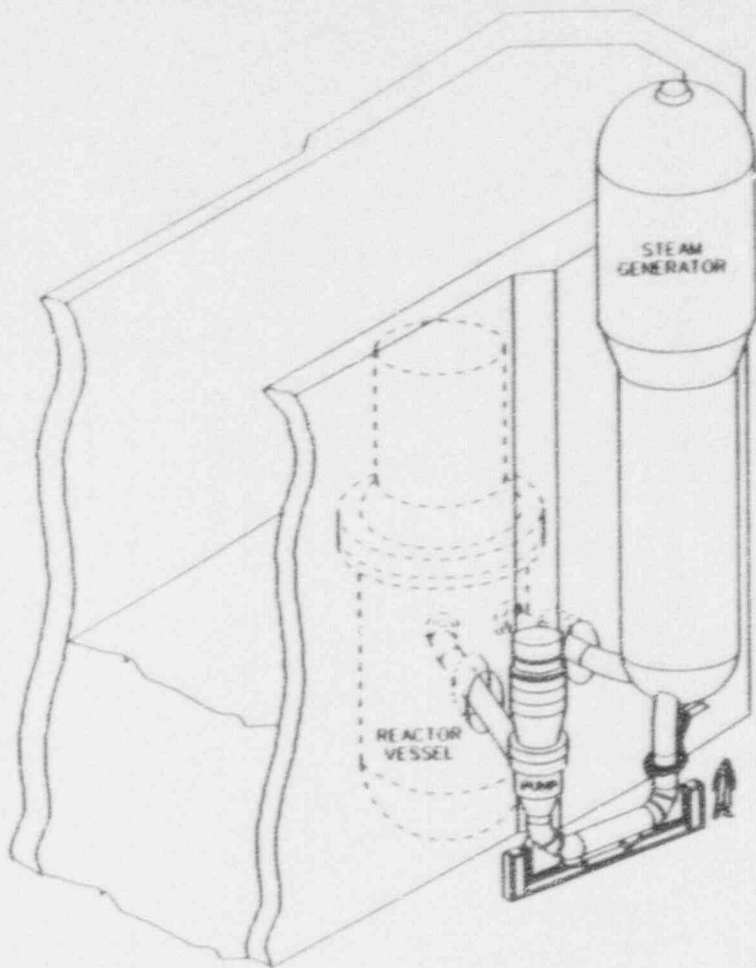
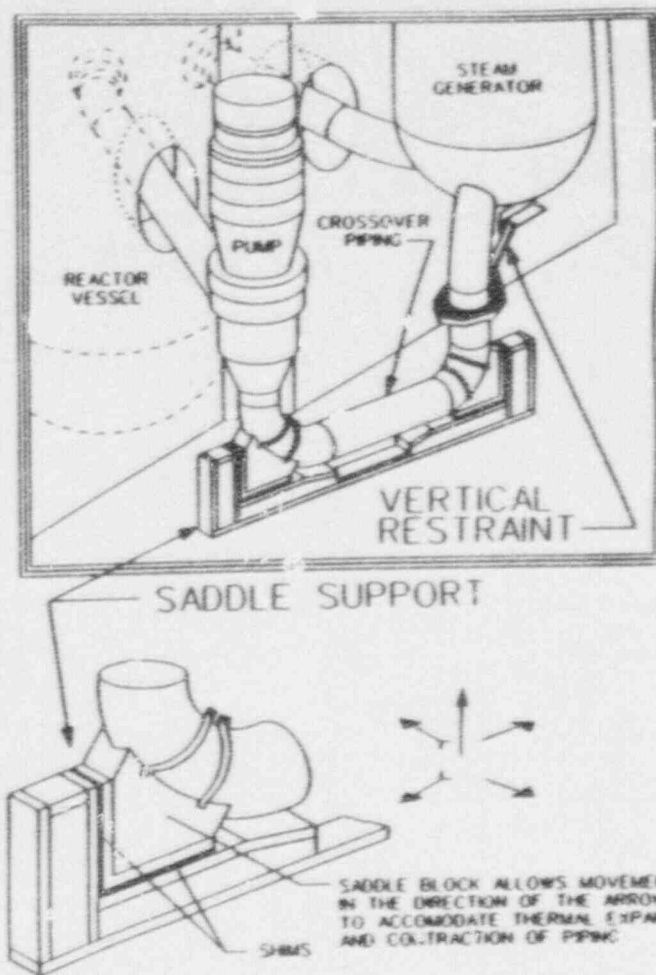
Figure 1

to approximately 440 degrees F (at the point the crossover leg saddles came in contact with the thrust block) closely followed the expected system designed thermal growth. Binding between the crossover leg saddles and the thrust block occurred above an RCS temperature of approximately 440 degrees F due to a lack of sufficient clearances. Additionally, the binding between the crossover leg saddles and the thrust block prevented the crossover leg from moving in the out-of-plane direction. The resultant binding and the friction force between the crossover leg saddles and the thrust block is believed to have initiated gouging of the thrust block shims.

Evaluation of the data from the Thermal Expansion Monitoring Program and the four events determined that the source of the noise for the January, February and March 1992 events was thermal binding and subsequent slippage between the crossover leg saddles and the thrust block (see Figure 1). The crossover leg saddles became bound at the restraint by friction as temperature increased above 500 degrees F, restricting further free thermal expansion and resulting in limited movement. Subsequently, on March 18, 1992, a plant cooldown was initiated to approximately 440 degrees F to provide clearance between the crossover leg saddles and the thrust block to allow removal of the thrust block shims.

The shims on the RCP and steam generator crossover legs lower horizontal and the RCP vertical restraints were removed and machined to maintain minimum clearance at normal operating temperature. Rework of the shims at the binding points alleviated the restriction to thermal expansion, allowing expected uniform movement.
