Commonwealth Edison

RLB-92-150

LICENSEE EVENT REPORT (LER)

Facility Name (1) Quad Cities Unit One
 Docket Number (2) 0 | 5 | 0 | 0 | 0 | 2 | 5 | 4
 Page (3) 1 | of | 0 | 4
 Title (4) Design Deficiency In The Standby Gas Train Logic

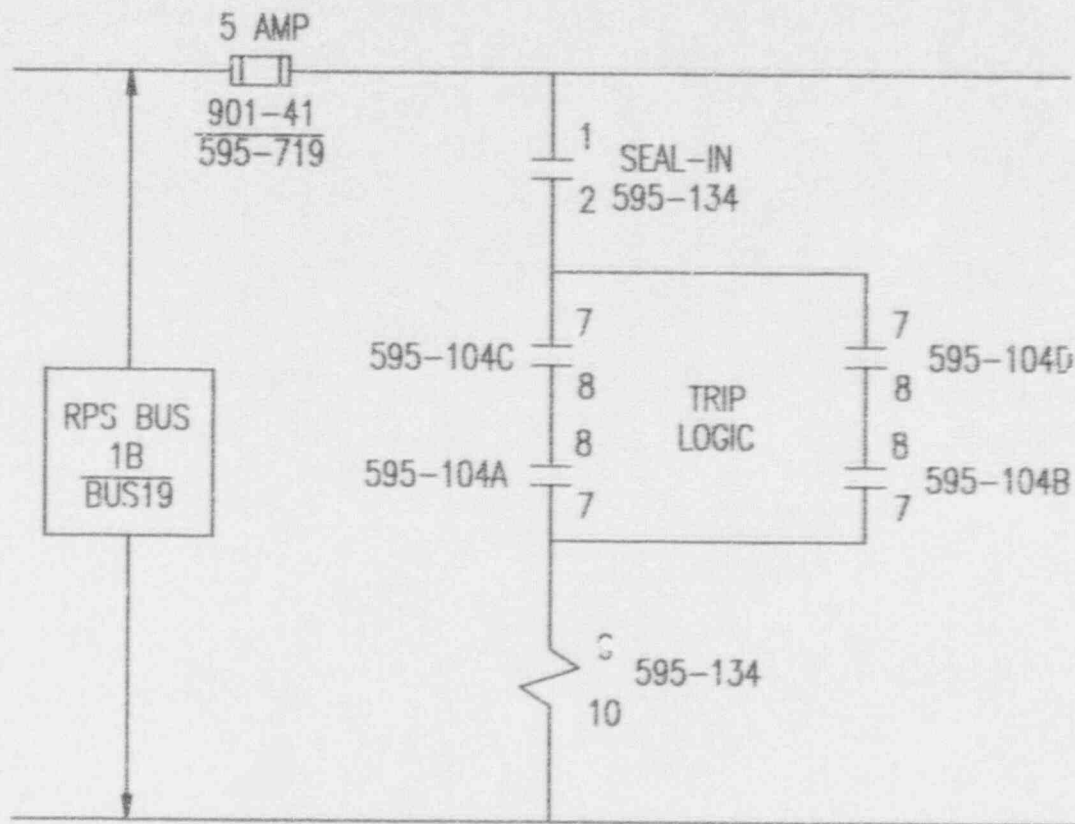
4E 1509B SH 1

The apparent cause of the event is a design deficiency in the SBT and Primary Containment Isolation (PCI) logic. The 595-134 relay, which provides a start signal for the "B" train of SBT, has the same power supply as the components of the "B" train of SBT.

The system design is being evaluated to determine if a modification is needed to change the power supply of the "B" train of SBT or "B" SBT start signal relays (NTS #2542009206102).

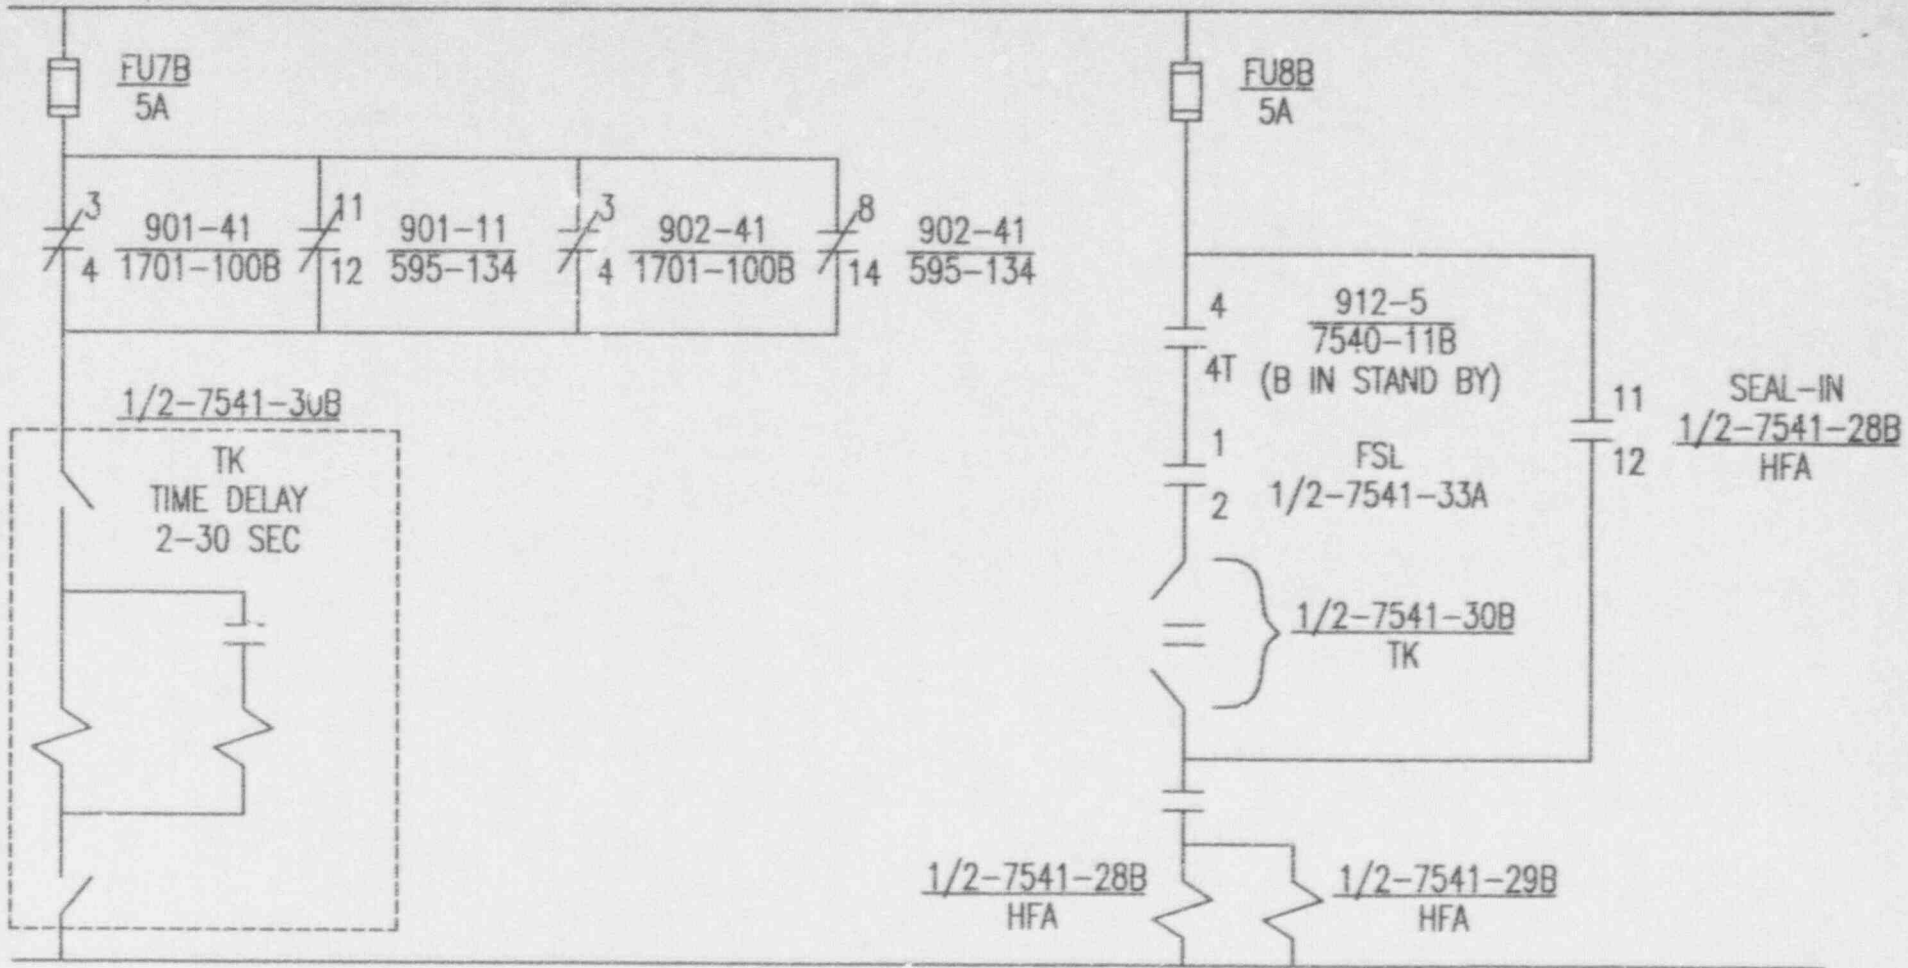
4E 1400A SH 2

This event would require operator action to switch the "B" train to OFF or PRIMARY. This action deenergizes the 1/2-7541-28B relay allowing the "A" train to be started either manually or automatically.

'B' TRAIN LOGIC
('B' TRAIN IN STANDBY)

DESCRIPTION OF EVENT
 Design deficiency in the SGBT Logic. Given the following line-up: "A" Train in primary and "B" Train in Standby, if a loss of power occurs to Bus 19 which powers the "B" Train, it will not be possible to manually restart the "A" train. This will not occur with the opposite line-up, i.e. "A" Train in Standby and "B" Train in primary.

The immediate corrective action was to change the lineup of the Standby Gas Treatment system so that the "B" train would not be in the standby mode of operation. A caution card has been placed on the "B" train mode switch to warn against placing "B" train in Standby.

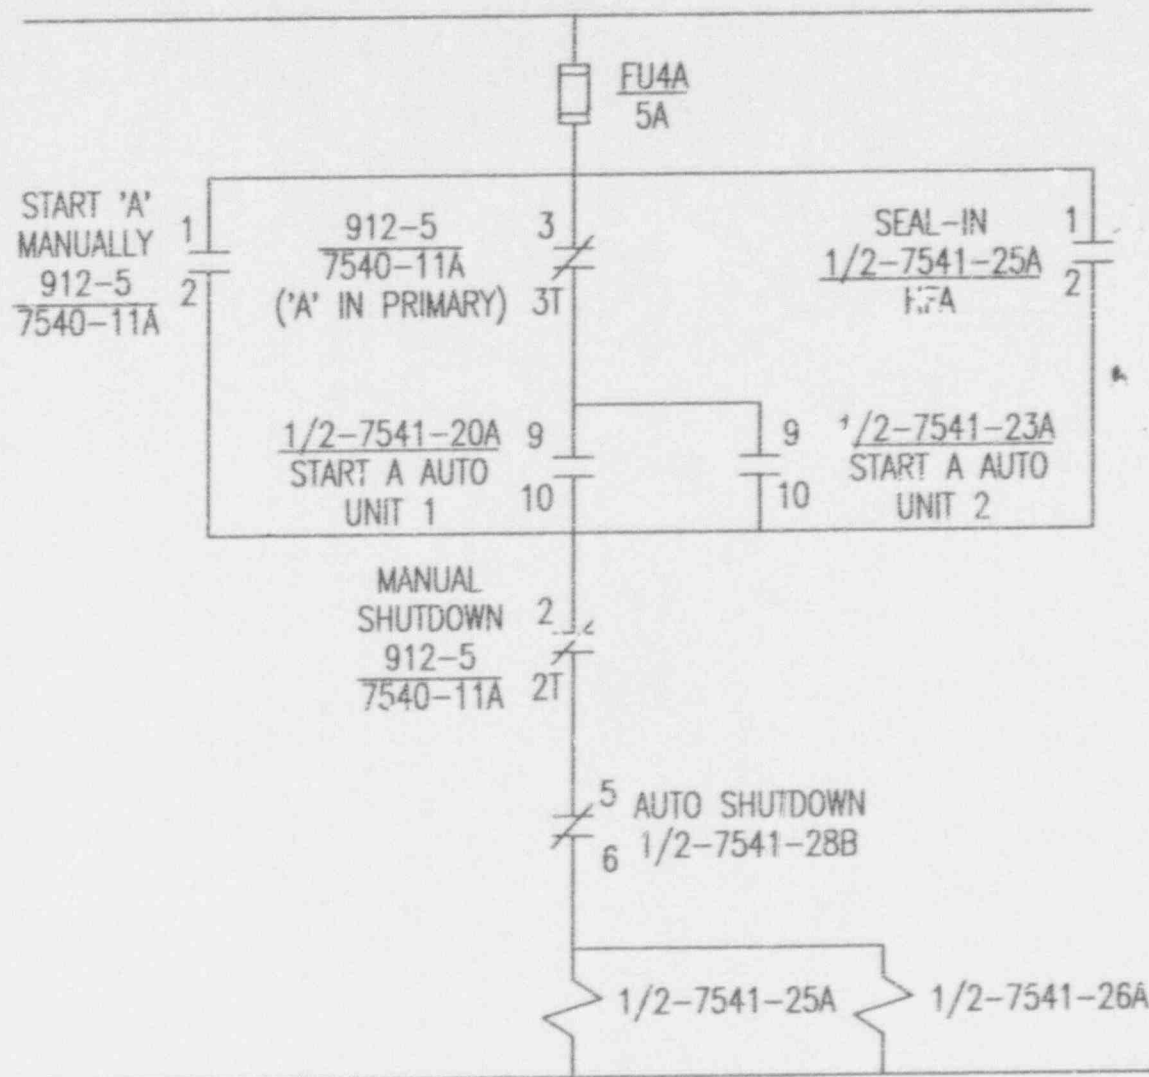
4E 1400C

'A' TRAIN LOGIC
('A' TRAIN IN PRIMARY)
