SUBJECT: Calvert Cliffs Nuclear Power Plant
Unit Nos. 1 and 2; Docket Nos. 50-317 and 318;
License Nos. DPR 53 and DPR 69
Licensee Event Report 92-003

LICENSEE EVENT REPORT (LER)

TITLE (4) Inoperable Fire Dampers Due to Surveillance Test Procedure Omission

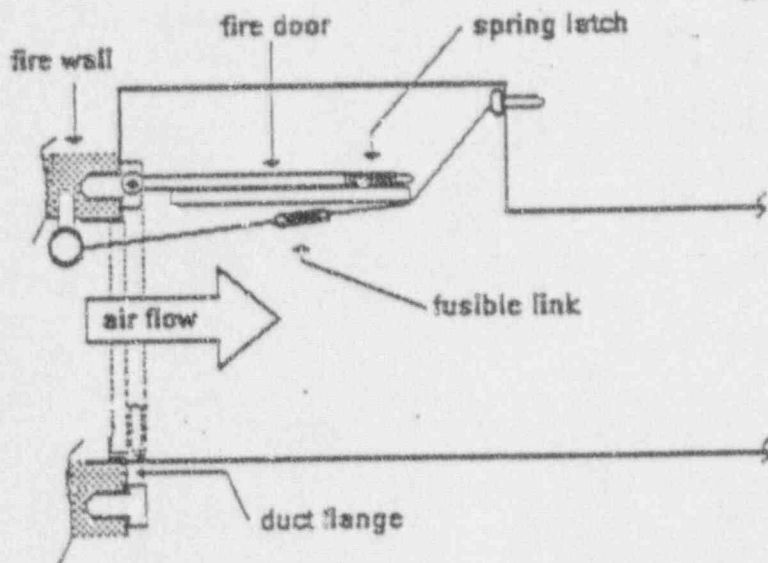
Figure 1

We tested fire damper 1FDTB255 on May 21, 1992. Test personnel discovered the damper would not fully shut. They noted the damper as having an INOPERABLE latching mechanism. The latch's spring and bolt were missing and the fusible-link lanyard was connected to the latch housing. (See Figure 1)

It is not known if the latch internals had failed or were removed at some time. We conducted an investigation to determine the cause of the missing spring and bolt. On June 19, 1992, we determined that the internals had been missing for over nine months. Maintenance personnel recall the fusible links attached to the fire-damper door as far back as last summer. They were not aware, however, that a latch was missing. The fire damper had been INOPERABLE for a time greater than allowed in the TS ACTION Statement.

The root cause for the INOPERABLE spring latch is indeterminate. Maintenance records do not show any work conducted that might have resulted in latch disassembly.

- A. We declared the Unit 1 MSIV Pipe Tunnel fire damper INOPERABLE, verified automatic fire detection and stationed a fire-watch patrol as required by plant TSs.
- B. We latched the damper shut and then declared it OPERABLE, securing the fire watch.
- C. We tested Unit 2 MSIV Pipe Tunnel fire damper 2FDTB256 and verified it OPERABLE.
- D. We are investigating the omission of the fire dampers from the STP. Additional corrective actions are expected.

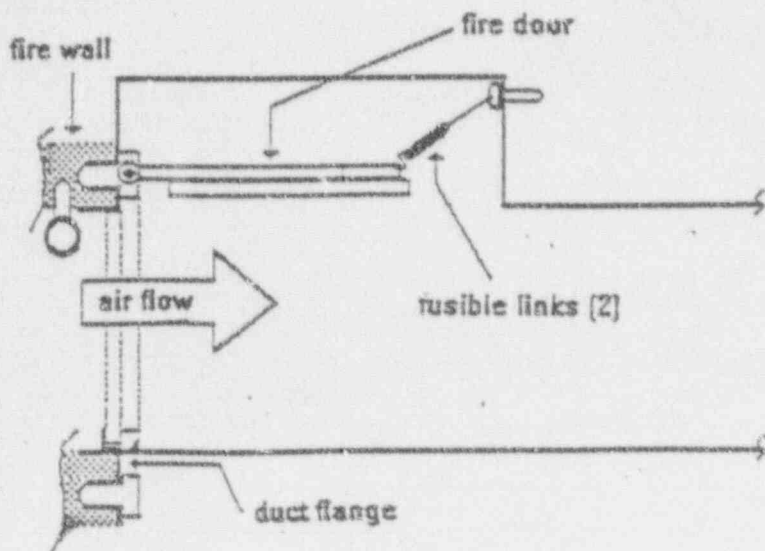
Figure 2

The correct fusible-link arrangement is shown in Figure 2. The existing lanyard arrangement did not impact fire damper OPERABILITY. The INOPERABLE latch, however, allowed the door to hang open two inches.
