Subject: McGuire Nuclear Station Unit 1
Docket No. 50-369
Licensee Event Report 369/91-07, Revision 1

LICENSEE EVENT REPORT (LER)

TITLE(4) Train B Of The Residual Heat Removal System Was Inoperable Due To Inappropriate Actions And An Unknown Possible Installation Deficiency

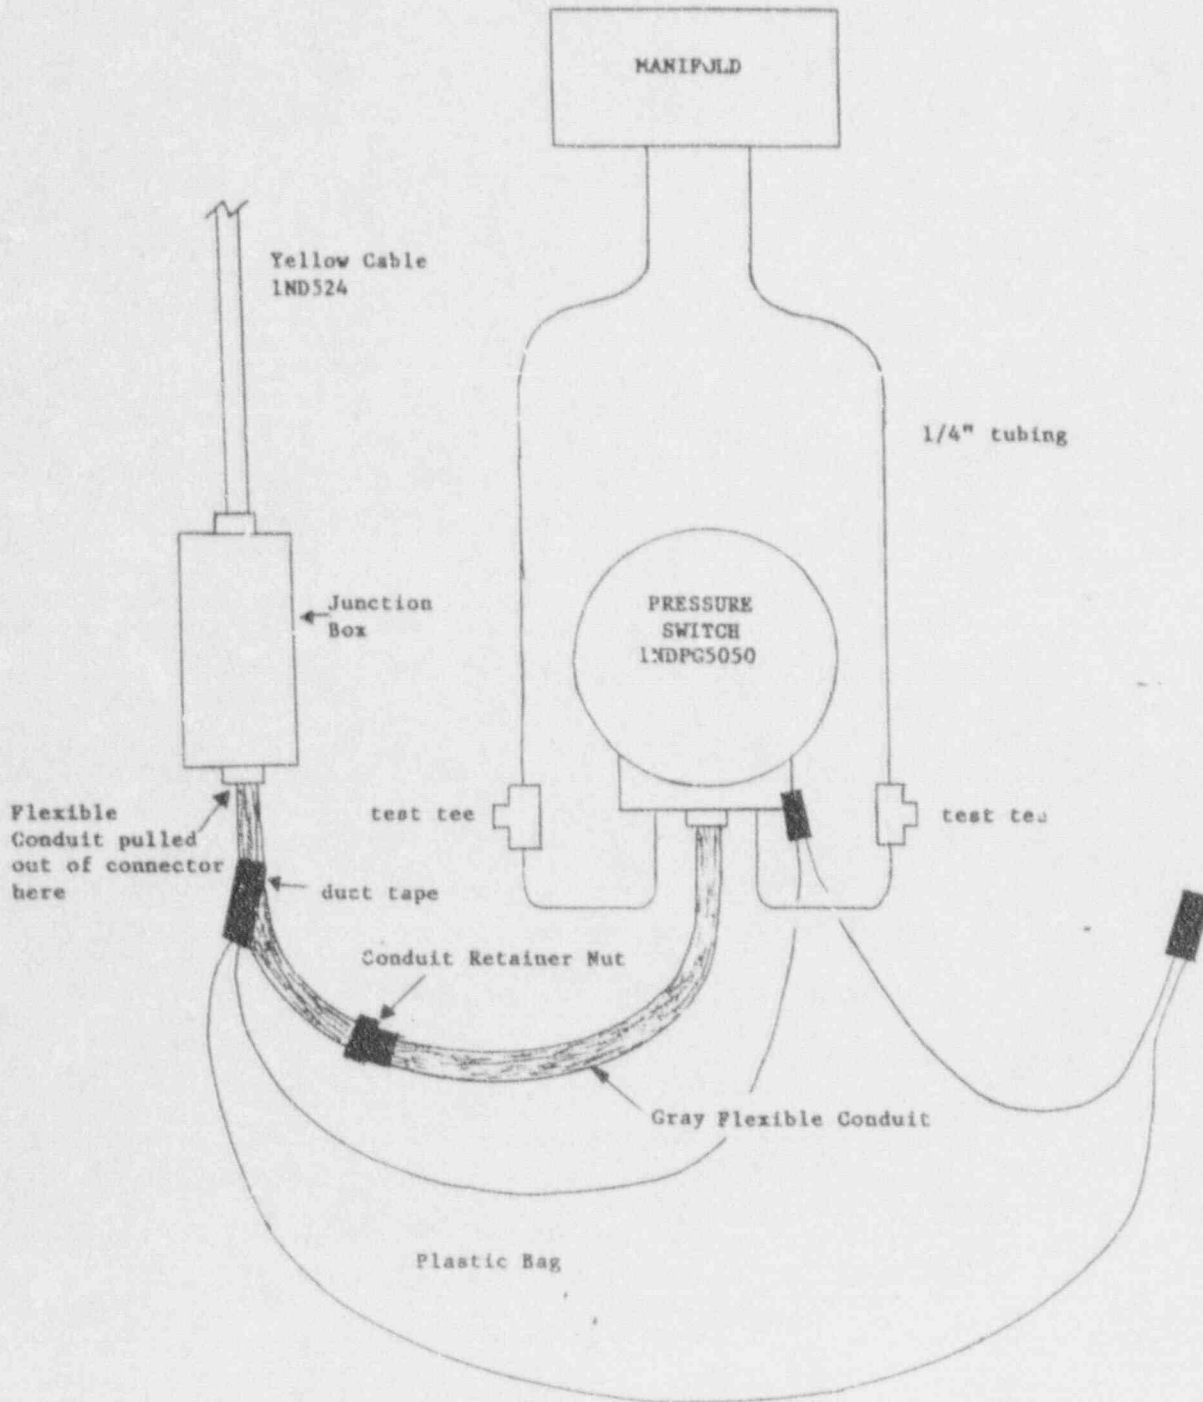
FIGURE 1
EQUIPMENT ARRANGEMENT

A cause of Inappropriate Action is assigned to PRF Technician A due to inattention to detail. The Yellow cable (1ND524) and junction box are mounted at eye level (See Figure 1, page 10 of 10). PRF Technician A should have observed this during installation or removal of the plastic bag under pressure switch 1NDPG5050. Since pressure switch 1NDPG5050 was fed by a Yellow cable, Technician A should have realized that it was nuclear safety related and should have informed his supervisor.

This event is also assigned a cause of Unknown due to the separated liquid tight flexible metal conduit which originated in a nearby junction box and terminated in pressure switch 1NDPG5050. The flexible conduit pulled out of its connector at the junction box when PRF Technician A removed the plastic bag and duct tape from under pressure switch 1NDPG5050. PRF Technician A then noticed that the flexible conduit retaining nut was not screwed on the junction box connector. The retaining nut had slid down the flexible conduit. The weight of the plastic bag and its contents was negligible and should not have caused the cable to pull out of the connector. The retaining nut may have been loose or completely off prior to this event. However, no problems were noted with this particular flexible conduit section when a material condition inspection of 695' elevation of the Auxiliary building (which addressed and corrected improperly installed and broken conduit) was performed during November and December, 1990. The connector is designed to provide strain relief from external forces applied to the cable. One possible cause for this was an installation deficiency. Had the flexible conduit been properly installed, it should not have pulled apart from the force applied by PRF Technician A to the cable. A search of equipment history files revealed that the junction box wiring was last repaired in February 1986. This repair was documented on work request 1222170PS. This work request documented, among other items, the repair of a loose crimp on a batt splice connector on the wiring inside the junction box. The junction box contained wiring that was electrically continuous and did not pull apart until an external force was applied to the cable assembly. However, IAE personnel believe existing installation procedures and calibrated crimping tools are adequate.

- Subsequent:**
- 1) The wiring and conduit feeding pressure switch 1NDPG5050 was repaired as directed by work request 1449770PS.
 - 2) This event was reviewed with the personnel involved.
 - 3) ND Pump 1B was successfully tested by PRF personnel on 6/6/91.
