SAN ONOFRE NUCLEAR GENERATING STATION

Subject: Docket No. 50-361
30-Day Report
Licensee Event Report No. 92-009
San Onofre Nuclear Generating Station, Unit

LICENSEE EVENT REPORT (LER)

Title (4)
MIS-ALIGNMENT OF UNIT 2 SALT WATER COOLING PUMP P112 EMERGENCY SEAL WATER SUPPLY ISOLATION VALVE

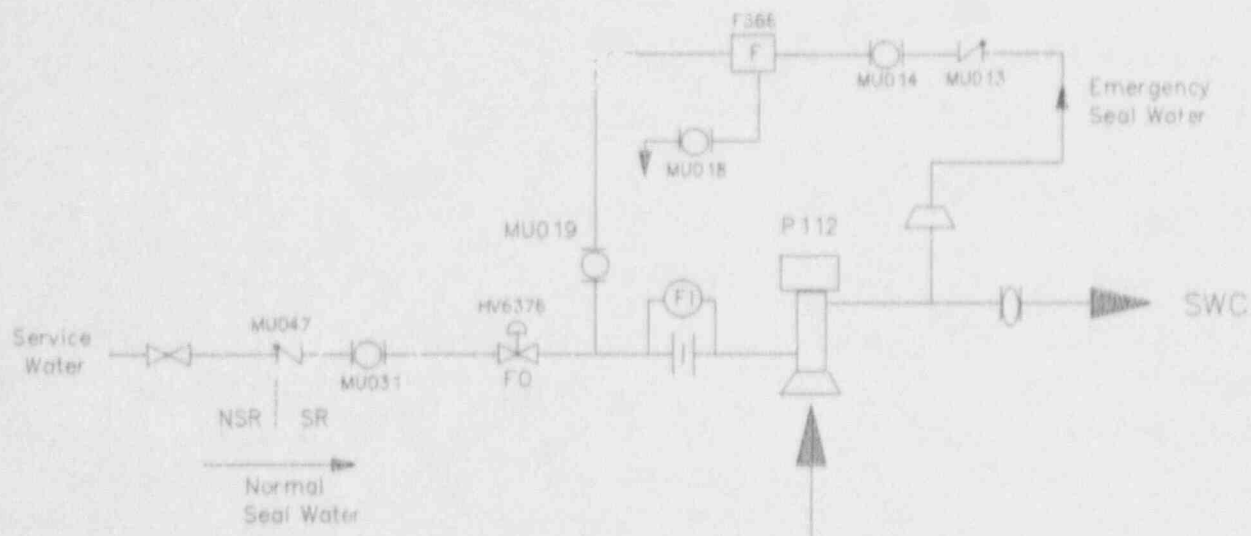
Figure 1 - SWC Pump P112 Seal Water System

At approximately 2330 on June 14, 1992, with Unit 2 in Mode 1 at 100% power, a plant operator (utility, non-licensed) identified that SWC Pump P112 emergency seal water isolation valve MU019 was in the "closed" position, rather than "open" as required. The operator identified this discrepancy while installing a maintenance order tag on an unrelated piece of equipment in the Unit 2 SWC pump room. The valve was opened at 0030 on June 15, 1992, thus restoring the emergency seal water supply to SWC pump P112. At 0220, a SWC system flow path alignment was performed for both Units 2 & 3 SWC pumps to determine if other SWC seal water valves were similarly mis-aligned. No other valves were found mis-aligned.

Although the cause and duration of the mis-alignment of MU019 cannot be definitively determined, SCE has concluded that the mis-alignment most likely occurred during the performance of the MU013 quarterly check valve test performed on 5/28/92. This conclusion is based on a review of SWC P112 seal water supply flow data, which is sensitive to the position of valve MU019 (as well as to other seal water system valves and parameter changes). The flow data appears to indicate that MU019 was likely in the "open" position when the data was taken on May 28, 1992, and may have been in the "closed" position on May 30, 1992. This conclusion is based on a step change increase of 3.5 gpm (from 10 gpm to 13.5 gpm) in the recorded P112 seal water flow between the 28th and the 30th. This step increase in seal water flow was not regarded by Operations as an anomaly since seal water flow typically varies from 2-5 gpm between SWC pumps and P112 seal water flow remained well within the normal limits of 7 gpm to 15 gpm. In hindsight, this step increase is consistent with a mispositioning of MU019 during this time frame.

Although the cause and duration of the mis-alignment of MU019 cannot be definitively determined, SCE has concluded based on our investigation, that the valve mis-alignment most likely occurred on 5/28/92 during the performance of MU013 quarterly check valve test. A thorough investigation of this incident was performed which considered three possible causes; unauthorized manipulation, inadvertent repositioning of the valve, (e.g., accidental bumping which was not recognized), and possible failure to reclose the valve after opening it for an authorized work activity.

The most likely scenario appears to be that the valve was left in the closed position following the check valve test performed on 5/28/92. The investigation included reviewing past work activities associated with the Units 2 and 3 SWC pumps, interviewing Operations and Engineering personnel, and reviewing round sheets in which the local seal water supply flow rates are recorded approximately once every 2 days. A review of Operations round sheets indicate that on May 30, 1992, seal water supply flow was approximately 3.5 gpm above that previously recorded on May 28, 1992. This increase is consistent with the closure of MU019, since the portion of the normal seal water flow which is diverted to flush filter F366 and then to the floor drain would be supplied to the pump and would be indicated on the flow meter. Additional seal water supply flow data is being reviewed to further substantiate this conclusion. If this information changes the conclusions provided in this report, a revision will be submitted.

As discussed above, MU019 was closed on May 28, 1992 for the purpose of testing check valve MU013. Engineering procedure SO23-V-3.5.4, used to perform the quarterly check valve test, was signed by the test engineer indicating that he requested Operations to open MU019. Additionally, the test engineer recalls that MU019 was opened by the operator as requested. Notwithstanding this, as previously discussed, flow data taken by Operations suggests that MU019 may have been inadvertently left closed following the check valve test. Operations personnel did not recognize that Engineering procedure SO23-V-3.5.4 did not comply with the requirements specified in Operations procedure SO123-0-20 prior to authorizing the test engineer to perform the check valve test. Specifically, the requirements for an Operations sign-off and independent verification of a plant manipulation were not contained in the Engineering procedure. Therefore, the likely cause of this event is considered to be a procedural deficiency of the Engineering procedure and the improper implementation of the requirements specified in SO123-0-20.

- a. Once identified, MU019 was re-opened, restoring emergency seal water supply to SWC Pump P112 such that all of its operability requirements were satisfied.
- b. Engineering Procedure SO23-V-3.5.4 was enhanced as follows; 1) the check valve testing valve alignment was modified such that it will not be necessary to remove the emergency seal water supply from service (i.e., rather than closing MU019, the enhancement requires the closing of the normal seal water supply system isolation valve (MU031) for the purpose of testing the check valve), 2) a sign-off step was provided for the operator manipulating the valve during the testing, and 3) an independent verification sign-off step was added to ensure that MU031 was re-opened following the test.

- a. The Operations Manager will issue a memorandum to all licensed operators conveying management expectations with respect to rigorous enforcement of the equipment status controls delineated in SO123-O-20.
- b. This event will be reviewed by appropriate Engineering personnel for lessons learned.
- c. A review will be performed of appropriate station procedures to ensure that they are in compliance with the requirements specified in Operations Division Procedure SO123-O-20 for the manipulation of plant equipment. Enhancements will be incorporated as appropriate.
