LICENSEE EVENT REPORT (LER)

FACILITY NAME (1) Fort St. Vrain, Unit No. 1	DOCKET NUMBER (2) 05000267	PAGE (3) 1 OF 10
---	-------------------------------	---------------------

TITLE (4) Failure Of Diesel Generator To Close-In During Loss Of Outside Electrical Power Test
SR 5.6.1b-SA

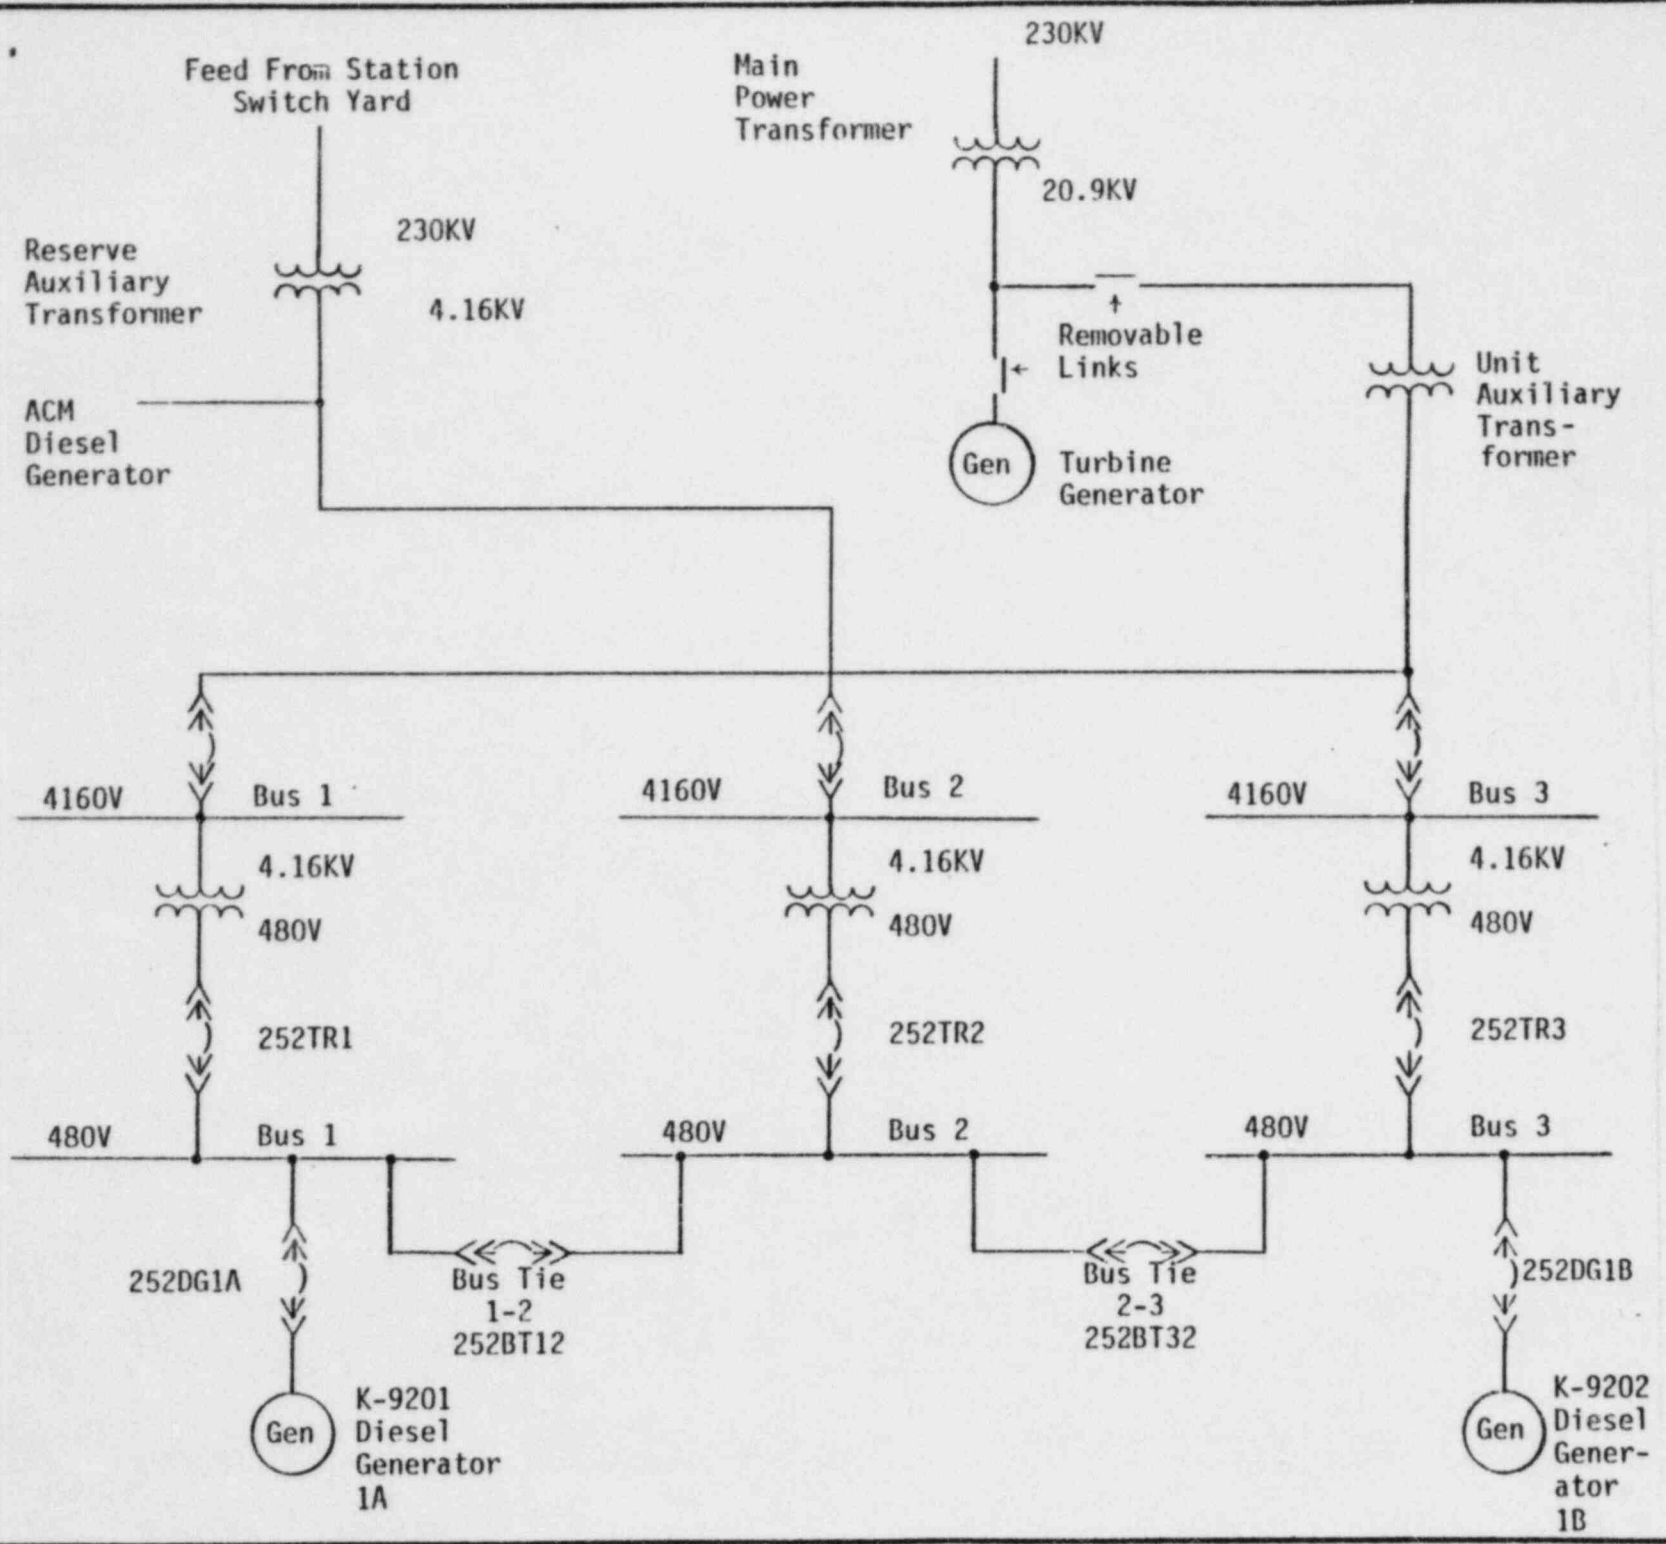
FIGURE 1

In the event that the plant should experience a total loss of power resulting from the simultaneous loss of all outside 230KV power and the tripping of the turbine generator, the two standby diesel generators (1A, K9201 and 1B, K9202) will automatically start (see Figure 1). The first normally functioning unit will be automatically selected to pick up the programmed load of essential equipment on its 480V bus (480V Bus 1 for Generator 1A and 480V Bus 3 for Generator 1B), and also the essential load on 480V Bus 2 (load sequence "A"). The second functioning unit will then be automatically tied to its 480V bus and pick up the programmed load of essential equipment for that bus (load sequence "B").

In the "Loss of Outside Power and Turbine Trip" surveillance ran on December 18, 1984, neither generator set closed onto its respective 480V bus, and power was manually restored to the 480V busses via the 4160V breakers (see Figure 1). Some difficulty was encountered restoring power to the 480V busses from the 4160V busses due to a previously identified problem with the undervoltage relay system logic preventing the 4160V breakers from closing onto a de-energized 480V bus. The problem was immediately recognized, and the fuses for the undervoltage logic power supply were pulled, allowing power to be restored to 480V busses. There is currently a Change Notice prepared to allow a manual over-ride of this logic from a handswitch to be placed at the synchroscope in the Control Room. During the test, personnel entering the diesel generator room found that both Engine 1A and 1B on generator set 1A (1) had shutdown and declutched, and that Engine 1C on generator set 1B (2) had shutdown and declutched.

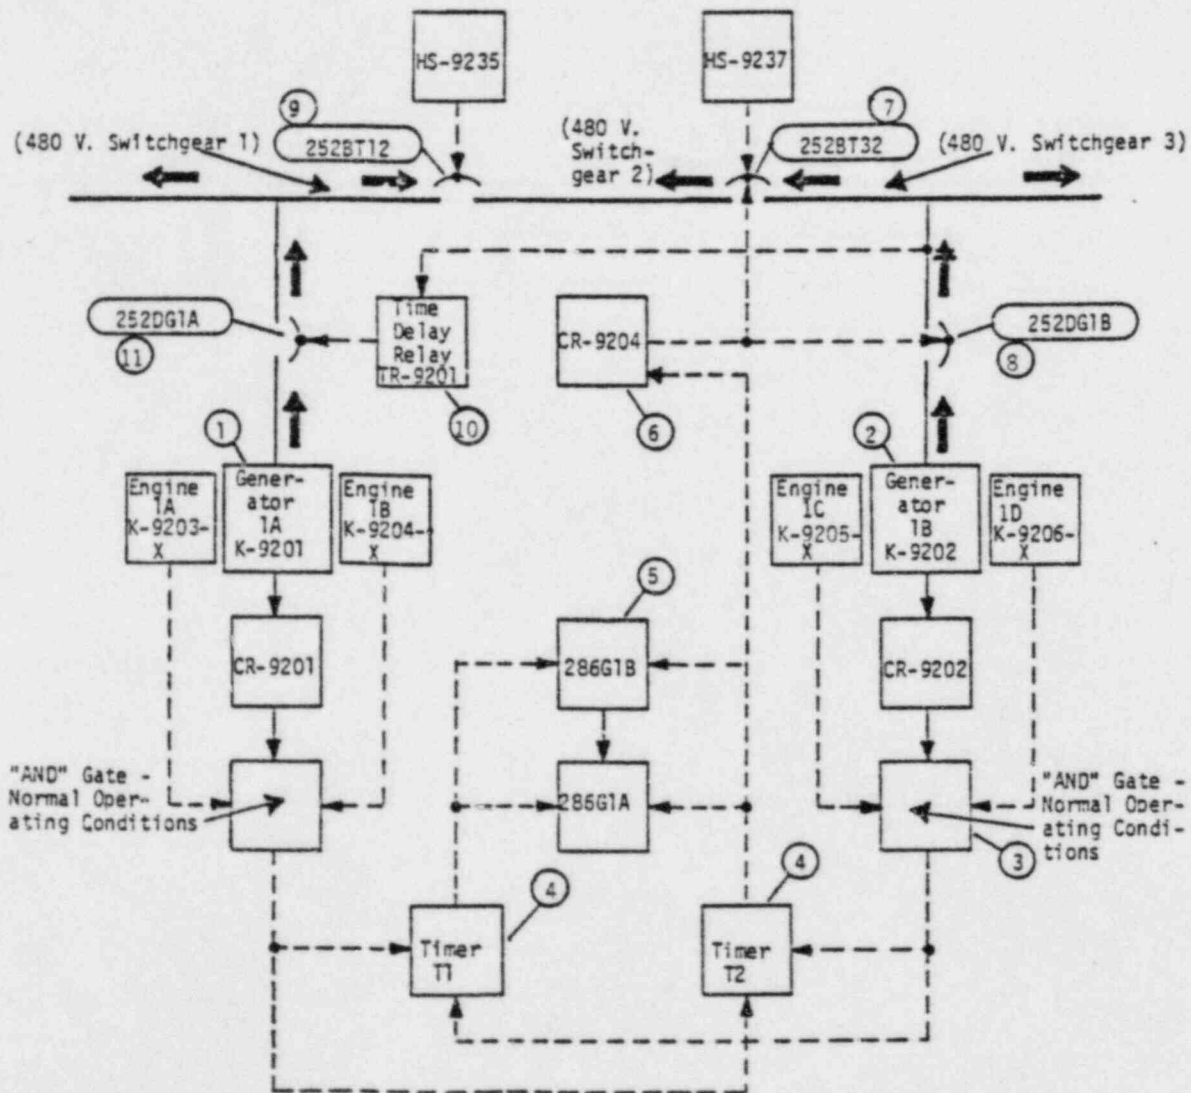
FIGURE 2

During performance of SR 5.6.1b-SA, one section of the test procedure requires that the failure of an engine to start on a generator set be simulated in order to test the proper operation of the lock-out relay logic associated with the other standby generator set. Referring to Figure 2, the test performed on December 18, 1984, simulated the failure of an engine on standby generator set 1A (1) to start. This would have then forced standby generator set 1B (2) to appear to reach normal operating conditions first, completing the logic (3) to start program sequence timers T1 and T2 (4). The "AND" gate of the logic is completed by a match on the intake manifold ΔP 's for both engines on a generator set. On December 18, 1984, all four engines started normally, and it is believed that for set 1B, this logic should have been successfully completed to start timers T1 and T2 (4). The identical logic for generator set 1A had been intentionally disabled by lifting the wire for the "AND" gate on set 1A, thereby creating a simulated engine failure condition.

It has been subsequently determined that timer T1 was malfunctioning and that the timer's motor would not turn. Redundant timer T2 has been tested and found to operate properly and should have operated as designed; a control signal should have successfully passed through contact 286G1A (closed due to lifting the wire on 1A set), immediately followed by energizing lock out relay 286G1B (5) and control relay CR-9204 (6), closing the Bus 3-2 Tie Breaker 252BT32 (7) and generator 1B-Bus 3 breaker 252DG1B (8).

The 480V bus tie breakers, 252BT12 (9) and 252BT32 (7) would have opened automatically during load shedding (if not already opened at the time the loss of outside power occurred). The closure of generator set 1B-480V Bus 3 breaker 252DG1B (8) energizes contacts creating a permissive for generator set 1A indicating that set 1A was being selected as the second generator set and could pick up the programmed loads on 480V Bus 1. The permissive energizes TR-9201 (10), closing generator 1A-480V Bus 1 breaker 252DG1A (11) onto 480V Bus 1.

The failure of the generator set 1A 480V Bus 1 breaker (252DG1A) to close indicates that a permissive generated by CR-9204, (4) on Figure 2, was not received. However, the loss of Instrument Bus 1A could have been a factor in preventing 252DG1A (11) to close if Inverter/Static Transfer Switch 1A had tripped on low output voltage very early in the test. That trip would have removed the 120V AC instrument power supply required to power the logic for generator set 1A to be automatically selected as the second operating set and automatically tie onto 480V Bus 1.

The cause for failure of the 1B standby generator to complete the logic to be identified as the first operating generator and to load onto 480V Bus 3 and close the bus 3-2 tie breaker is not known. Plant electricians are currently testing all relays and contacts in the generator set 1B logic. Testing to this point indicates that contact sticking in the logic for the intake manifold ΔP comparisons on Engines 1C and 1D was at fault.

The faulty cell on station Battery 1A has been jumpered out of service, and malfunctioning temperature switches have been replaced. Relays and contacts on the 1B generator set are currently being tested to identify the precise cause of B set not being able to complete logic for selection as first operating set prior to the trip of Engine 1C.

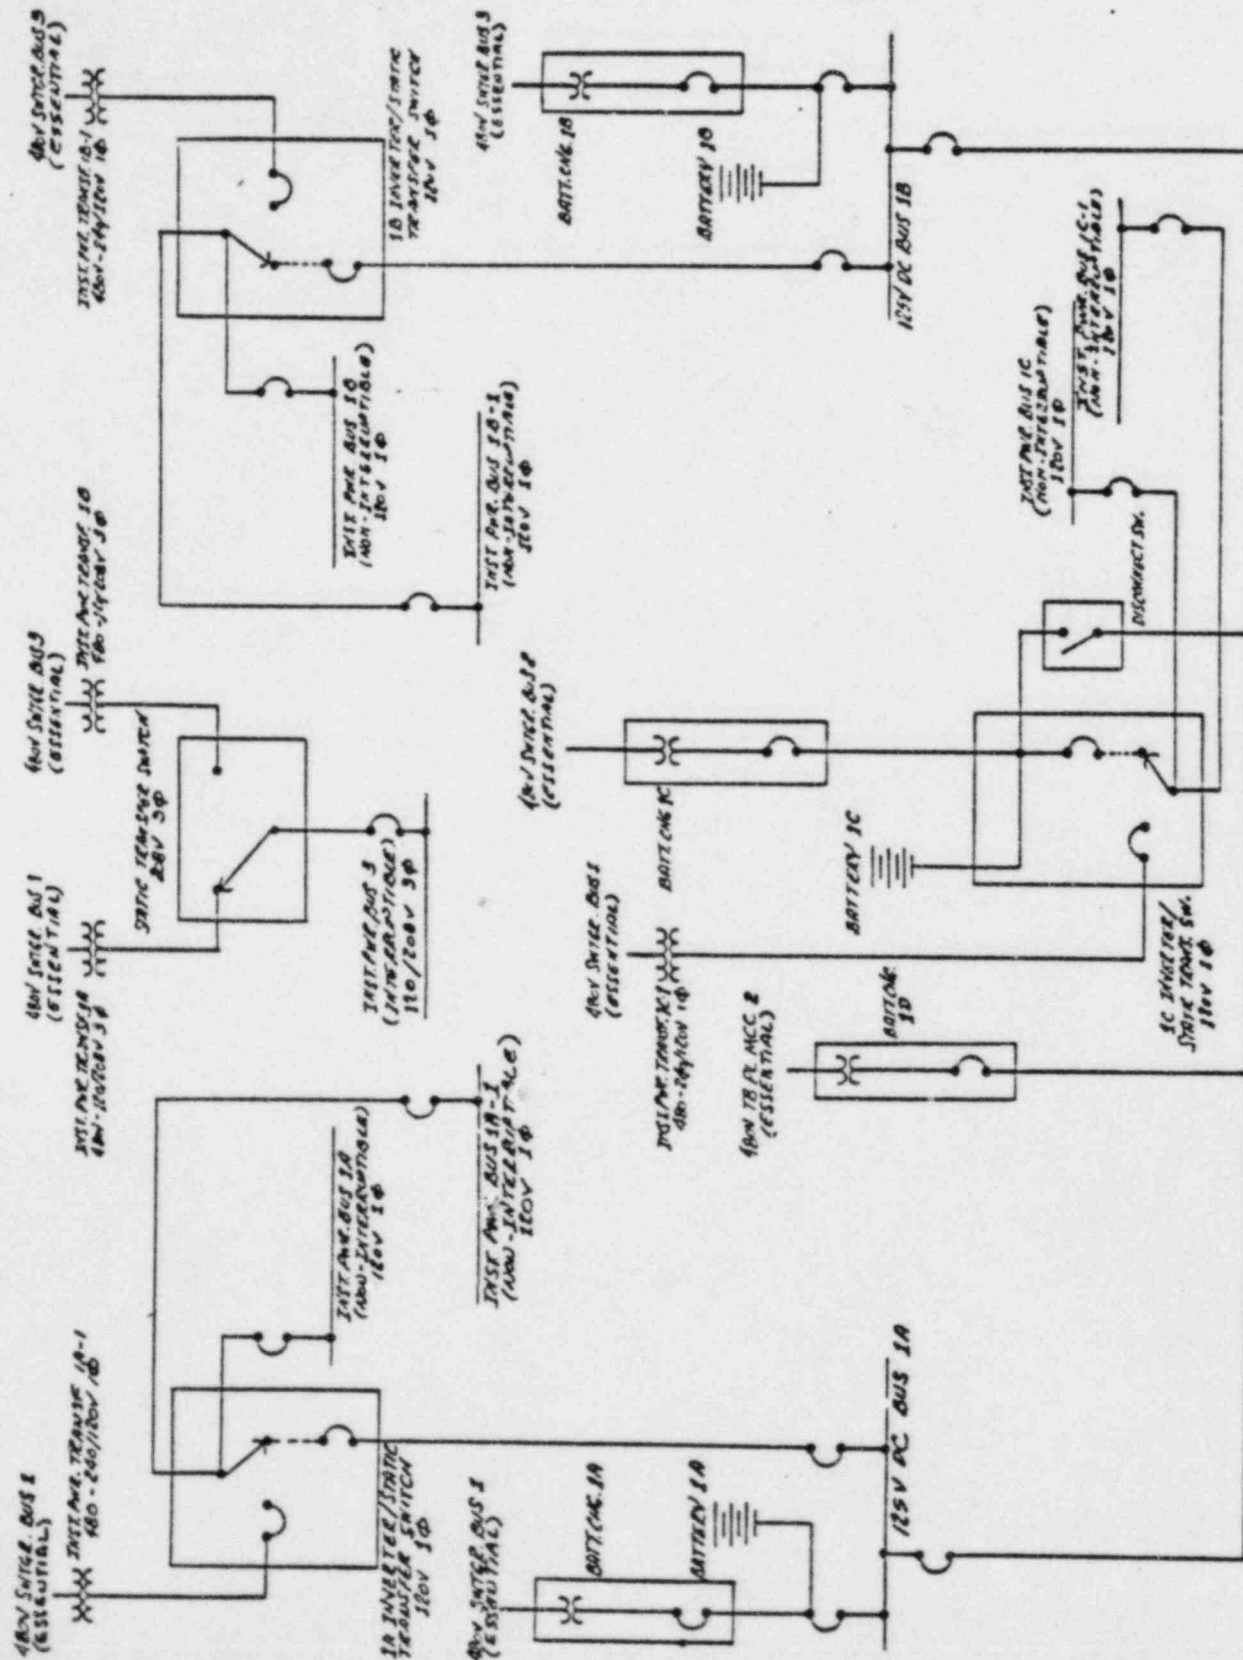
FIGURE 3

In the surveillance test ran on December 18, 1984, a faulty cell on Station Battery 1A resulted in the Inverter/Static Transfer Switch 1A inverter section (see Figure 3) tripping on low output voltage (less than 105V). This resulted in the loss of 120V AC Instrument Bus 1A. Load testing on the 1A Station Battery done after this event resulted in a similar trip occurring in approximately twenty seconds. The loss of Instrument Bus 1A eliminated power supply to the Low Exhaust Temperature Switches on engines 1A and 1B. The Low Exhaust Temperature Switches fail downscale on an AC instrument power loss. A thirty second timer operates to close the exhaust temperature time delay contacts in the Low Exhaust Temperature logic after thirty seconds elapsed time. These contacts are downstream in series with the Low Exhaust Temperature Switch contacts, which are closed on low temperature (also on a switch failure or loss of power to the switch). On a normal engine start and warm-up, exhaust temperature exceeds 175°F in approximately ten seconds, and the low exhaust temperature contacts are opened indicating a normally operating engine, hence, preventing the Low Exhaust Temperature engine trip and declutch after closure of the thirty second time delay contacts. The 125V DC Bus 1A, though operating at a degraded voltage, was not lost and after completion of the initial thirty second time delay, maintained time delay contacts in the closed position. Following the manual restoration of 4160V power, Instrument Bus 1A power to standby diesel generator engines 1A and 1B would have been immediately recovered via Battery Charger 1A (see Figure 3). Upon recovering instrument power, the contacts for the Low Exhaust Temperature Switches on engines 1A and 1B would have promptly closed due to the temperature switches having previously failed downscale, thus resulting in engine trip and declutch. The 4160V power was manually restored to 4160V Bus 1, and hence, Instrument Bus 1A approximately five minutes after test initiation.

Had this been an actual loss of outside power with a turbine trip under the conditions described herein, generator set 1A could have been manually tied into bus 1. Engines 1A and 1B would have subsequently tripped and declutched, however, when 480V power was restored to Battery Charger 1A (Figure 3). Standby generator 1B would have still had one operating engine (engine 1D) and could have been manually tied into 480V Bus 3, with essential equipment loads being restored manually.

The cause for the failure of Station Battery 1A to supply adequate DC output for Inverter/Static Transfer Switch 1A has been determined to be a faulty cell on the battery. This cell has been jumpered out of service, and Station Battery 1A restored to service. The 480V/120V transformer on Battery Charger 1A was damaged during testing (unrelated) after Station Battery 1A was placed back in service. Repairs to this transformer are not expected to be completed until later in January, 1985, delaying the rescheduling of SR 5.6.1b-SA.
