SUBJECT: Calvert Cliffs Nuclear Power Plant
Unit Nos. 1 and 2; Docket Nos. 50-317 and 318;
License Nos. DPR 53 and DPR 69
Licensee Event Report 92-003

LICENSEE EVENT REPORT (LER)

TITLE (4) **Inoperable Fire Dampers Due to Surveillance Test Procedure Omission**

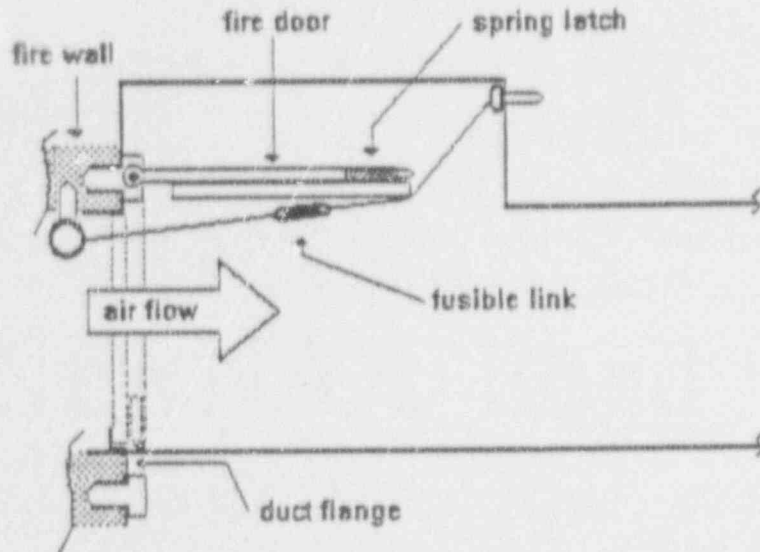
Figure 1
Design Condition

The correct fusible-link arrangement is shown in Figure 2. The existing lanyard arrangement did not impact fire damper OPERABILITY. The INOPERABLE latch, however, allowed the door to hang open two inches.

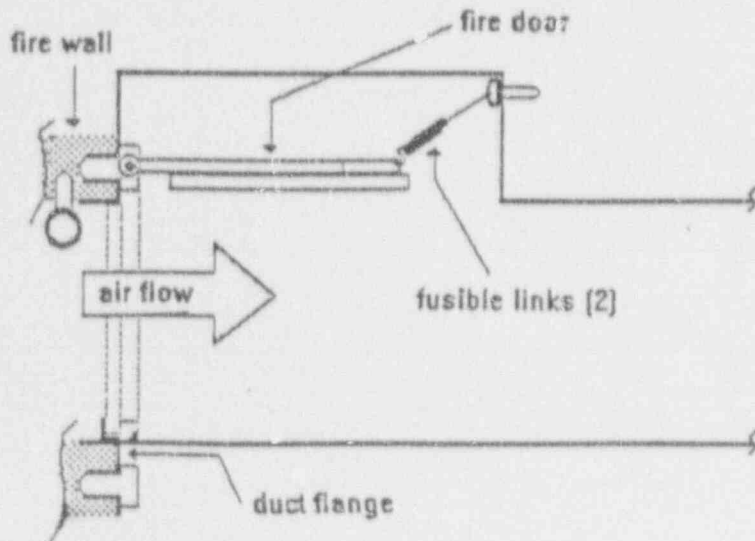
Figure 2
As-Found Condition

We tested fire damper 1FDTB255 on May 21, 1992. Test personnel discovered the damper would not fully shut. They noted the damper as having an INOPERABLE latching mechanism. The latch's spring and bolt were missing and the fusible-link lanyard was connected to the latch housing. (See Figure 1)

It is not known if the latch internals had failed or were removed at some time. We conducted an investigation to determine the cause of the missing spring and bolt. On June 19, 1992, we determined that the internals had been missing for over nine months. Maintenance personnel recall the fusible links attached to the fire-damper door as far back as last summer. They were not aware, however, that a latch was missing. The fire damper had been INOPERABLE for a time greater than allowed in the TS ACTION Statement.

The root cause for the INOPERABLE spring latch is indeterminate. Maintenance records do not show any work conducted that might have resulted in latch disassembly.

- A. We declared the Unit 1 MSIV Pipe Tunnel fire damper INOPERABLE, verified automatic fire detection and stationed a fire-watch patrol as required by plant TSs.
- B. We latched the damper shut and then declared it OPERABLE, securing the fire watch.
- C. We tested Unit 2 MSIV Pipe Tunnel fire damper 2FDTB256 and verified it OPERABLE.
- D. We are investigating the omission of the fire dampers from the STP. Additional corrective actions are expected.
