James A. FitzPatrick
Nuclear Power Plant
P.O. Box 41
Lycoming, New York 13093
315 342-3840

SUBJECT: DOCKET NO. 50-333
LICENSEE EVENT REPORT: 92-033-00 - Local Leak Rate
Test Program Deficiencies

TITLE (4) Local Leak Rate Test Program deficiencies as a result of personnel errors.

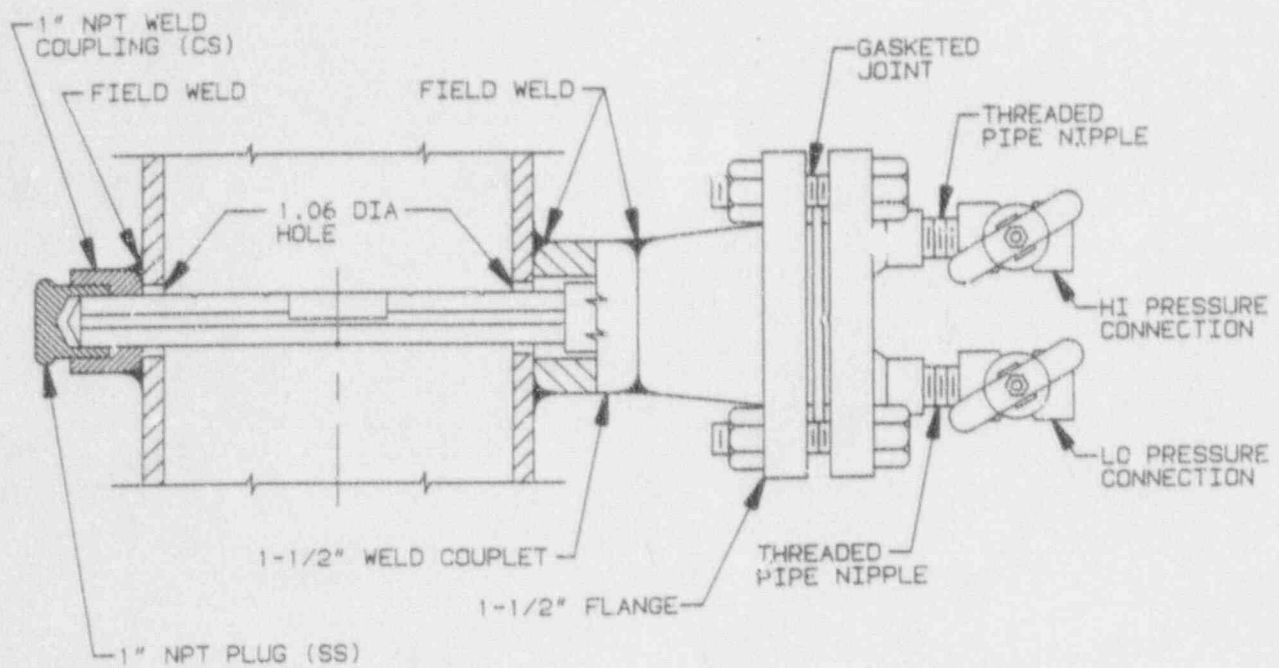
FIGURE 1
TORUS SPRAY FLOW ELEMENT
10FE-137A & B

In November 1988, during a refuel outage, flow elements 10FE-137A & B were installed in torus spray lines A and B to provide an indication of spray flow to meet the requirements of Regulatory Guide 1.97. The flow elements are installed in the torus spray lines between the inboard primary containment isolation valves and the primary containment penetrations. That is, at a point where the flow elements are exposed to primary containment pressure at all times and thus are part of the primary containment pressure boundary. During the design phase of the modification one of the factors involved in selecting the flow element was the consideration of the leakage testing which would be necessary to meet 10CFR50, Appendix J and Technical Specification requirements. A flow element which would require

Examination of the installed flow elements revealed an as built design which made application of Code Case N-236-1 improper. The installation of each flow element includes two field welds which are larger than the nominal one inch diameter and six mechanical (rather than welded) joints. None of the mechanical joints are designed to permit local leak rate testing. (See Figure 1)

2. Torus Spray Flow Elements
The cause of the failure to periodically subject torus spray flow elements A & B to LLRT was the result of a personnel error in the application of Code Case N-236-1. While the holes cut in the torus spray line for the flow element were nominally one inch in diameter the actual attachment weld, and an additional field weld, which are part of the torus pressure retaining boundary are nominally one and one-half inches in diameter. In addition, the flow element assembly contains 5 mechanical (threaded) joints and one gasketed joint that are potential leakage paths that were not subjected to LLRT.

- 1) Procedures for LLRT have been changed to include test of drywell to torus vent line bellows and torus spray flow elements. Completed July 13, 1992.
- 2) Both torus spray flow elements were subjected to LLRT. The combined test of both flow elements (and the plugs installed in place of the spray nozzles) resulted in a detected leak rate of 0.1843 standard cubic feet per day (SCFD), Completed July 15, 1992.
- 3) Each of the 16 drywell to torus vent line expansion bellows will be subjected to a Local Leak Rate Test (LLRT) prior to plant startup. Currently scheduled for August 15, 1992.

- 4) Prior to the next scheduled PCILRT, the torus spray flow element assembly will be modified as necessary to result in a configuration which can be tested without plugging the spray nozzles. This will minimize radiation dose associated with future testing.
