Subject: McGuire Nuclear Station  
Inplant Review Number 92-10

McGUIRE SAFETY REVIEW GROUP

INPLANT REVIEW REPORT

1. REPORT NUMBER: 92-10
2. DATE OF REVIEW: June 12, 1992 Through July 9, 1992
3. SUBJECT DESCRIPTION: This Inplant Review is being submitted to the NRC as a voluntary special report of the circumstances relating to the incident described on Problem Investigation Report (PIR) 1-M92-0104, Inadequate Vent Path For The Reactor Coolant (NC) System While At Midloop Operation. The specific purpose of the review was to determine the cause of the incident and possible solutions to prevent further problems of the type described by the PIR.
4. EVALUATION AND COMMENT: PIR 1-M92-0104 documented an incident in which there was not an adequate vent path for the NC system as specified by Generic Letter 88-17.

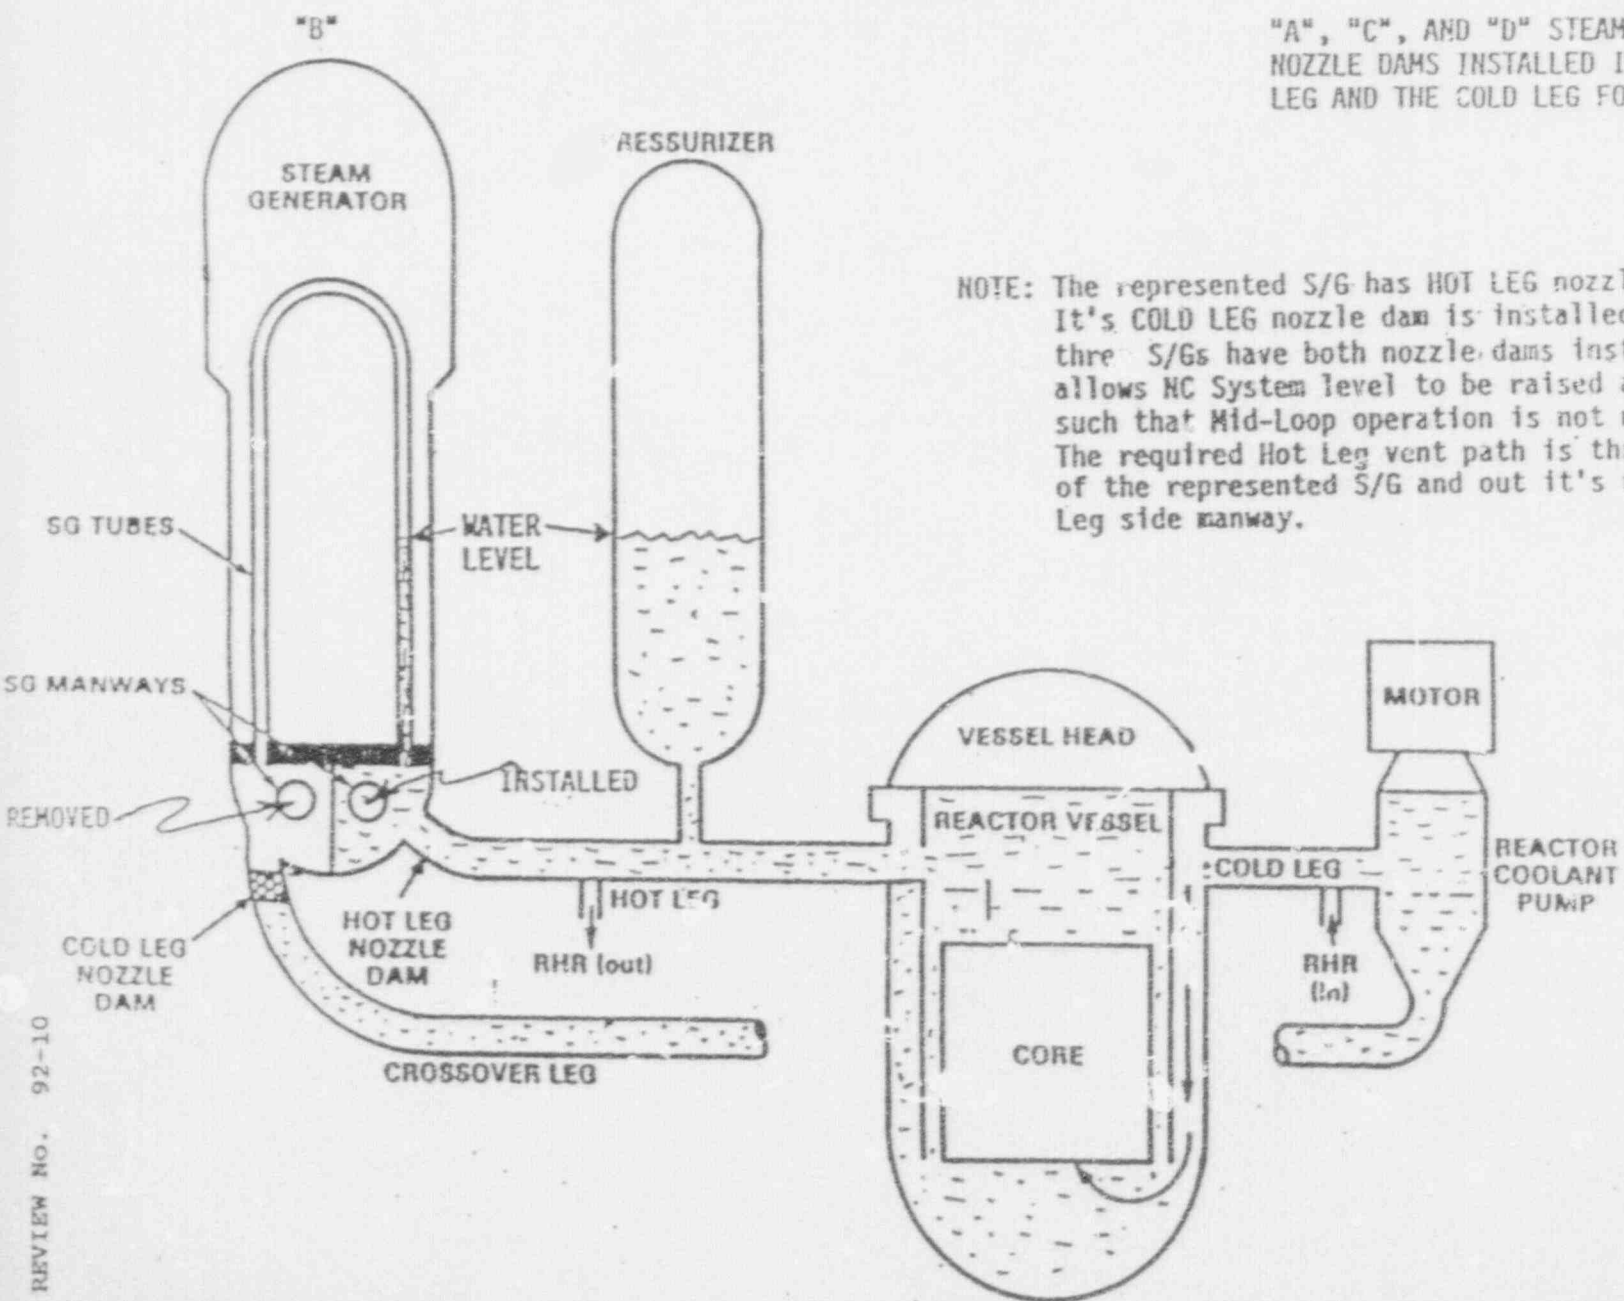
# REACTOR COOLANT SYSTEM

Prior to the start of the Unit 1 Steam Generator (SG) Tube Inspection Outage, in May of 1992, McGuire Management personnel made a decision to establish a vent path through the Hot Leg of SG 1B to avoid having to remove the Reactor Vessel head during the outage. (Reference the attached NC system drawing page 9.) Discussion of the consequences of this decision was held between Work Control, Operations, and Component Engineering personnel. However, even though the vent path was discussed prior to the start of the outage and current vent path status covered during daily outage and SG status meetings, no changes to the existing administrative and procedural controls were made to ensure this new vent path configuration would be properly maintained.

At approximately 0100 on the morning of June 11, 1992, Maintenance personnel installed the diaphragm for the manway on SG 1B. This effectively blocked the VC system vent path. At approximately 0530 the Component Engineer arrived on site. Upon arrival he proceeded to contact the Maintenance personnel involved and discovered that the vent path had been closed. At approximately 0630 he verified that the manway had been installed. Concurrently, the Shift Manager and Unit 1 Operations Engineer contacted him with the same conclusion concerning the vent path. Immediate action was then taken to begin removal of the Hot Leg nozzle dam on SG 1A and thereby reestablish the vent path. The vent path was reestablished at approximately 1100 on June 11, 1992.

"A", "C", AND "D" STEAM GENERATORS HAVE NOZZLE DAMS INSTALLED IN BOTH THE HOT LEG AND THE COLD LEG FOR WORKING.

NOTE: The represented S/G has HOT LEG nozzle dam left out. It's COLD LEG nozzle dam is installed. The other three S/Gs have both nozzle dams installed. This allows NC System level to be raised as indicated such that Mid-Loop operation is not necessary. The required Hot Leg vent path is through the U-tubes of the represented S/G and out it's removed Cold Leg side manway.
