U. S. ATOMIC ENERGY COMMISSION
DIVISION OF COMPLIANCE
HEADQUARTERS

Report of Inspection

JERSEY CENTRAL POWER & LIGHT COMPANY
CONSTRUCTION PERMIT NO. CPPR-15

(PRESSURE VESSEL REPAIR PROGRAM)

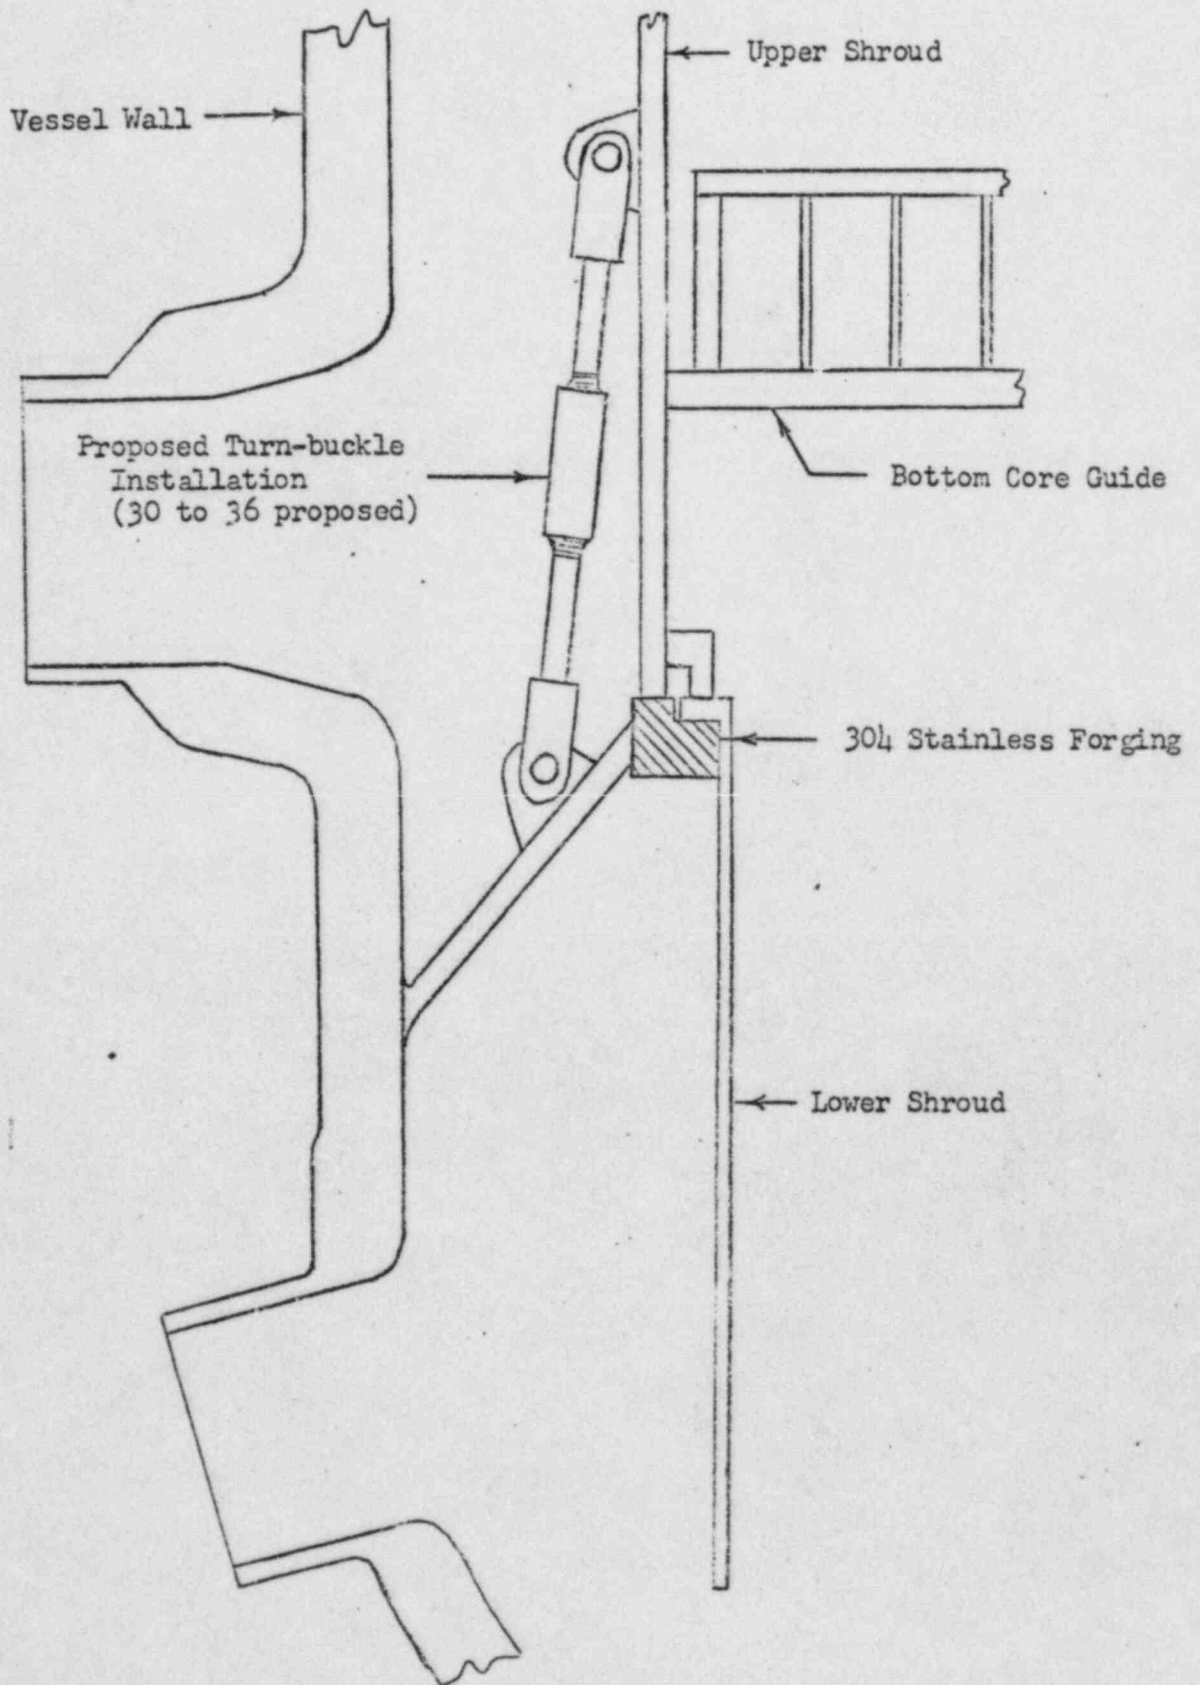
APPENDIX B

One sample from the stainless steel forging, which is part of the shroud support structure, also showed evidence of intergranular attack. Rather than attempt to clad in place, G-E is proposing to add additional mechanical support. A sketch of the proposed turn-buckle design is enclosed as Appendix B. According to G-E, the forged ring could crack in any direction or dissolve without causing a problem. The sketch should not be considered final as design details and stress analyses were still in progress. An amendment covering this repair will be submitted in about three weeks.
