U. S. ATOMIC ENERGY COMMISSION  
DIVISION OF COMPLIANCE  
HEADQUARTERS

CO Report No. 219/68-9

REPORT OF REACTOR PRESSURE VESSEL REPAIR PROGRAM

Licensee: JERSEY CENTRAL POWER AND LIGHT CO.  
CONSTRUCTION PERMIT NO. CPPR-15

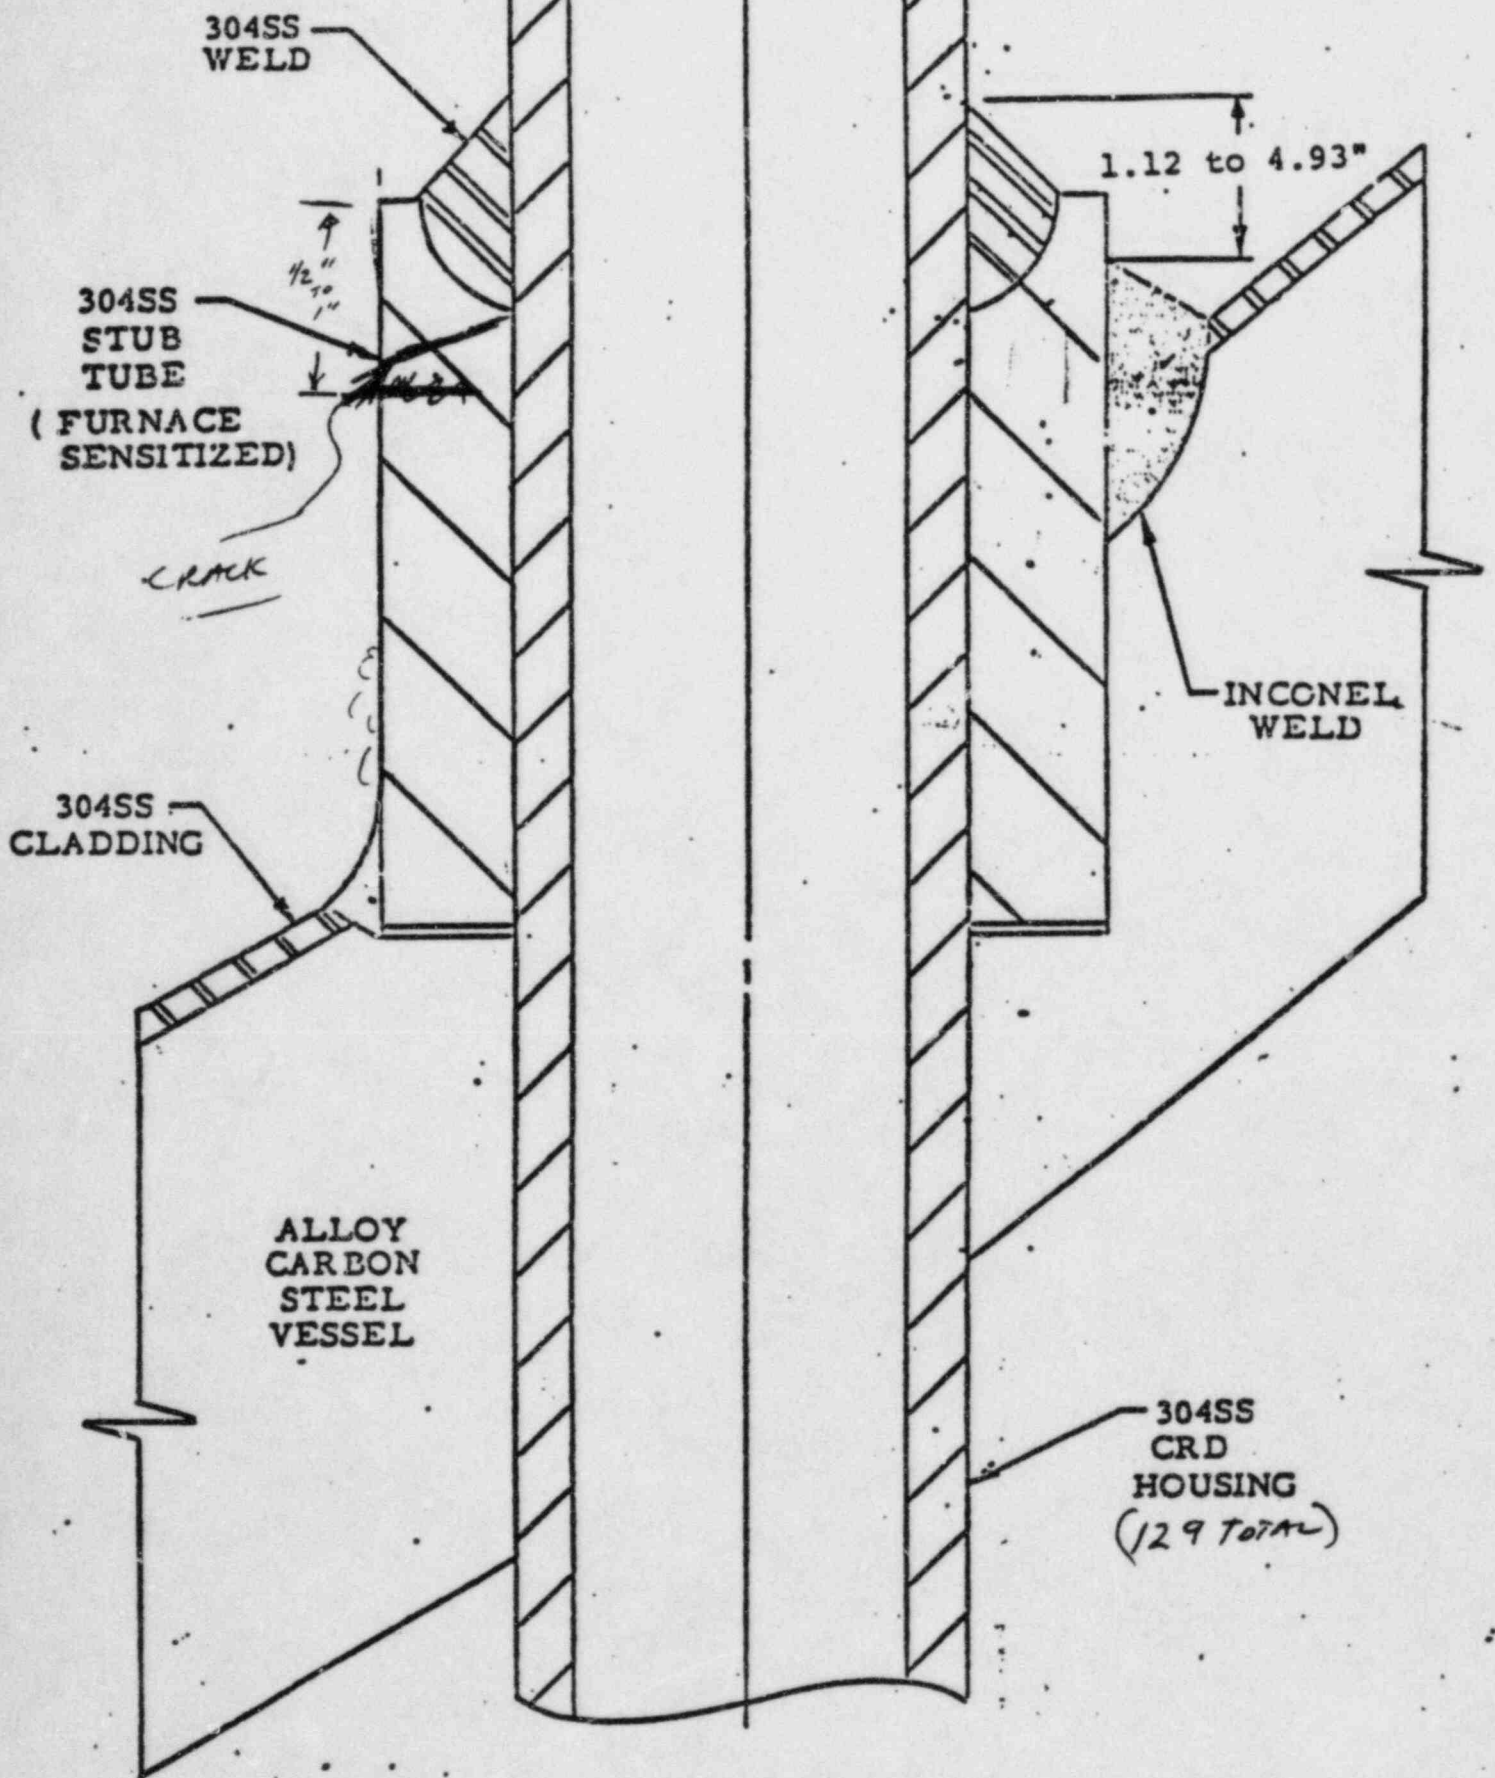
NMP-1 CRD  
PENETRATION ASSEMBLY  
(OUTER ROW)

- o STUB TUBE INSTALLED IN SHOP, HEAT TREATED WITH VESSEL AND IS FURNACE-SENSITIZED TYPE 304 STAINLESS STEEL
- o STUB TUBE-TO-VESSEL SHOP WELD IS INCONEL
- o CRD HOUSINGS WERE INSTALLED IN THE FIELD AND ARE SOLUTION ANNEALED TYPE 304 STAINLESS STEEL
- o HOUSING-TO-STUB TUBE FIELD WELD IS 304 STAINLESS STEEL
- o STUB TUBES AND WELDS EXTENSIVELY EXAMINED PRIOR TO INITIAL START-UP IN 1969 (SUPPLEMENTS 3 AND 6 OF NMP-1 FSAR)

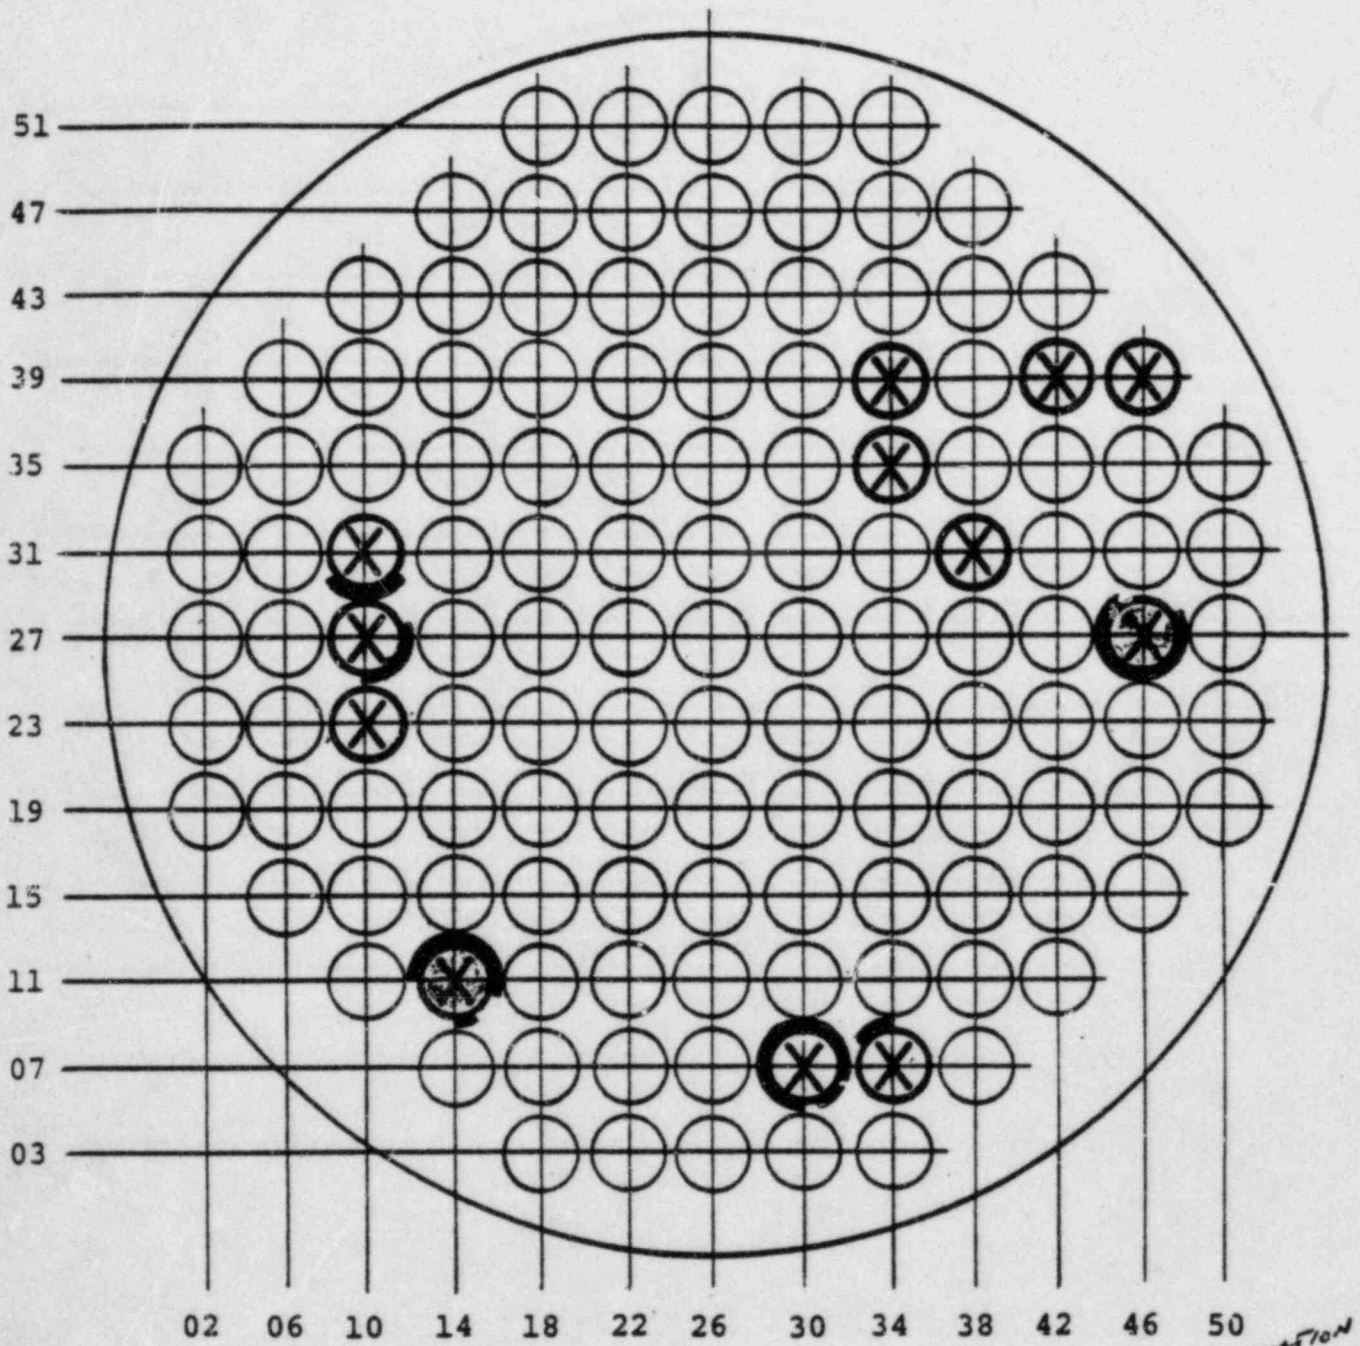
# INSPECTION RESULTS

Note: Observed cracks were generally horizontally oriented and approximately 1/2 to 1 inch below the elevation of the CRD housing to stub tube field weld.

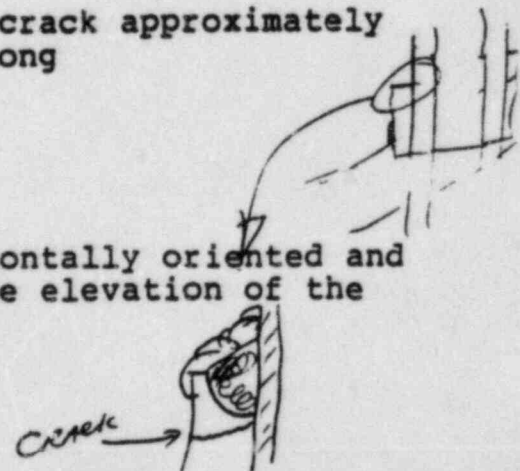
*CRACKS - ON DOWNHILL SIDE*

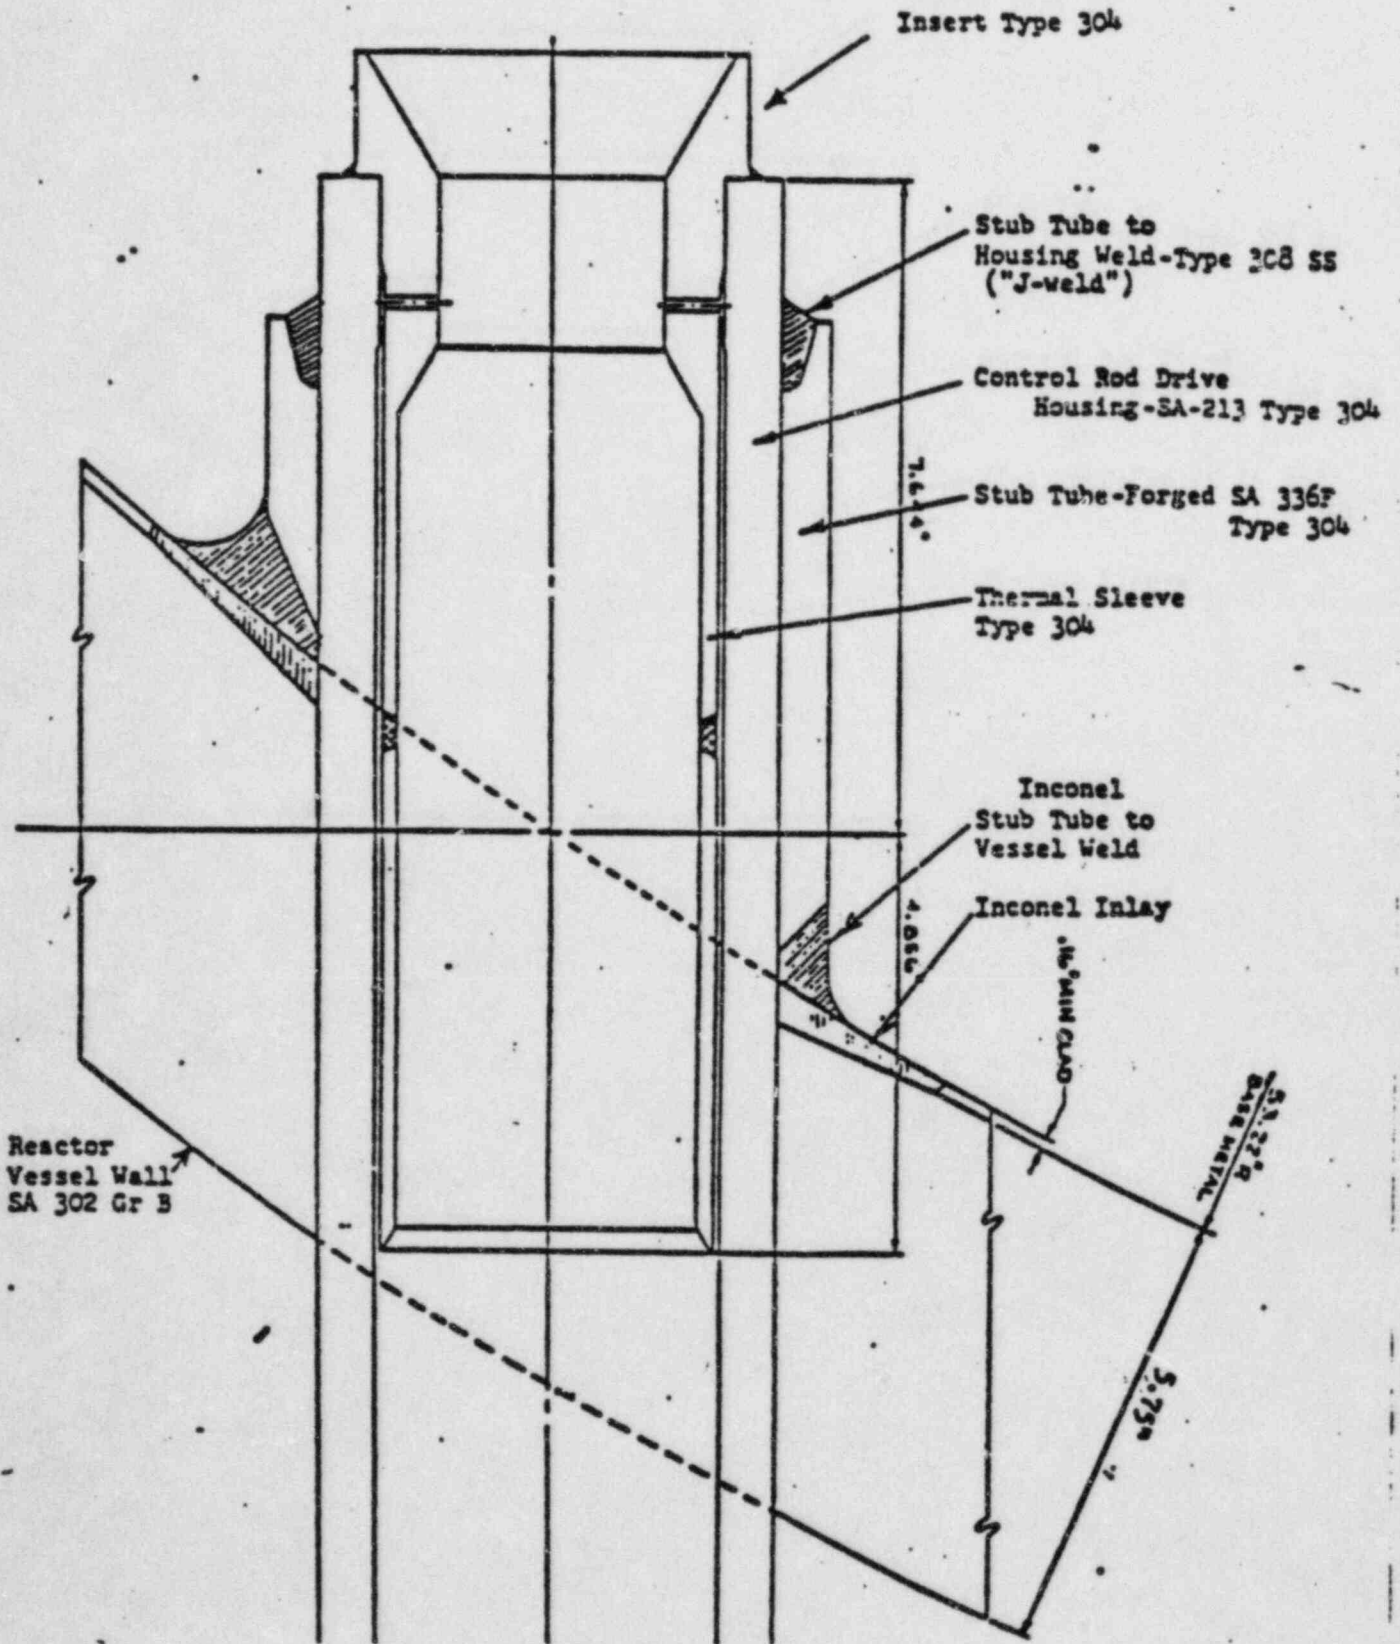
BIG ROCK PT - CRD PENETRATION

- A SECOND STUB TUBE WAS FOUND TO BE LEAKING IN SEPTEMBER 1983 DURING A HYDROTEST

- TO DATE 55 STUB TUBES OUT OF 97 HAVE BEEN EXAMINED AND 42 CONTAIN DEFECTS. ONLY THE TWO LEAKERS HAVE BEEN REPAIRED TO MINIMIZE LEAKAGE

ROLL REPAIR AT BIG ROCK POINT
