PEACH BOTTOM ATOMIC POWER STATION

SUBJECT: Licensee Event Report
Peach Bottom Atomic Power Station - Unit 3

Reference:	Docket No. 50-278
Report Number:	3-91-017
Revision Number:	01
Reportability Date:	11/08/91
Report Date:	07/20/92
Facility:	Peach Bottom Atomic Power Station RD 1, Box 208, Delta, PA 17314

TITLE (4) Automatic Depressurization System Inoperability Due to Components Being Unqualified, as a Result of Insulation not being Installed Properly

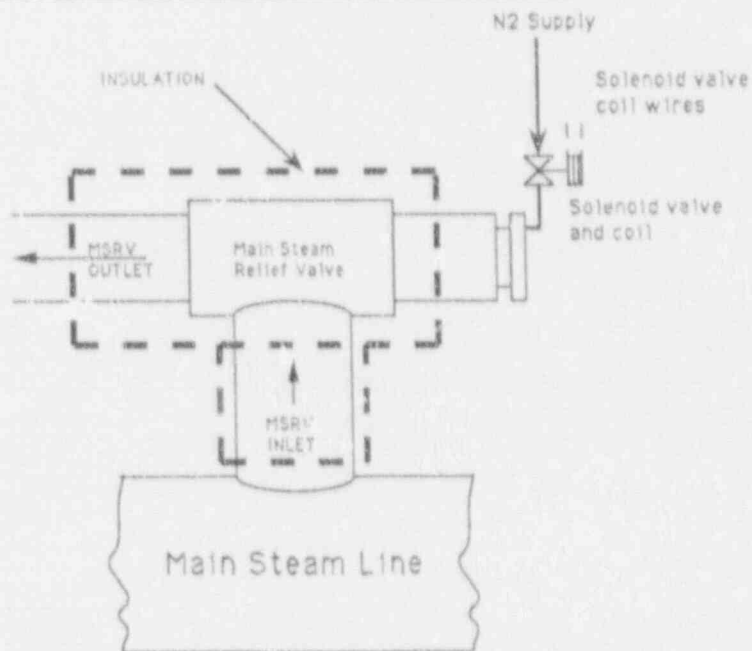
INCORRECTLY INSTALLED INSULATION

On 9/24/91 at 1300 hours, during the performance of routine preventive maintenance on the Main Steam Relief Valve (MSRV) solenoid valves (SV) associated with the eighth Refueling Outage, the MSRV SV wiring insulation was discovered to be degraded. An investigation revealed that the MSRV thermal insulation had been improperly installed (see attached drawing) during the previous Refueling Outage in 1989. This caused an unusually high temperature environment in the immediate vicinity of the SVs and associated wiring. This high temperature condition caused the MSRV SV wiring insulation to degrade.

The cause of this event has been determined to be that the MSRV insulation was improperly installed.

After discovery of the event, the Unit 3 MSR/V thermal insulation was properly reinstalled and the SVs were replaced.
