PEACH BOTTOM ATOMIC POWER STATION

SUBJECT: Licensee Event Report
Peach Bottom Atomic Power Station - Unit 3

Reference:	Docket No. 50-278
Report Number:	3-92-004
Revision Number:	00
Event Date:	06/25/92
Report Date:	07/21/92
Facility:	Peach Bottom Atomic Power Station RD 1, Box 208, Delta, PA 17314

TITLE (4)
Inoperability of the High Pressure Coolant Injection System due to High Water Level in the Turbine Casing

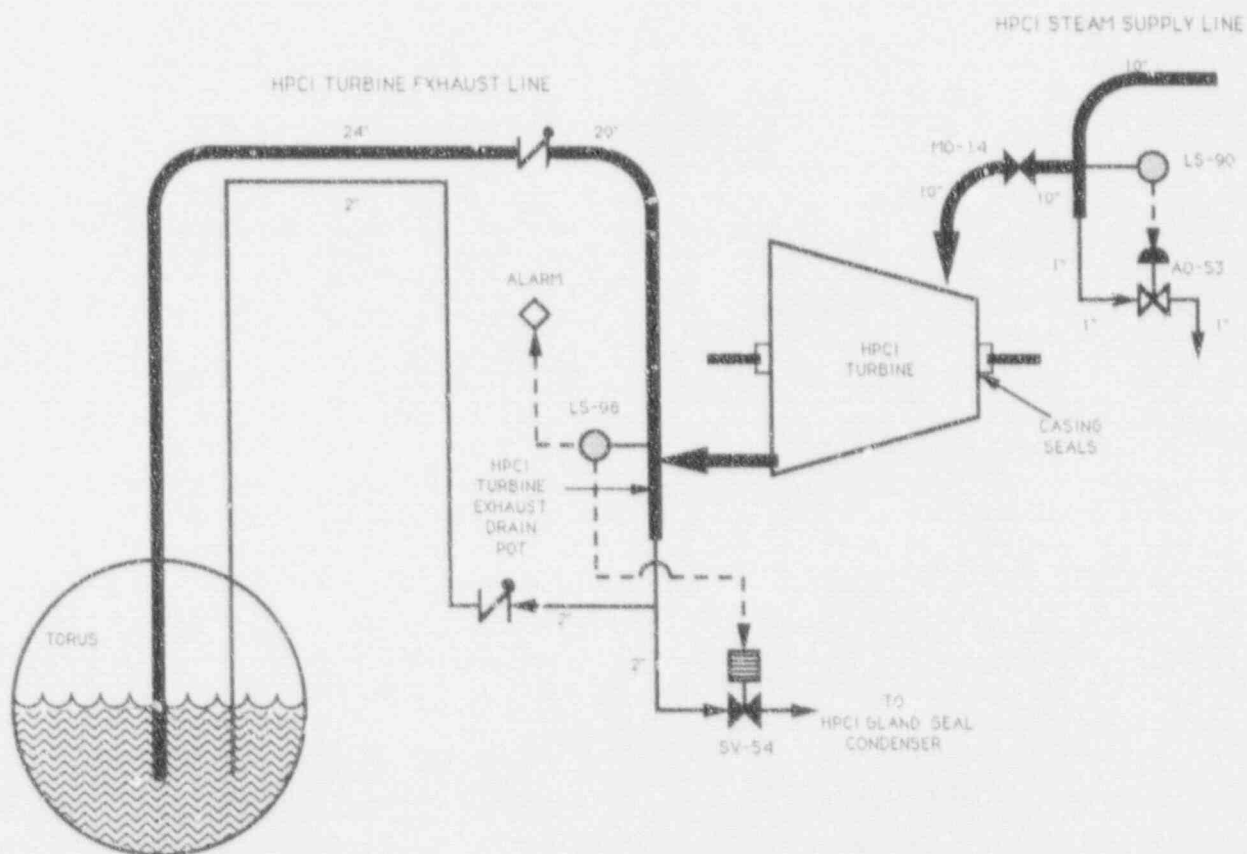
HPCI SIMPLIFIED PIPING DIAGRAM

On 6/25/92 at 1345 hours, during the performance of the High Pressure Coolant Injection (HPCI) System (EIIS:BJ) Logic System Functional Surveillance Test (LSFT) prior to turbine (EIIS:TRB) operation, the HPCI system was declared inoperable and removed from service when water was found leaking out of the turbine casing seals (see attached diagram) by a plant operator. Further investigations revealed that water was in the HPCI turbine casing due to a failed HPCI Turbine Exhaust Drain Pot level switch (LS-98). The failed LS-98 prevented the automatic draining of the HPCI Turbine Exhaust Drain Pot through the Drain Pot Solenoid Valve (SV-54) and prevented the HPCI Turbine Exhaust Drain Pot High Level alarm from actuating. The appropriate Technical Specification Limiting Condition for Operation was entered and the NRC was notified. The turbine casing was immediately drained. The level in the HPCI Turbine Exhaust Drain Pot was monitored and maintained at normal level to ensure HPCI operability via manual operation of SV-54. The HPCI system was then tested satisfactorily per the LSFT and returned to an operable status on 6/26/92 at 1055 hours. Based on later engineering review, it is believed that HPCI was capable of performing its design function with the amount of water that was found in the turbine casing.

The cause of the event has been determined to be the failure of LS-98. The LS-98 failure prevented automatic operation of SV-54 and prevented the HPCI Turbine Exhaust Drain Pot High Level alarm from actuating. Through-valve leakage of approximately one-half gallon per hour from the HPCI Steam Supply Valve (MO-14) in conjunction with the failed LS-98 allowed excessive condensation to collect in the HPCI turbine casing. It appears that LS-98 was mechanically jarred which caused a loss of the alarm and SV-54 control function.

The level in the Unit 3 HPCI Turbine Exhaust Drain Pot will be monitored and maintained at normal level using a drain valve to ensure HPCI operability as an interim corrective action.

The defective LS-98 will be replaced and MO-14 will be reworked during a future unit outage or system outage.
