U. S. NUCLEAR REGULATORY COMMISSION

Report No. 50-334/85-03  
Docket No. 50-334 License No. DPR-66  
Licensee: Duquesne Light Company  
One Oxford Center  
301 Grant Street  
Pittsburgh, PA 15279

Facility Name: Beaver Valley Power Station, Unit 1

Inspection Summary: Inspection No. 50-334/85-03 on January 8 - 15, 1985.

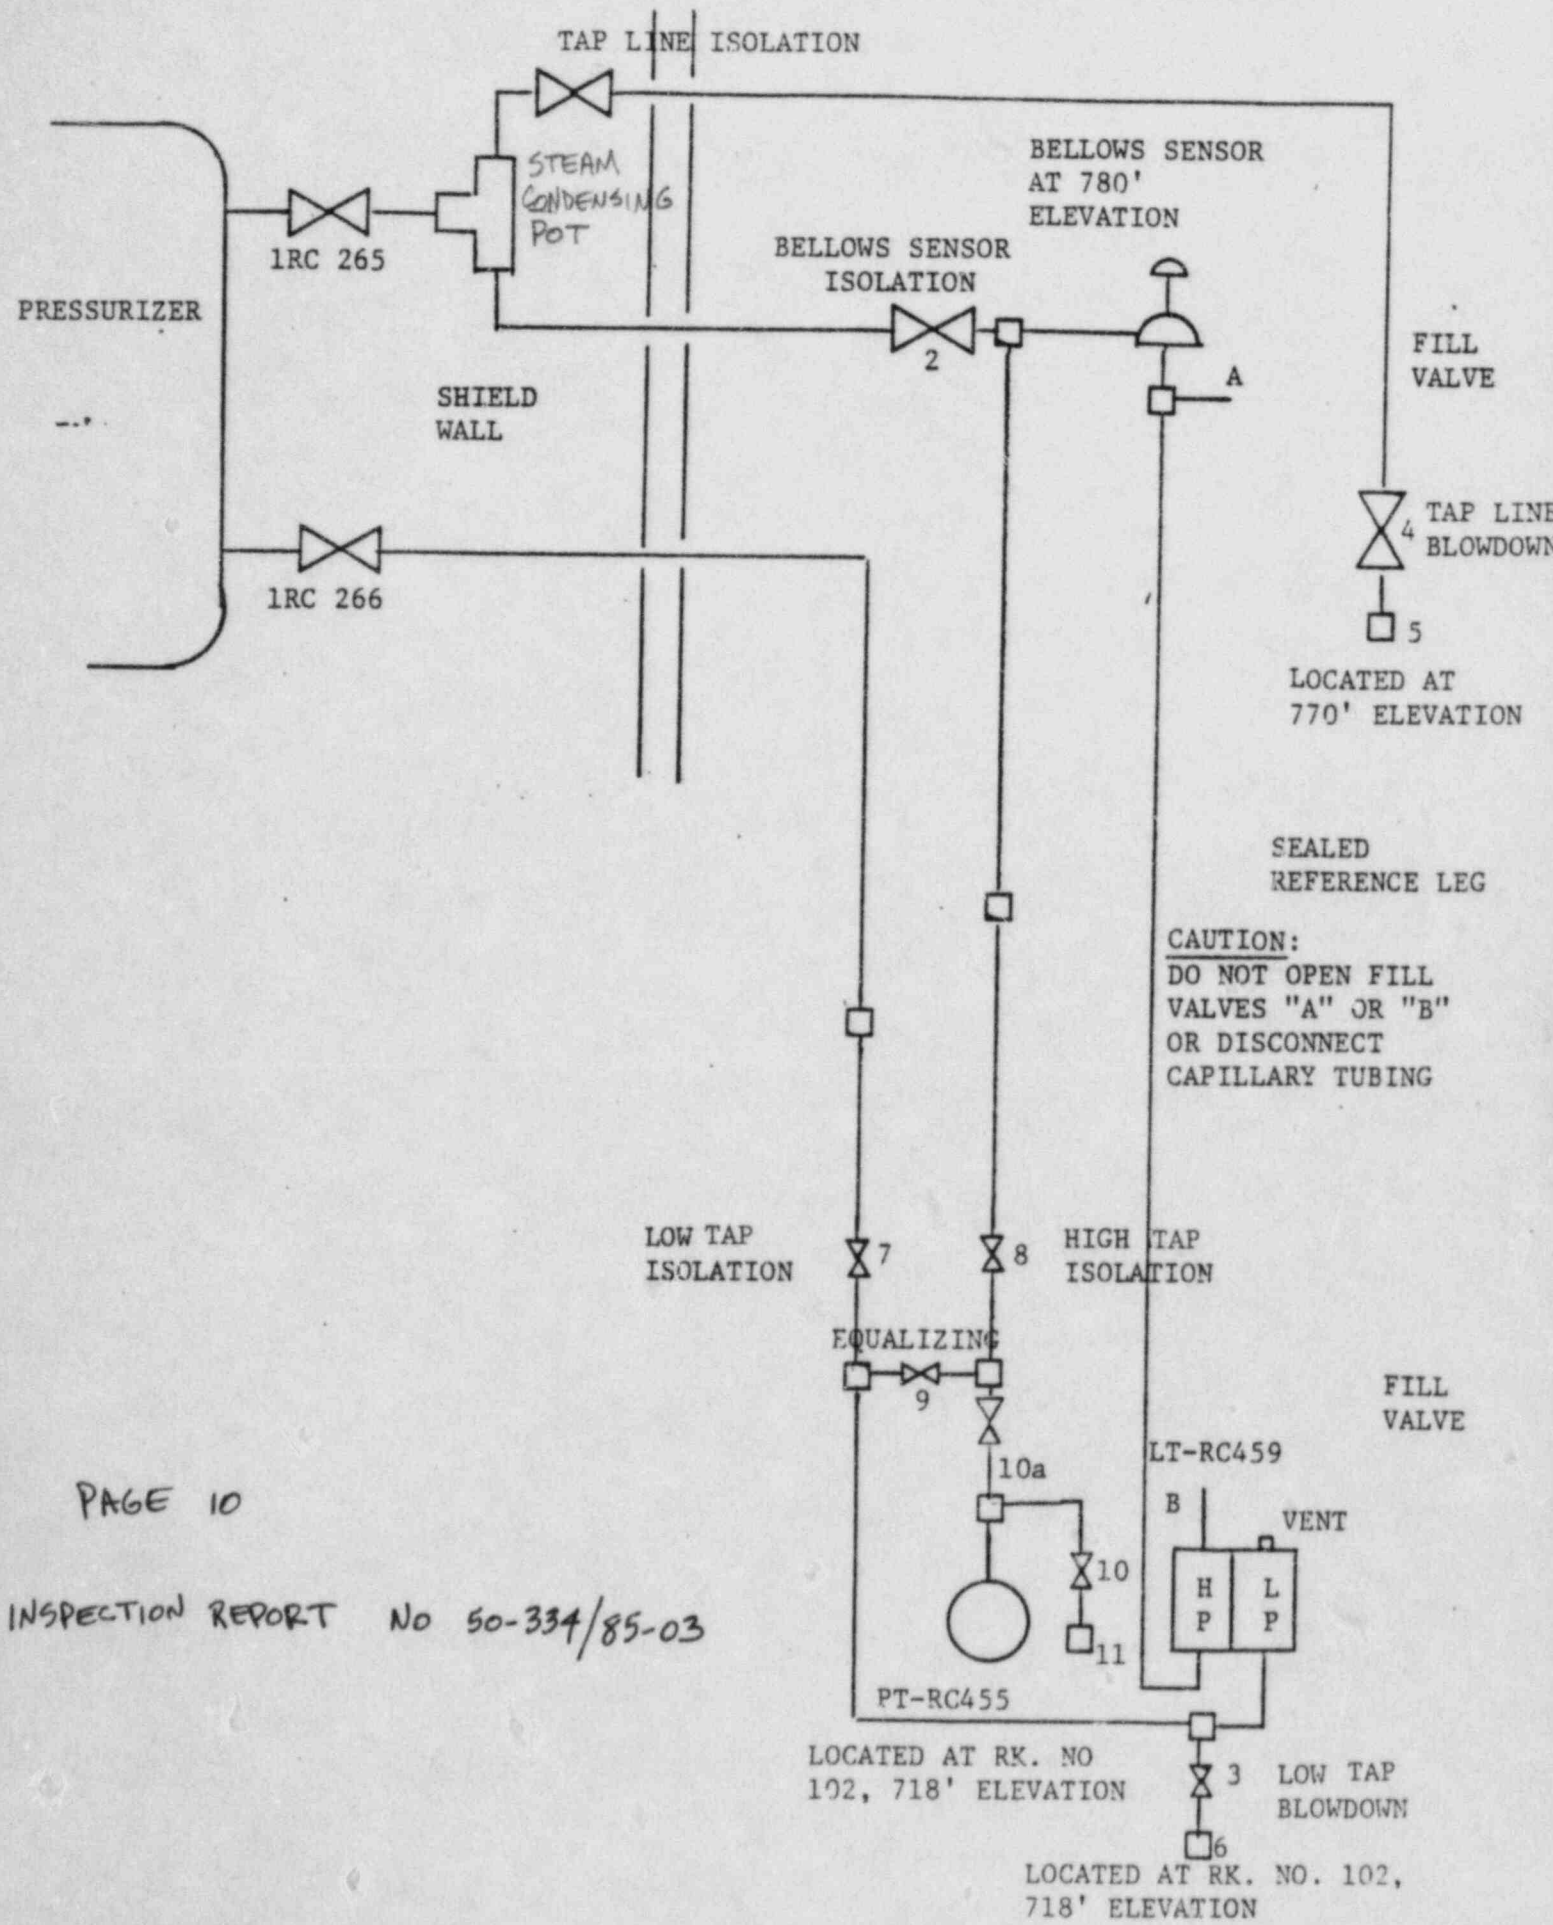
FIGURE 1

The pressurizer level protection system provides three separate instrumentation channels. The high pressure instrument line tap is routed to a steam condensing pot used to generate a liquid filled reference leg. From there, the instrument line drops 7 inches before making a 90° turn and is routed through the missile barrier inside containment. On the other side of the missile barrier, there is a manual isolation valve before the line branches to a pressure transmitter reference leg and a bellows sensor. The slope of this instrumentation tubing is such that an additional 6 inch drop occurs between the condensate pot and the bellows sensor. This sensor isolates the condensing pot from the high pressure (reference) line to the Barton level transmitter. A second line runs from the low pressure tap of the Barton transmitter back through the shield wall and into a lower elevation of the pressurizer.

During plant operations, there have been several occasions where a pressurizer transmitter isolation valve has experienced packing leaks which partially drained the reference leg for one instrumentation channel. When this occurred, the water between the condensing pot and the bellows sensor was lost. Routine operator checks of the three control room instrumentation channels would identify this condition as a level increase of from 5 to 7 percent on one channel. A Maintenance Work Request would be issued to return the inoperable channel to service. In each of the several instances, licensee maintenance personnel would repair the packing leak and refill the reference line with water. The affected channel would return back to a normal reading in close agreement with the two other independent channels.

Instrument and Control engineers informed the inspector that with a total water drop of 7 inches as was expected to occur when water is drained from the condensate pot to the bellows sensor, over a total span of about 200 inches on hot calibration, a total level increase of 3-1/2 percent was expected. After several occasions where the observed increase was greater, the licensee initiated an investigation during the fourth refueling outage. Calculations indicated that for a channel response of up to 7 percent full scale, the level drop between the condensate pot and bellows sensor would have to be about 13 inches. A hand-over-hand walkdown of the system identified that only the 7 inch drop between the condensate pot and the 90° elbow had been taken into account in the original A-E calibration procedure. The level change due to the slope of the piping running from the condensate pot to the bellows sensor had not been included.

All three pressurizer level channel trip setpoints were set below Technical Specification 2.2.1, Reactor Trip System Instrumentation Setpoints, allowable ranges since plant startup because of a common mode error in developing calibration procedures that did not accurately reflect elevation changes between the condensate pot and the bellows sensor. The calibration procedure development and review process did not identify this deficiency.

L-459 PRESSURIZER LEVEL PROTECTION CHANNEL I CALIBRATION (Cont.)

The Supervisor of Instrumentation and Control informed the inspector that revisions to the test procedures (MSP 6.41, -42, -43, Pressurizer Level Protection Channel Calibration) have been completed. Review of plant level instrumentation systems indicate that a bellows sensor system was only employed in the pressurizer level channels.
