Subject: McGuire Nuclear Station Unit 2
Docket No. 50-370
Licensee Event Report 370/92-08

LICENSEE EVENT REPORT (LER)

TITLE(4) A Technical Specification Was Violated On Unit 2 Because Power Operated Relief Valve 2NC-36 Was Inoperable Due To An Unknown.

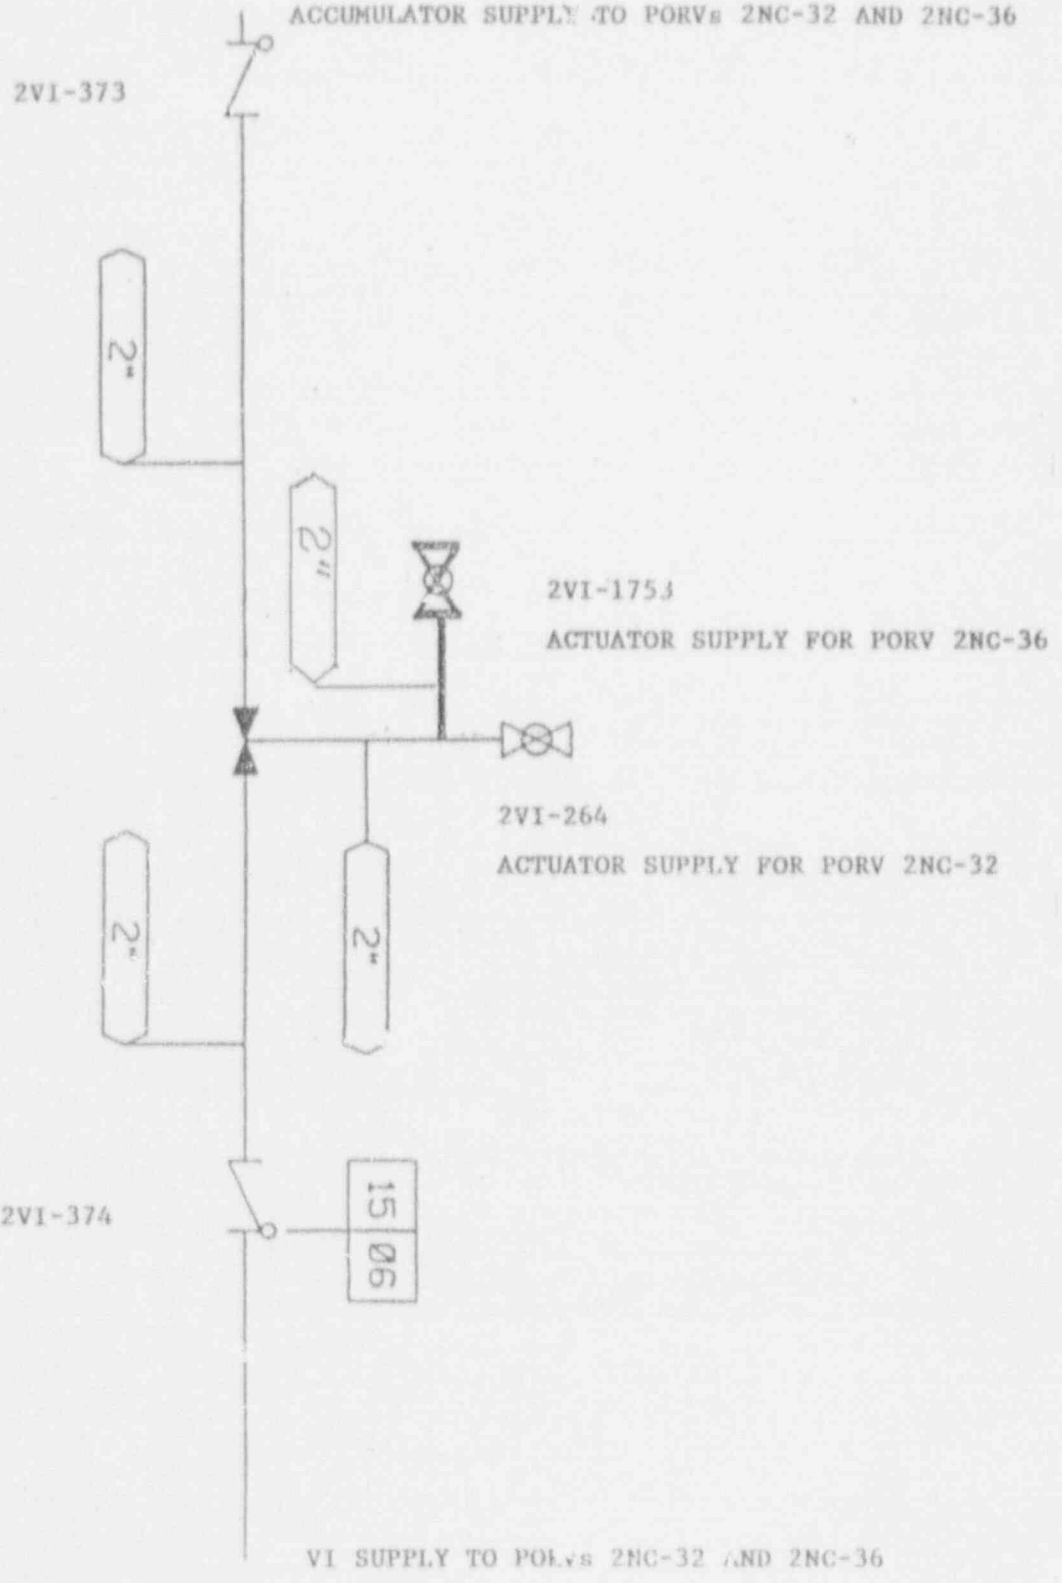
This event has been assigned a cause of Unknown because it cannot be conclusively determined why valve 2VI-1753 was in the closed position. In September, 1991, MEVN-2879 was generated to install a new 2 inch VI isolation valve [EIS:ISV] and branch tee in the 2 inch VI supply header upstream of valve 2VI-264, (formally B Header Containment 733' 6 Inch VI Connection). Valve 2VI-264 now supplies VI to PORV 2NC-32 and the new 2 inch VI valve (2VI-1753) supplies VI to PORV 2NC-36 (see one line diagram on page 7). The work was scheduled for the Unit 2 EOC 7 refueling outage and clearance to begin work was given to Generation Services Department (GSD) IAE Modification personnel by OPS personnel on February 6, 1992. The valve was installed in early February.
