**GULF STATES UTILITIES COMPANY**

River Bend Station - Unit 1  
Docket No. 50-458

**LICENSEE EVENT REPORT (LER)**

TITLE (4) **DISCREPANCY IN TECHNICAL SPECIFICATION LED TO FAILURE TO PROPERLY PERFORM SURVEILLANCES TESTS**

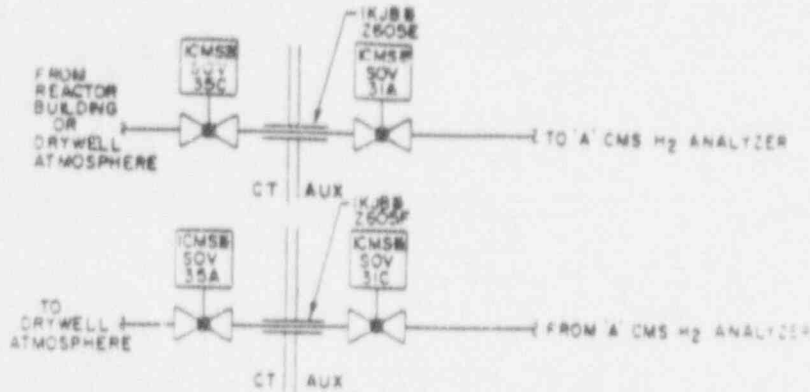
DIV I CMS HYDROGEN ANALYZER PENETRATIONS  
1KJB\*Z605E & F

Condition report (CR) 92-0280 was issued to document a discrepancy with respect to containment penetrations serving CMS lines. The penetrations (1KJB\*Z605E and F) for the CMS 'A' hydrogen analyzer supply and return lines (valves (\*ISV\*) 1CMS\*SOV31A and 35C for 1KJB\*Z605E and 1CMS\*SOV31C and 35A for 1KJB\*Z605F) are included in TS Table 3.6.1.3-1. However, penetrations 1KJB\*Z601E and F are not included in TS Table 3.6.1.3-1. These penetrations serve the CMS 'B' hydrogen analyzer and post-accident sampling system (PASS) panel supply and return lines. Valves 1CMS\*SOV35D, 31B, 1SSR\*SOV133 and 134 isolate penetration 1KJB\*Z601E and 1CMS\*SOV35B, 35D, 1SSR\*V706, and 1SSR\*SOV140 isolate penetration 1KJB\*Z601F. Figure 1 shows the penetrations with the valves indicated. The discrepancy identified in the CR was that the CMS 'A' lines, which were listed in the TS, did not meet the criteria for inclusion in the TS due to the fact that all of the piping was ASME class 2 (safety-related). However, the PASS panel supply and return lines include class 4 piping. This piping is non-safety-related and thus it should have been included in the TS.

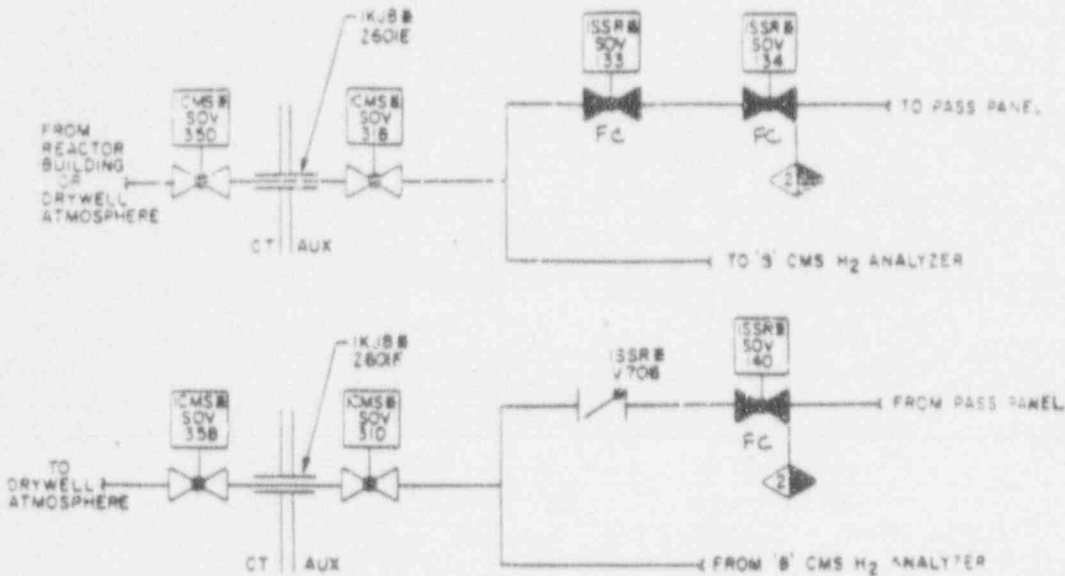
DIV II CMS HYDROGEN ANALYZER PENETRATIONS  
1KJB\*Z601E & F

On June 18, 1992, GSU determined that a discrepancy in Technical Specification (TS) 3.6.1.3, Table 3.6.1.3-1 resulted in the non-performance of required surveillance tests for valves 1SSR\*SOV133, SOV134, SOV140, and 1SSR\*V706. These valves are located in the post-accident sampling system (PASS) panel supply and return lines. The TS table included the penetrations for the containment atmosphere and monitoring system (CMS) 'A' hydrogen analyzer supply and return lines. However, the penetrations for the CMS 'B' hydrogen analyzer and PASS lines should have been included instead of the CMS 'A' lines because of the presence of non-safety-related piping in the PASS lines which branch off the CMS 'B' lines outside containment.

On June 18, 1992, GSU determined that a discrepancy in Technical Specification (TS) 3.6.1.3, Table 3.6.1.3-1 resulted in the non-performance of required surveillance tests for valves (\*ISV\*) 1SSR\*SOV133, SOV134, SOV140, and 1SSR\*V706. These valves are located in the post-accident sampling system (\*IP\*) (PASS) panel supply and return lines. The TS table included the penetrations for the containment atmosphere and monitoring system (\*BB\*) (CMS) 'A' hydrogen analyzer supply and return lines. However, the penetrations for the CMS 'B' hydrogen analyzer and PASS lines should have been included instead of the CMS 'A' lines because of the presence of non-safety-related piping in the PASS lines which branch off the CMS 'B' lines outside containment. This condition created an annulus bypass leakage path. As a result of this discrepancy, the valves referenced above have not received the surveillance tests required by TS 4.6.1.3. Therefore, this event is reportable pursuant to 10CFR50.73(a)(2)(i)(B) as operation prohibited by the TS.

Initially the investigation focused on the containment isolation valves (\*ISV\*) (the CMS valves). GSU evaluated the as-left leak rate test histories of valves 1CMS\*SOV35D, 31B, 35B, and 31D, and found the as-left leakage data to be within the allowables of TS 3.6.1.3. This led to the preliminary conclusion that this condition was not reportable. However, further investigation revealed that an annulus bypass leakage path was created due to the presence of the non-safety-related piping in the PASS panel piping supply and return lines. It was then found that valves 1SSR\*SOV133, SOV134, SOV140 and V706 have been stroke tested but not leak tested. Thus, GSU determined that a reportable condition (ie., failure to perform surveillances on the valves) existed.

1. Surveillance Test Procedure (STP) 610-3827 will be revised to include testing of 1SSR\*SOV133, SOV134, SOV140, V706 in their existing condition to obtain baseline data for safety assessment. This STP will also be revised to delete 1CMS\*SOV31A, C and 1CMS\*SOV35A, C when the T/S change discussed below is approved. STPs 057-3880 and 057-3900 will be revised to include the SSR valve data.
2. Leak rate tests will be performed on the subject SSR valves.
3. A safety assessment will be performed on the unidentified annulus bypass pathway using the data collected from the leak tests.
4. A T/S change request will be prepared to correct Section 3.6.1.3. The USAR will be revised, as necessary, to insure agreement with the revised T/S.
