U.S. NUCLEAR REGULATORY COMMISSION

Report No. 50-461/92015(DRSS)

Facility Name: Clinton Power Station

TRAVERSING INCORE PROBE (TIP)  
MAINTENANCE  
ENFORCEMENT CONFERENCE  
JULY 14, 1992

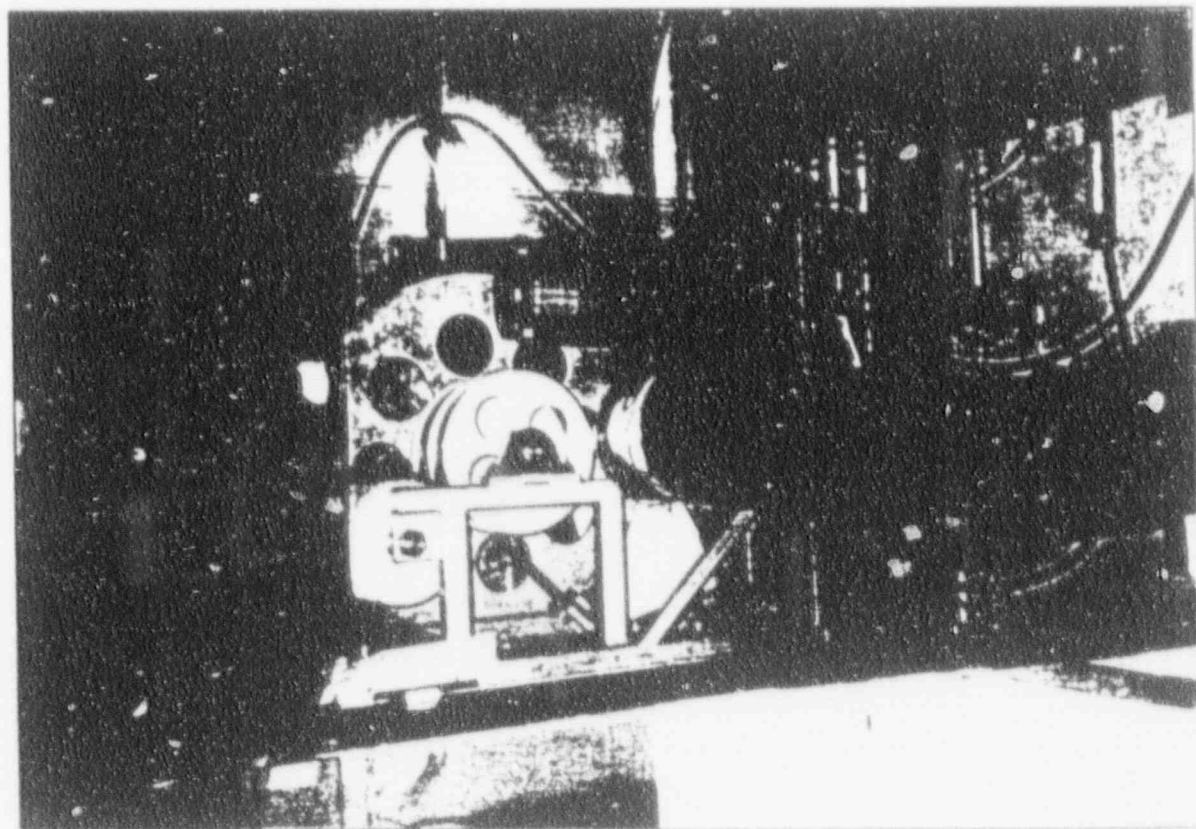
Pictured is the right and left view of the TIP drive mechanism internals. The drive unit cover has been removed and a prefabricated plexiglass enclosure (connected to a HEPA filter) has been installed.

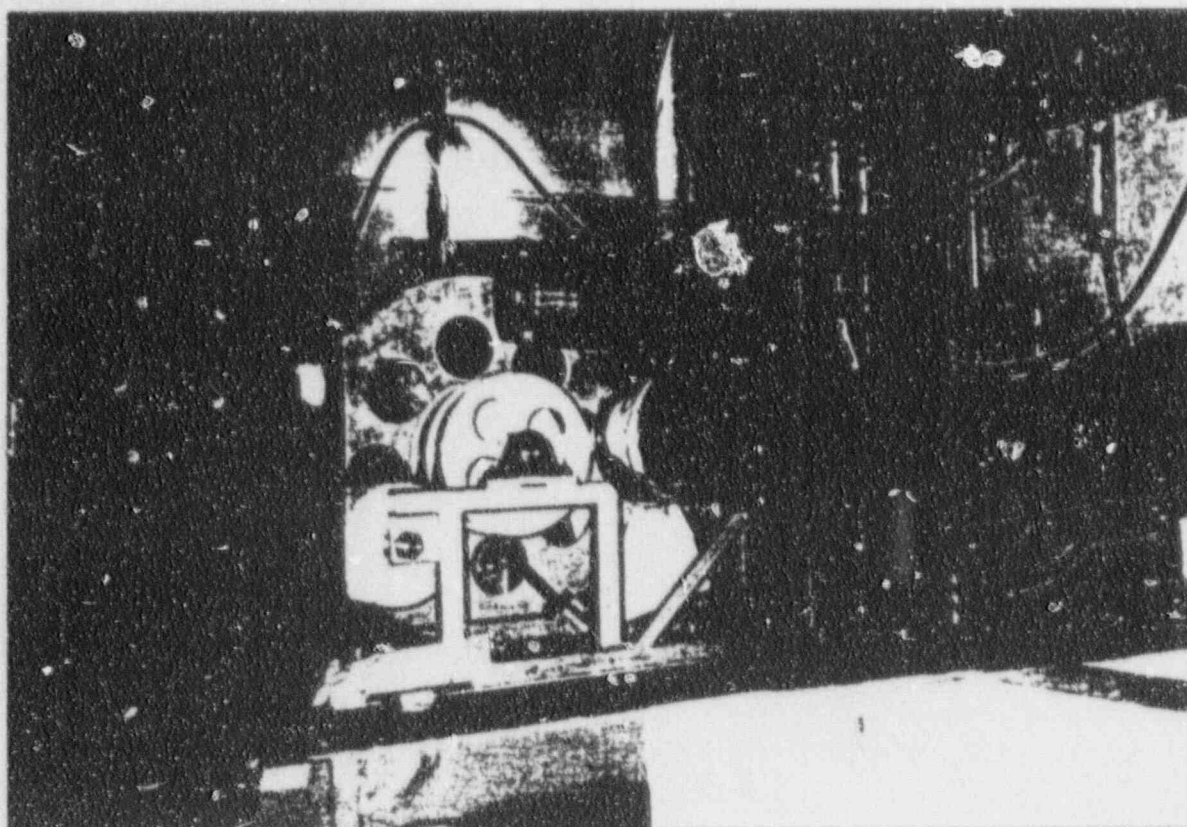
Pictured is the right and left view of the TIP drive mechanism internals. The drive unit cover has been removed and a prefabricated plexiglass enclosure (connected to a HEPA filter) has been installed.
