STATEMENT OF MATERIAL FACTS AS TO WHICH A GENUINE ISSUE EXISTS

1. Issue #16 in this proceeding states:

Applicant has not demonstrated that it can reliably generate emergency on-site power by relying on four Transamerica Delaval diesel generators, two for each of its Perry units.

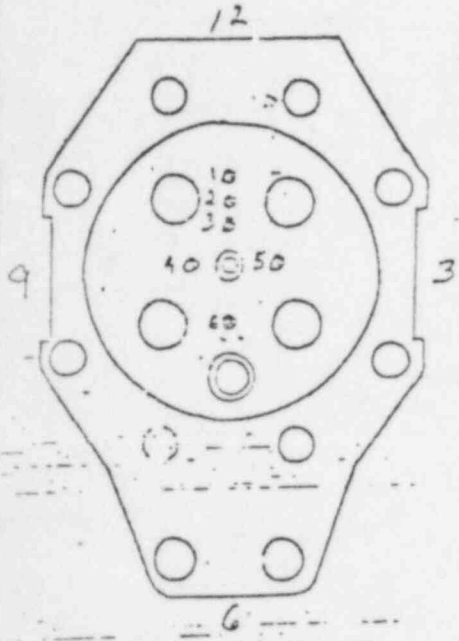
Cyl.No.	<u>1</u>	<u>2</u>	<u>3</u>	<u>4</u>	<u>5</u>	<u>6</u>	
1L	.824	.570	.551	.496	.489	.733	✓
2L	.863	.534	.536	.531	.520	.767	✓
3L	.862	.571	.562	.569	.534	.799	✓
4L	.951	.473	.552	.531	.524	.799	✓
5L	.771	.527	.571	.531	.542	.787	✓
6L	.453	.550	.543	.533	.519	.753	✓
7L	.444	.526	.513	.483	.498	.764	✓
8L	.890	.552	.563	.532	.535	.795	✓
1R	.911	.533	.537	.607	.525	.768	✓
2R	.799	.538	.525	.494	.487	.855	✓
3R	.859	.535	.527	.583	.505	.746	✓
4R	.776	.662	.514	.489	.539	.745	✓
5R	.800	.533	.547	.527	.534	.796	✓
6R	.871	.574	.565	.543	.545	.811	✓
7R	.869	.539	.544	.524	.527	.776	✓
8R	.796	.515	.525	.505	.499	.736	✓

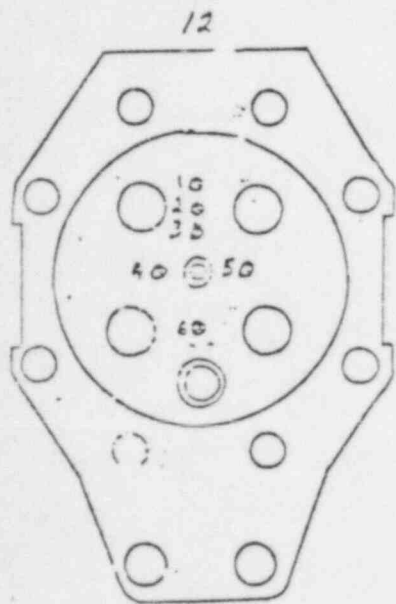
Cyl. No.	1	2	3	4	5	6	SAT	UN
1L	.835	.476	.481	.487	.480	.758	✓	
2L	.820	.539	.532	.521	.540	.792	✓	
3L	.523	.419	.470	.439	.449	.641	✓	
4L	.750	.546	.552	.534	.573	.787	✓	
5L	.715	.465	.447	.443	.428	.709	✓	
6L	.735	.502	.510	.505	.513	.800	✓	
7L	.715	.496	.505	.503	.492	.772	✓	
8L	.780	.522	.516	.582	.544	.835	✓	
1R	.650	.546	.599	.544	.502	.764	✓	
2R	.408	.554	.526	.555	.511	.816	✓	
3R	.844	.480	.469	.469	.442	.742	✓	
4R	.845	.556	.535	.524	.549	.802	✓	
5R	.881	.490	.490	.515	.462	.765	✓	
6R	.614	.406	.453	.437	.436	.698	✓	
7R	.769	.512	.503	.499	.500	.752	✓	
8R	.866	.538	.550	.554	.528	.759	✓

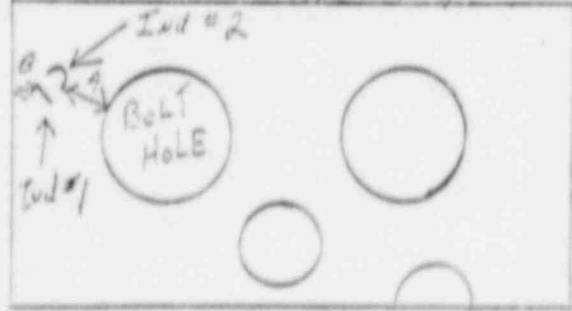
Sketch (if necessary) *
Two Linear indications noted, #1 is 1/8", #2 is 1/4" Half Circle. Dimension A is 2 1/2" from Ind. to Dist Hole. Dimension B is 1/2" to Edge of surface.

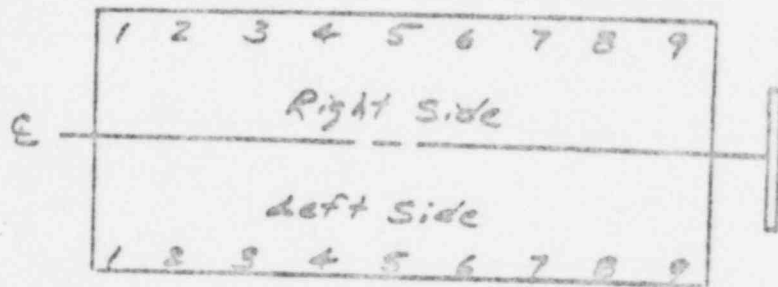
THE SURFACE AREA OF THE INTERMEDIATE CHOCK PLATES WHERE THE 10% CONTACT IS OCCURRING IS 145.1 IN². TEN PERCENT OF 145.1 IS 14.51 IN². SINCE 11.26 IS LESS THAN 14.51, THE CHOCK PLATES WILL NOT FAIL.

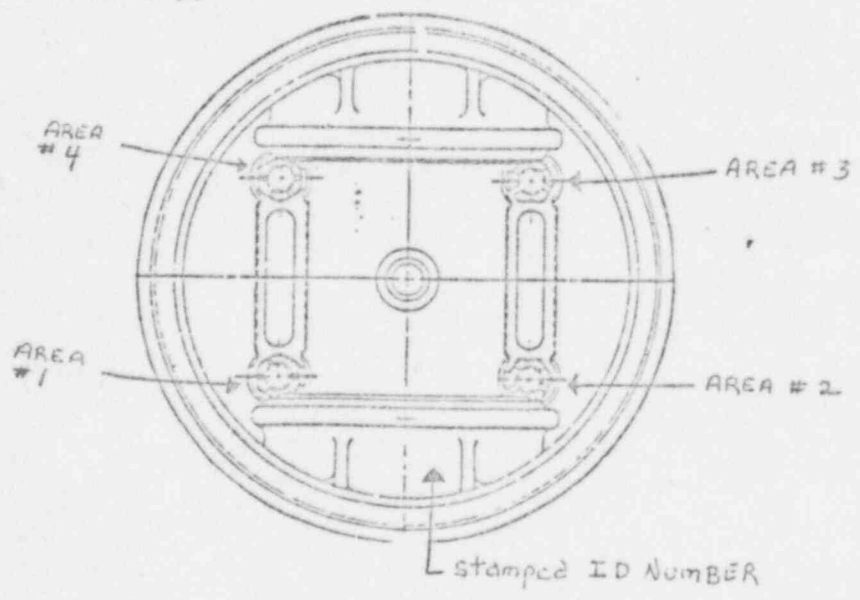
Item/Weld No.	A	R	Remarks/Indications
J53/537 K	✓		
K10/582 K	✓		
J23/513 K	✓		
J47/537 K	✓		
J26/513 K		✓	linear indication area #3 photo frames 1 & 2
K30/596 K		✓	linear indication area #2 photo frames 3 & 4 pitting area #3 photo frames 5 & 6
