FACILITY: Joseph M. Farley Nuclear Plant, Units 1 and 2

SUBJECT: SUMMARY OF MEETING HELD ON FEBRUARY 7, 1985, BETWEEN NRC AND APCo REPRESENTATIVES TO DISCUSS APCo's ACTION PLAN RELATING TO FAILURE OF A CONTAINMENT TENDON FIELD ANCHOR AT FARLEY UNIT 2

SUBJECT: FARLEY 2 - CONTAINMENT TENDON ANCHOR HEAD FAILURE

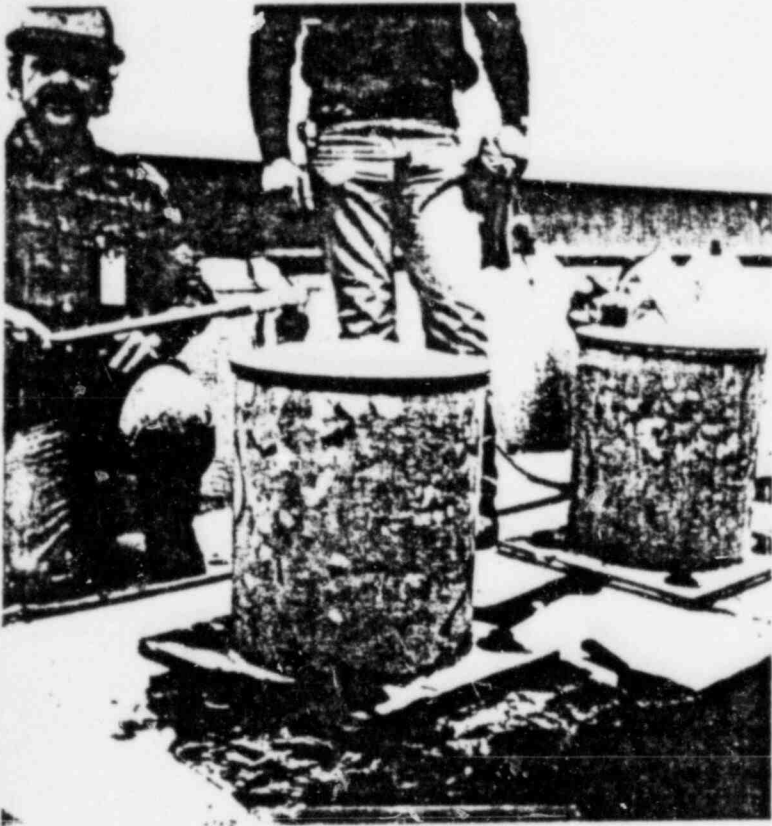
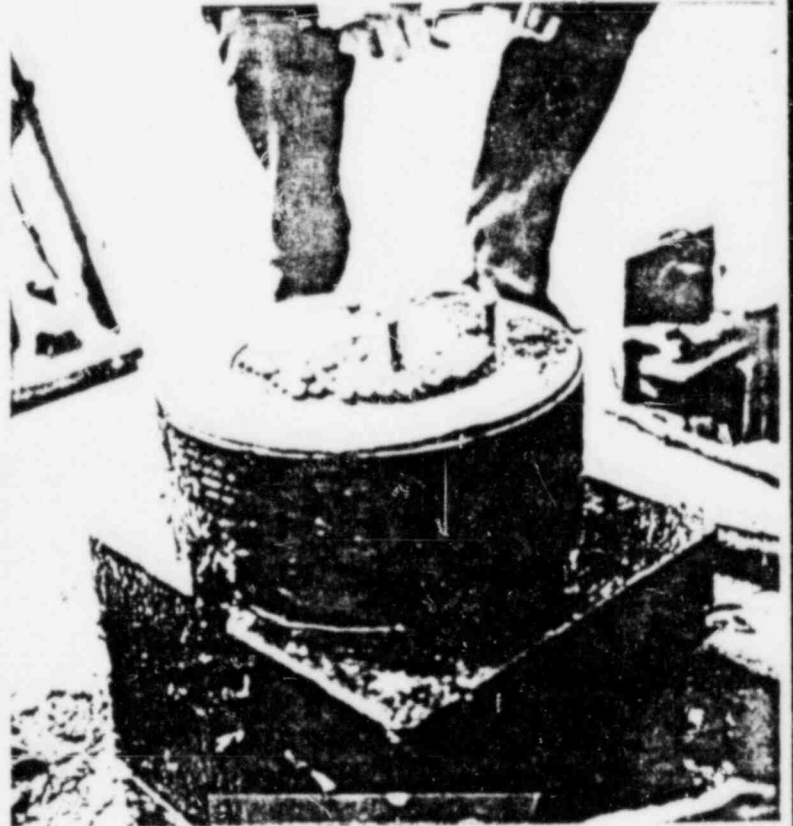
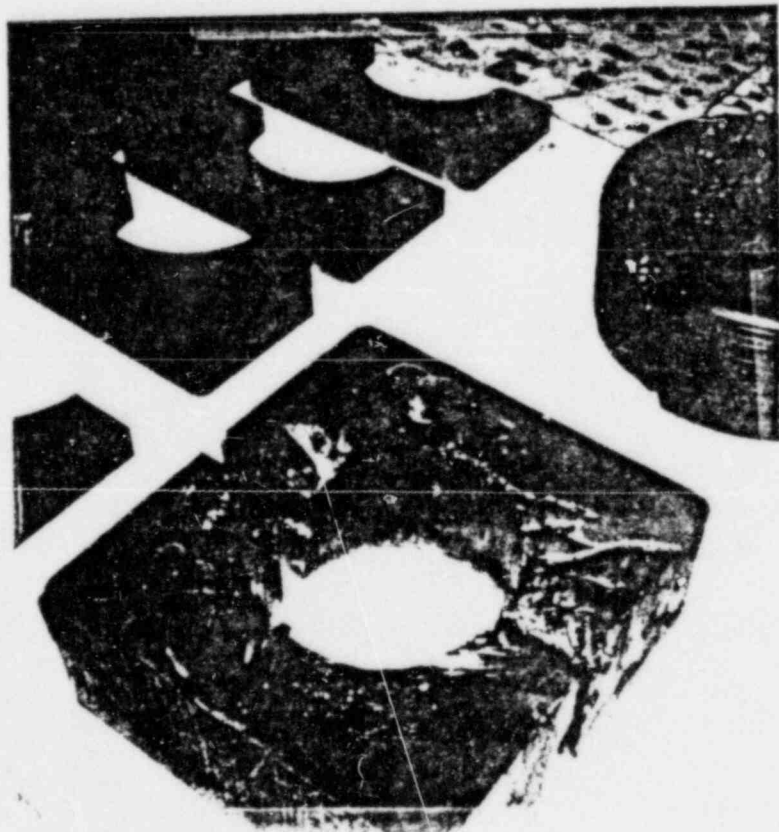
On Friday, January 25 of this year, while doing routine visual inspections of the containment as a part of the preparations for the ILRT, the grease can for the upper end of vertical tendon V17 was found to have a buldge in the end-cap and grease around the mounting base of the end-cap. Further examination determined the following. 1) The bottom tendon field anchor head had broken. 2) Many of the wires of the tendon were severed at the head. 3) A small portion of the honey-comb section of the head was still intact at the tendon and was located in the funnel area. 4) The upper head had left an impression on the upper plate of the grease end-cap.

Appropriate personnel were assembled for an on-site meeting to discuss this problem and determine an action plan. This plan consisted of sending the broken anchor pieces to Inland and Battelle for chemical and physical analysis as well as sending the 4 inch shim to a lab in Birmingham for physical analysis. The grease from around the lower head was sent to Law and Company for chemical analysis. Parallel with these activities, a program was initiated to examine other field anchor heads and their associate shim stacks. Shortly after initiating the field portion of this plan, V21 a vertical tendon of the same heat number as V17, was found to contain a crack.

To date, after modifying the action plan, V21 has been partially detentioned from the shop anchor end. The anchor is now cracked through but still held in position. Once this tendon is completely detentioned, the head will be sent to Inland lab and similarly analyzed to that of V17.

- (1) Detension all tendons with HV heat code field anchors (49).
- (2) Remove all HV heat code field anchors and replace with new anchors.
- (3) Retension all HV tendons.
- (4) Inspect a sufficient quantity of non-HV heat code field anchors to establish a 95% probability with a 95% confidence level that no further problems exist.
- (5) Continue analysis of failed components to provide assurance that corrective actions being taken correct the cause of failure.

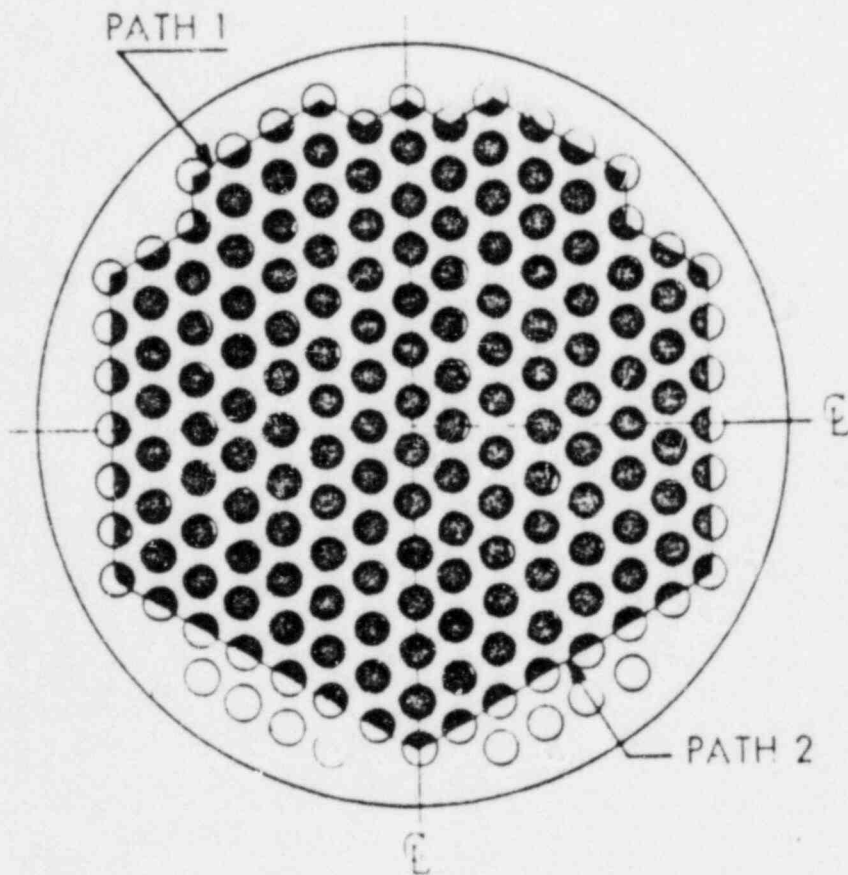
FIG. 3.2.8: Alternate shear paths for wire hole web shear failure with Path 1 shown above horizontal ζ and Path 2 below. Path 2 is slightly more critical than Path 1.
