JAN 28 1985

Docket Nos.: 50-445/50-446

APPLICANT: Texas Utilities Electric Company (TUEC)
 FACILITY: Comanche Peak Steam Electric Station, Units 1 and 2
 SUBJECT: SUMMARY OF MEETING TO DISCUSS THE COMANCHE PEAK TECHNICAL REVIEW TEAM (TRT) FINDINGS RESULTING FROM QUALITY ASSURANCE/QUALITY CONTROL (QA/QC) ALLEGATIONS

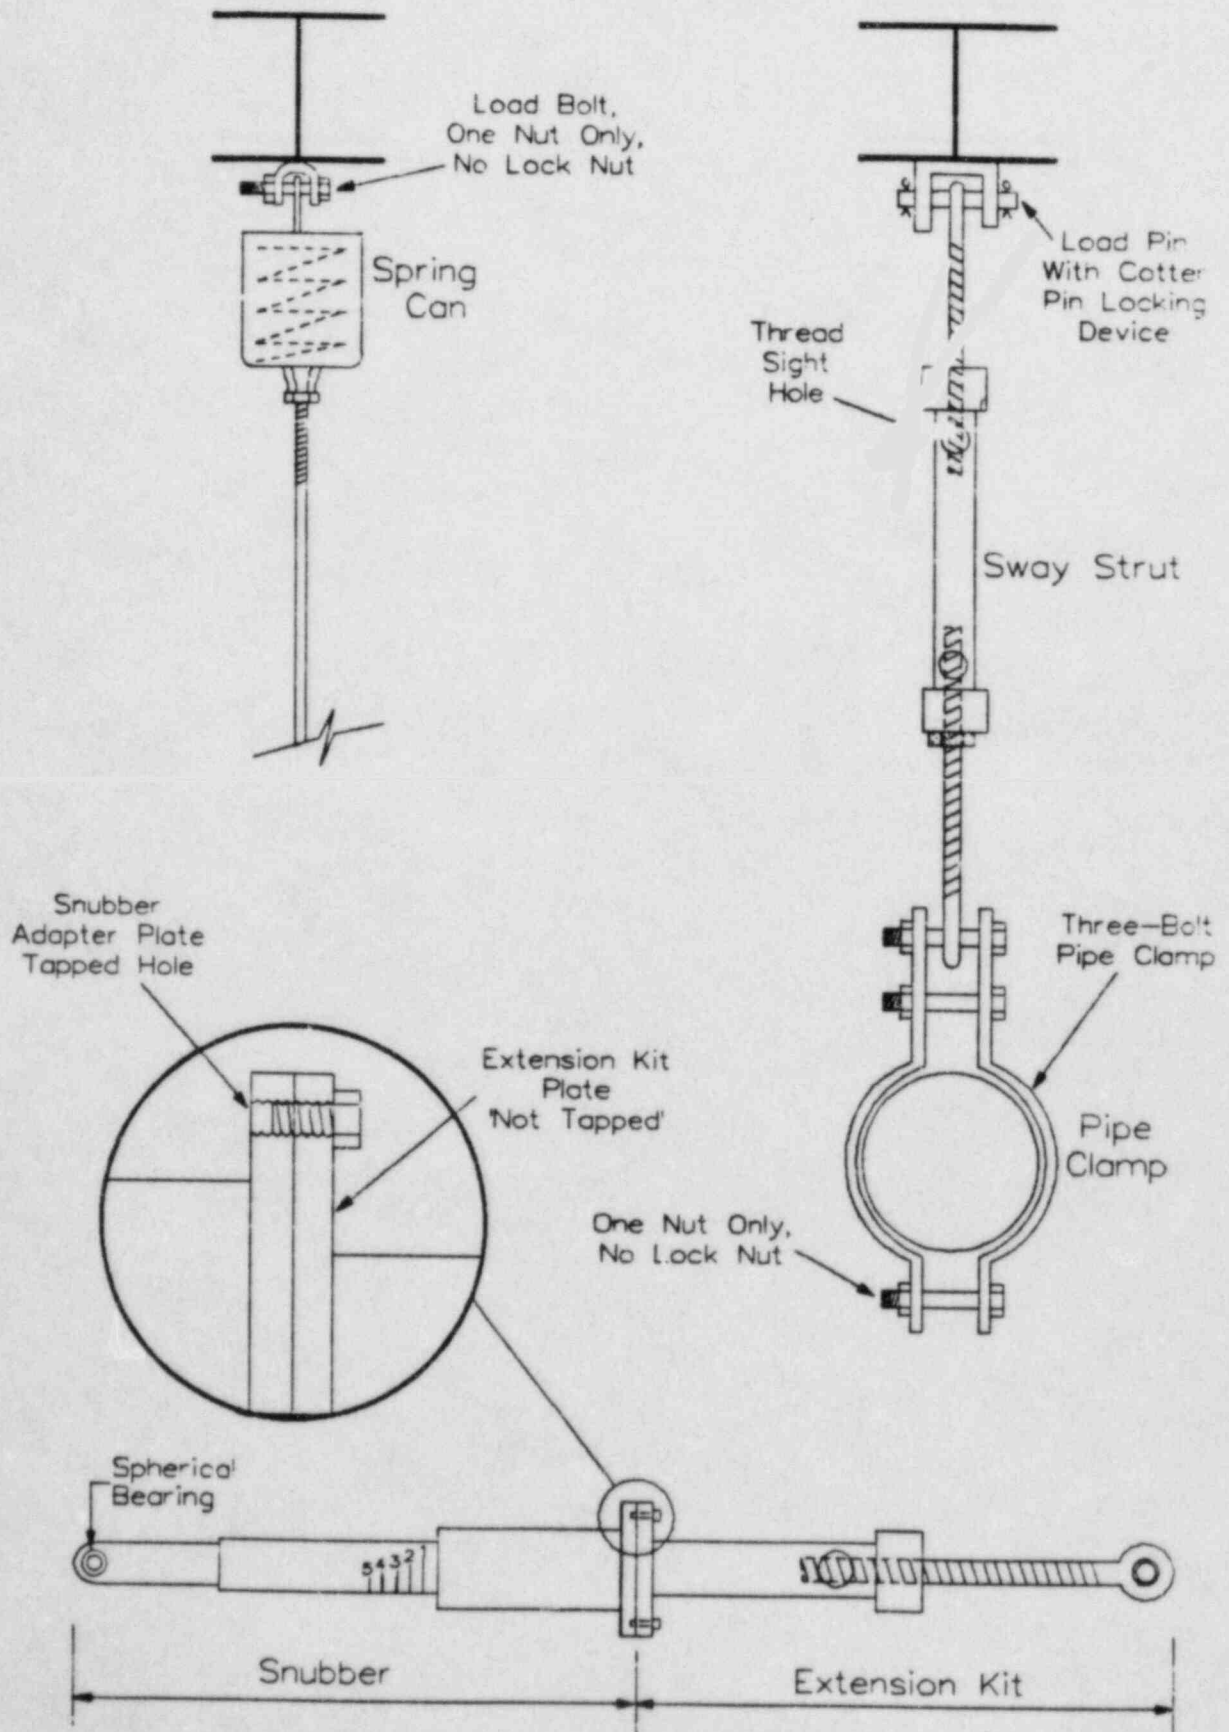
Figure 1. Hardware Examples

- 1) QC INSPECTIONS ARE INEFFECTIVE
- 2) CRAFT CONSTRUCTION IS FAULTY
- 3) HARDWARE IS NOT PER AS-BUILT DRAWINGS
- 4) HARDWARE POTENTIALLY NOT REPRESENTED CORRECTLY
IN THE FINAL STRESS ANALYSIS
