Millstone Nuclear Power Station, Unit No. 3
Relief Request From ASME Code Section XI Requirements

FORM FOR RELIEF REQUEST FROM ASME SECTION XI REQUIREMENTS

UNIT: Millstone Unit 3 NCR # 392-189 DATE: 8/10/92
TIME: 1100

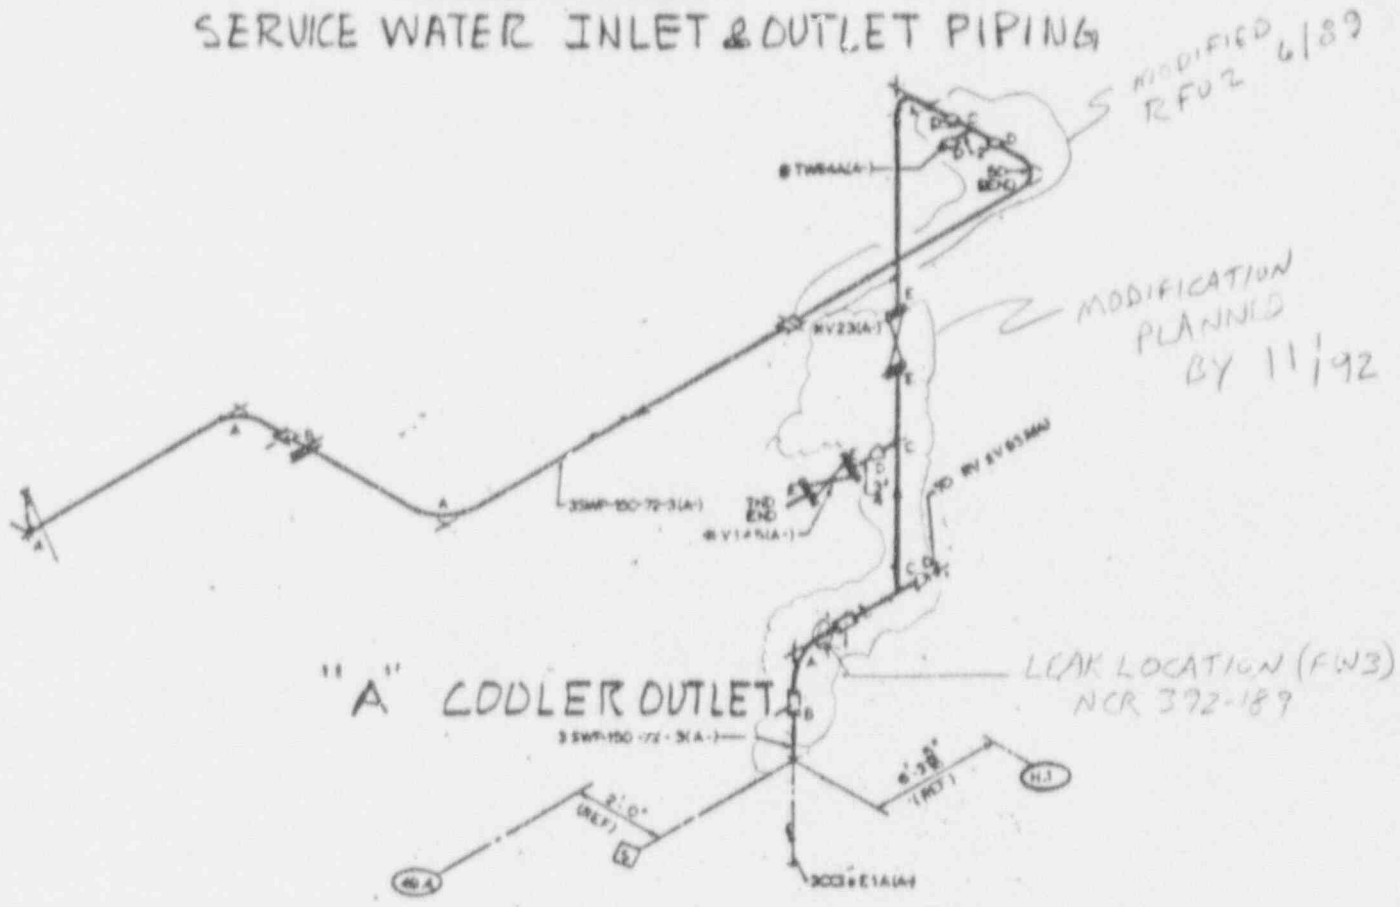
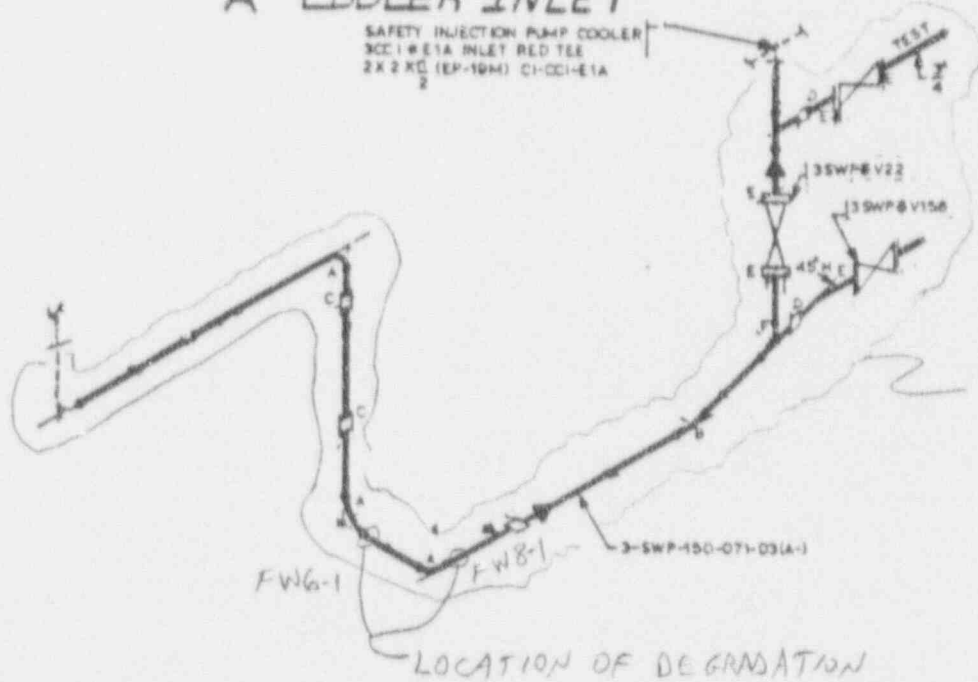
SERVICE WATER INLET & OUTLET PIPING

Leak in 1 1/2" 90/10 Cu-Ni piping, Line #3-SWP-150-072-03 (A-) at FW 3, SWP outlet from 3CCI*E1A.

Root Cause Description: Erosion corrosion of solid 90/10 copper nickel due to turbulent flow at elbow.

Pin hole leak with adjacent wall outside the affected area > 0.100". Entire circumference examined for 3 1/2" downstream of the fitting in 1/2" grids.

Flaw Location: In pipe at field weld 3 to elbow at the bottom (180°-190° from TDC) of the horizontal run.

Wrap with rubber tape, secure with hose clamp.

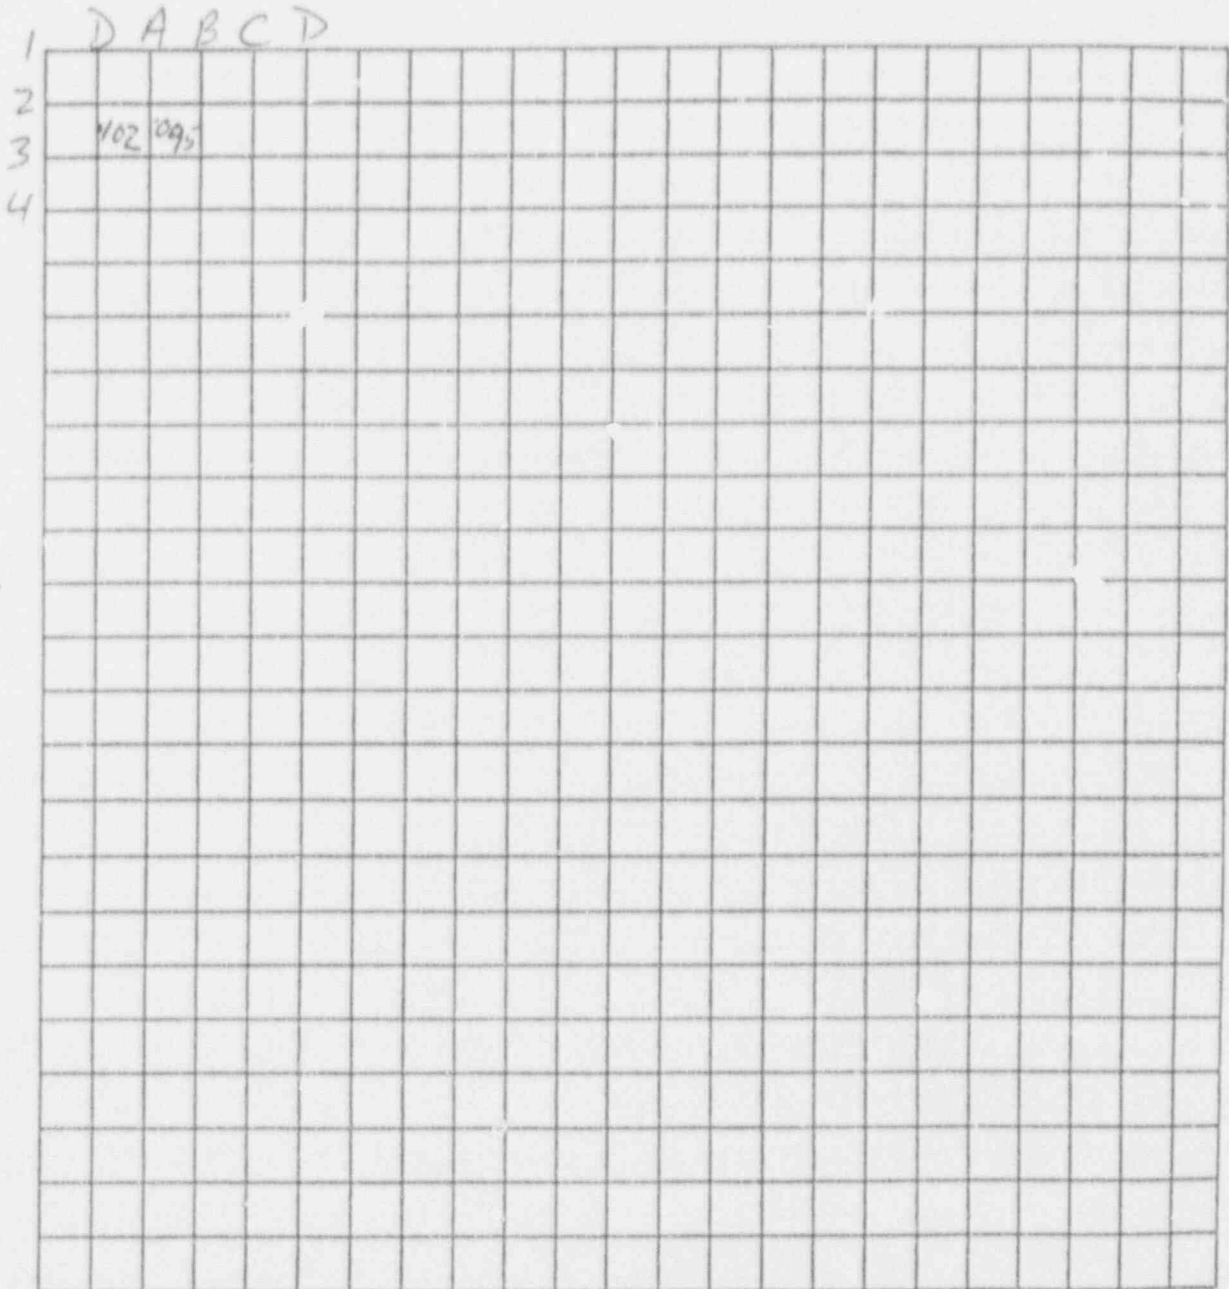
COMPONENT ID C 40 (FW 6-1) EXAMINER J. Jacobson DATE 9-1-92

A	B	C	D	RowMx	RowMn	Delta	Ave
1	0.153	0.164	0.157	0.157	0.164	0.153	0.011	0.158
2	0.073	0.150	0.146	0.150	0.150	0.073	0.077	0.130
3	0.073	0.150	0.135	0.150	0.150	0.073	0.077	0.127
4	0.157	0.139	0.142	0.146	0.157	0.139	0.018	0.146
5	0.157	0.146	0.142		0.157	0.142	0.015	0.148
6								
ColMx	0.157	0.164	0.157	0.157				
ColMn	0.073	0.139	0.135	0.146				
Delta	0.084	0.025	0.022	0.011				
Ave	0.123	0.150	0.144	0.151

Maximum Reading = 0.164 (1, B) Average = 0.141
 Minimum Reading = 0.073 (2, A) Standard Deviation = 0.025
 Total Readings = 19

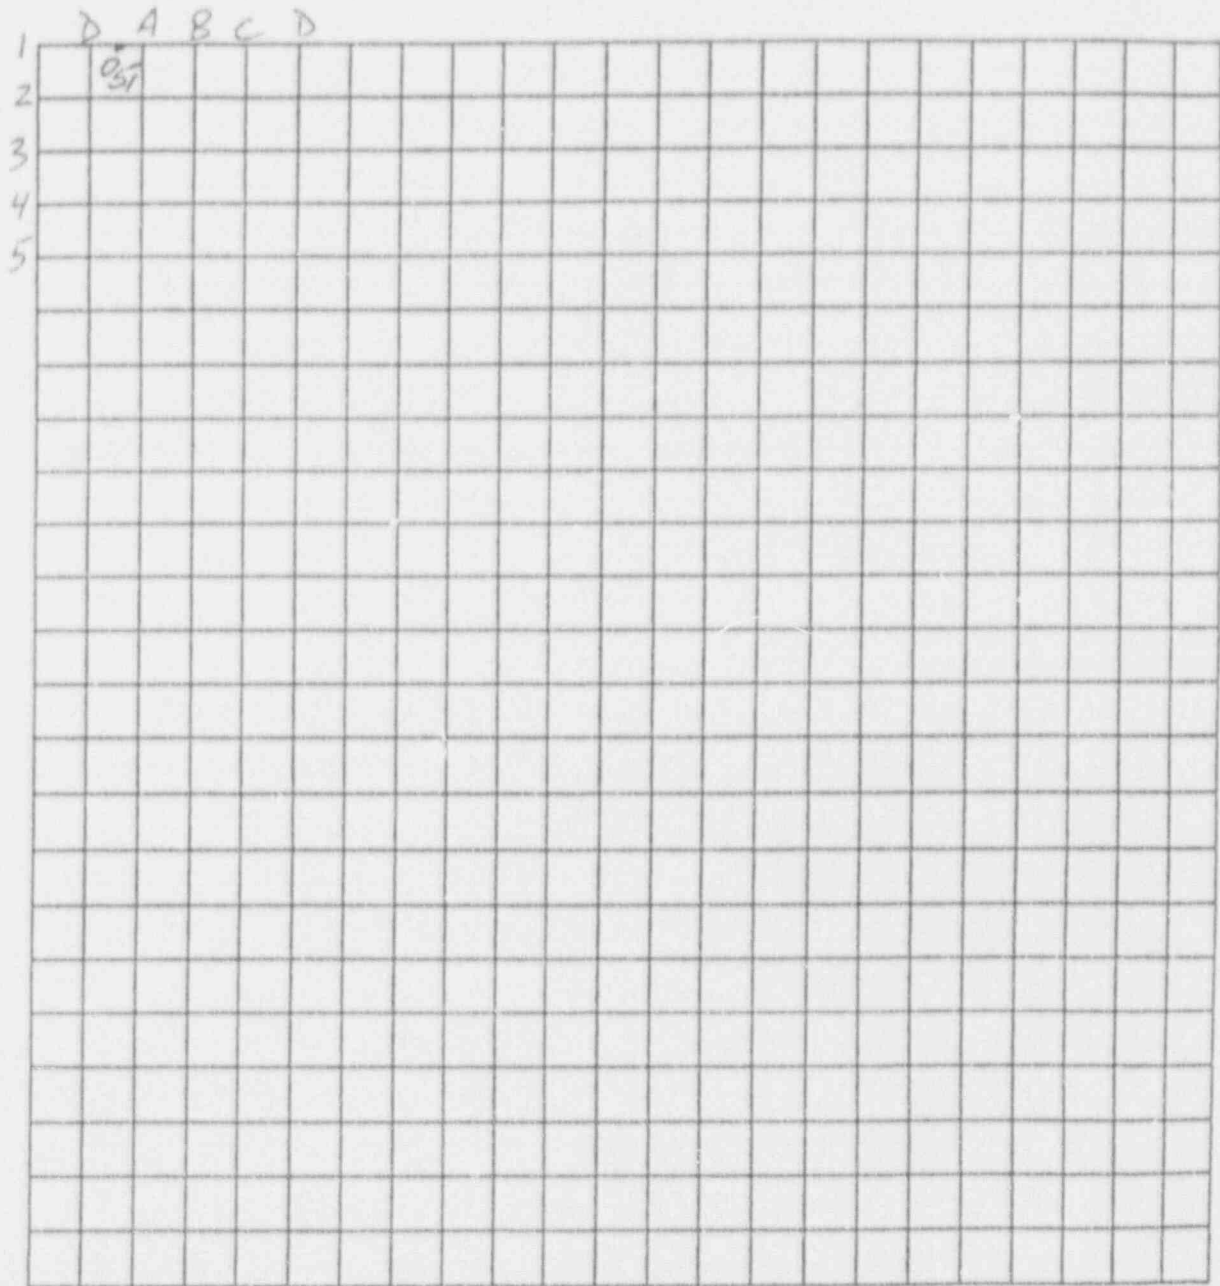
COMPONENT ID C 43 (FW 8-1) EXAMINER John Jackson DATE 9-1-92

A	B	C	D	RowMx	RowMn	Delta	Ave
1	0.142	0.153	0.157	0.139	0.157	0.139	0.018	0.148
2	0.150	0.150	0.161	0.153	0.161	0.150	0.011	0.154
3	0.150	0.150	0.153	0.153	0.153	0.150	0.003	0.152
4	0.150	0.153	0.153	0.153	0.153	0.150	0.003	0.152
5	0.150	0.168	0.153	0.153	0.168	0.150	0.018	0.156
	A	B	C	D	ColMx	ColMn	Delta	Ave
ColMx	0.150	0.168	0.161	0.153				
ColMn	0.142	0.150	0.153	0.139				
Delta	0.008	0.018	0.008	0.014				
Ave	0.148	0.155	0.155	0.150

Maximum Reading = 0.168 (5, B) Average = 0.150
Minimum Reading = 0.139 (1, D) Standard Deviation = 0.006
Total Readings = 20

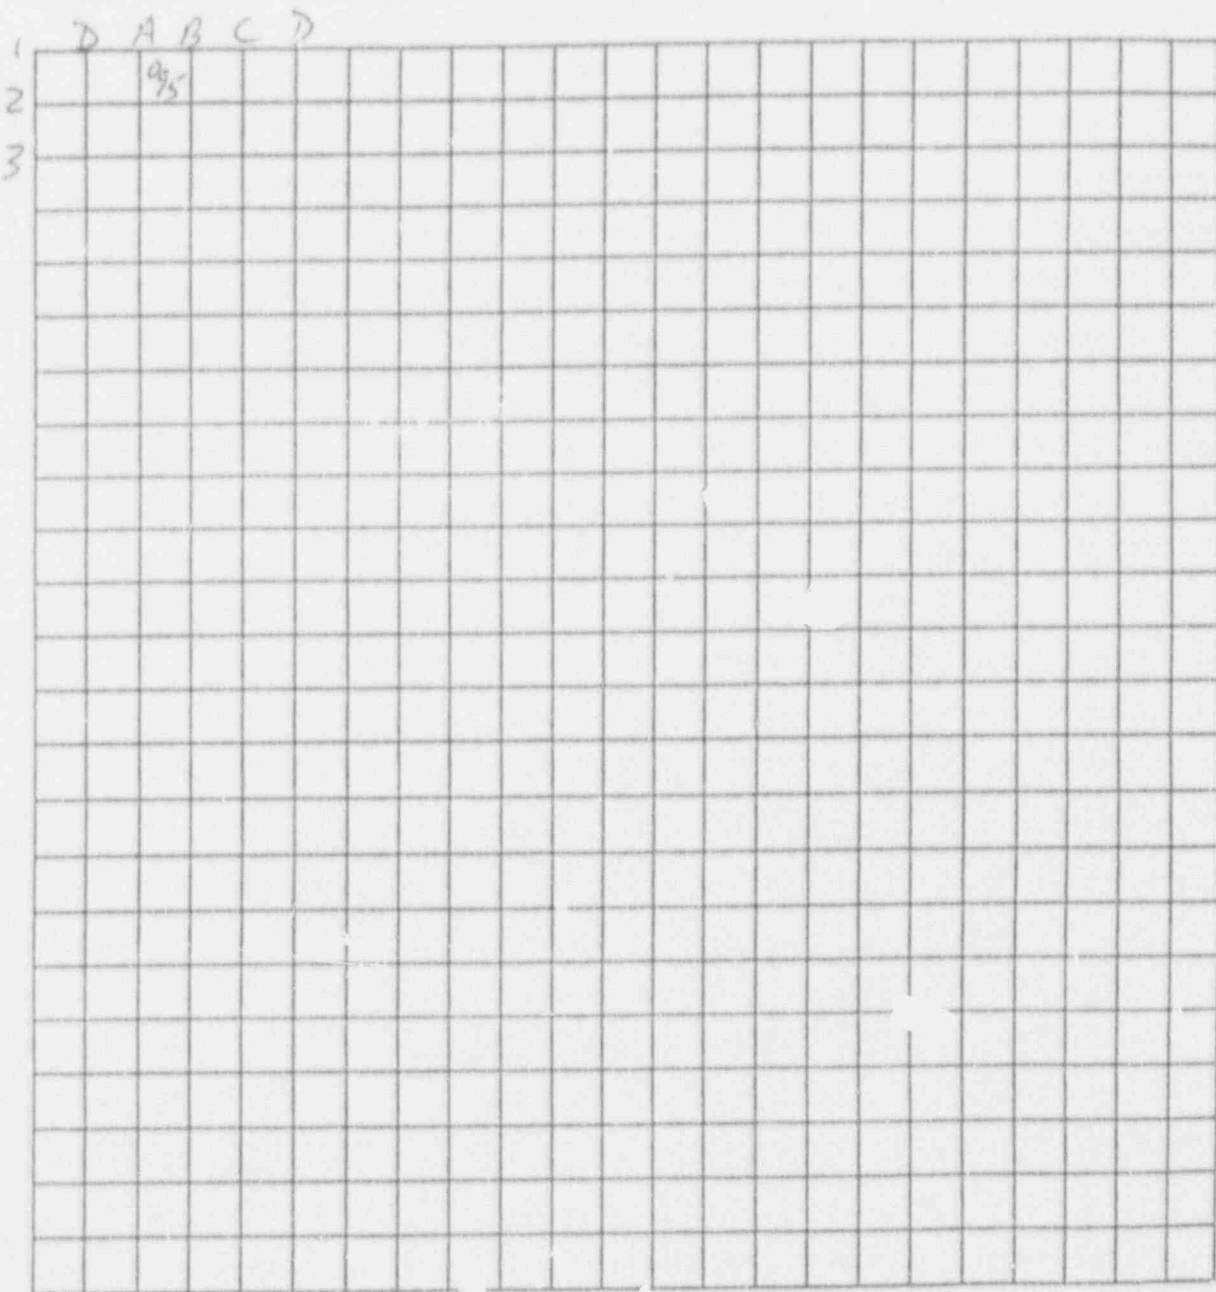
COMPONENT ID CS (Fw2) EXAMINER John Jacobson DATE 9-1-92

A	B	C	D	RowMx	RowMn	Delta	Ave
1	0.117	0.146	0.150	0.150	0.150	0.117	0.033	0.141
2	0.150	0.150	0.146	0.150	0.150	0.146	0.004	0.149
3	0.151	0.150	0.142	0.151	0.151	0.142	0.011	0.150
	A	B	C	D	ColMx	ColMn	Delta	Ave
ColMx	0.151	0.150	0.150	0.151				
ColMn	0.117	0.146	0.142	0.150				
Delta	0.036	0.004	0.008	0.001				
Ave	0.149	0.149	0.146	0.151

Maximum Reading = 0.151 (3, A) Average = 0.146
Minimum Reading = 0.117 (1, A) Standard Deviation = 0.010
Total Readings = 12
