UNITED STATES
NUCLEAR REGULATORY COMMISSION
WASHINGTON, D.C. 20555

FACILITY: Arkansas Nuclear One, Unit 2 (ANO-2)

SUBJECT: SUMMARY OF MEETING ON AUGUST 27, 1992, CONCERNING
THE STEAM GENERATORS AT ANO-2

**INFORMATION UPDATE
CONCERNING THE
ANO-2 STEAM GENERATORS**

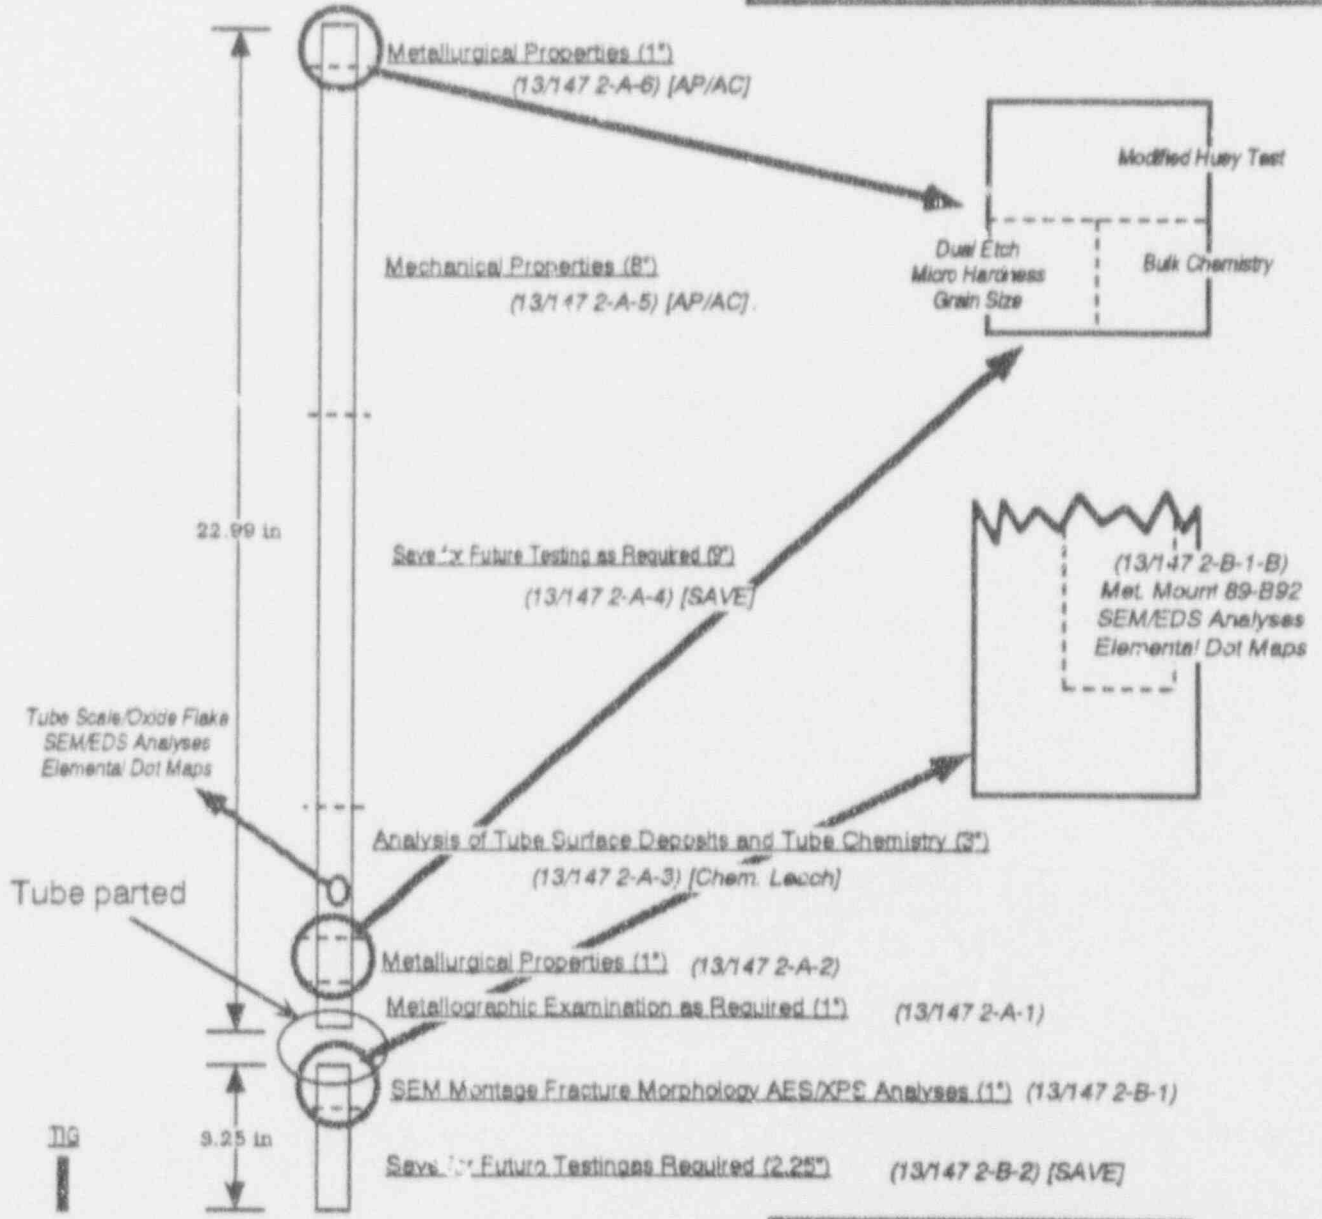
Figure 9-1. Sectioning Diagram for Steam Generator A Tube R13L147 Section 2.

X Ray - Part A Upper part, Distorted crack edge, some secondary cracks from lower part.
Part B Lower part, many secondary cracks

ECT Data:
 • MRPC 89% average TW
 80V Circ. Crack 360°
 • UT Average 61% TW
 with 100% TW

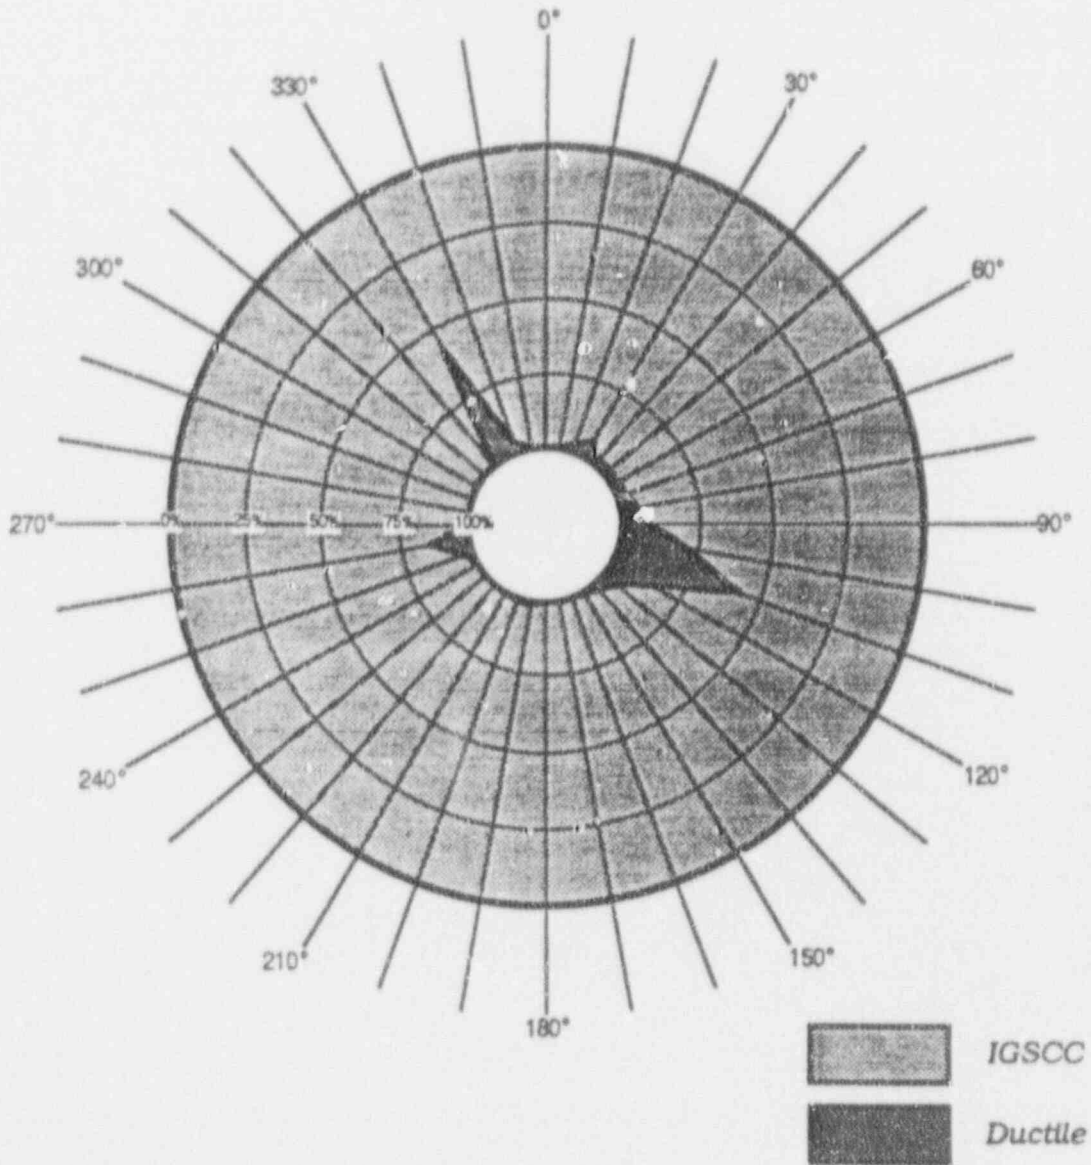
Figure 10-1. Degradation as a Function of Circumferential Location for Tube R13L147.

ANC Steam Generator "A"
Tube R13-L147
Through Wall Crack

Average Penetration 94%

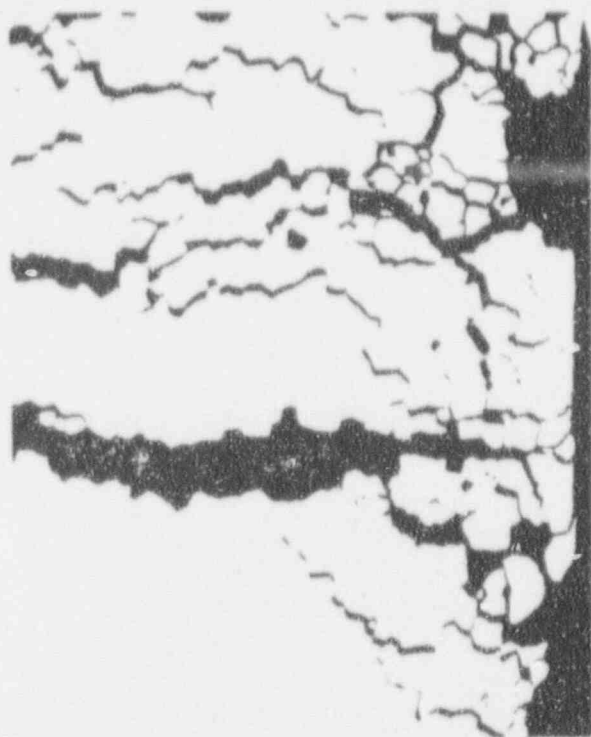
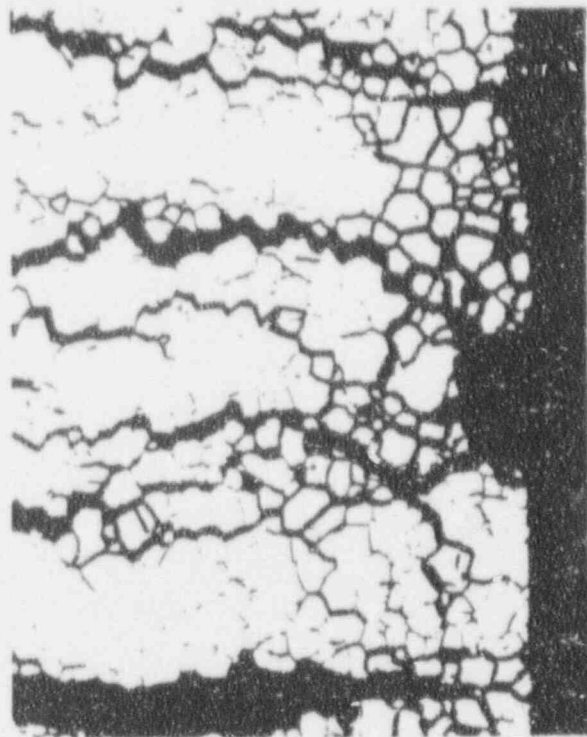
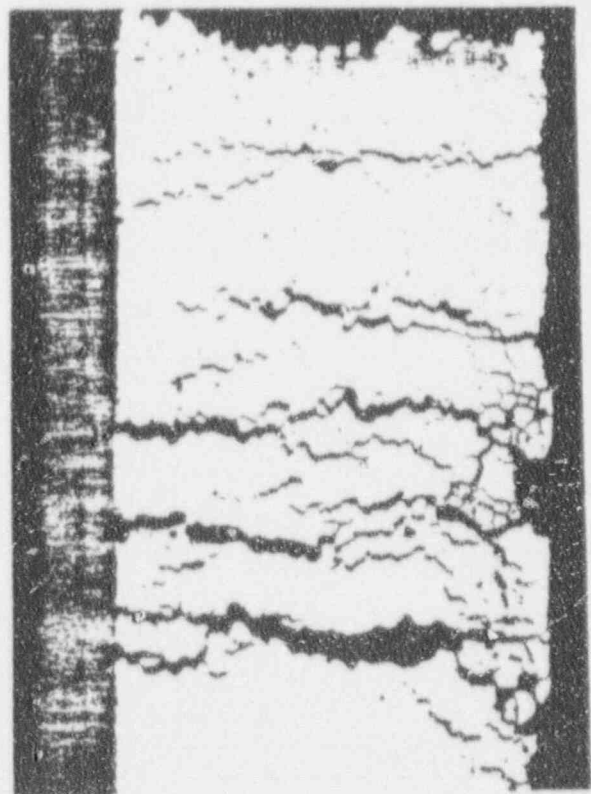
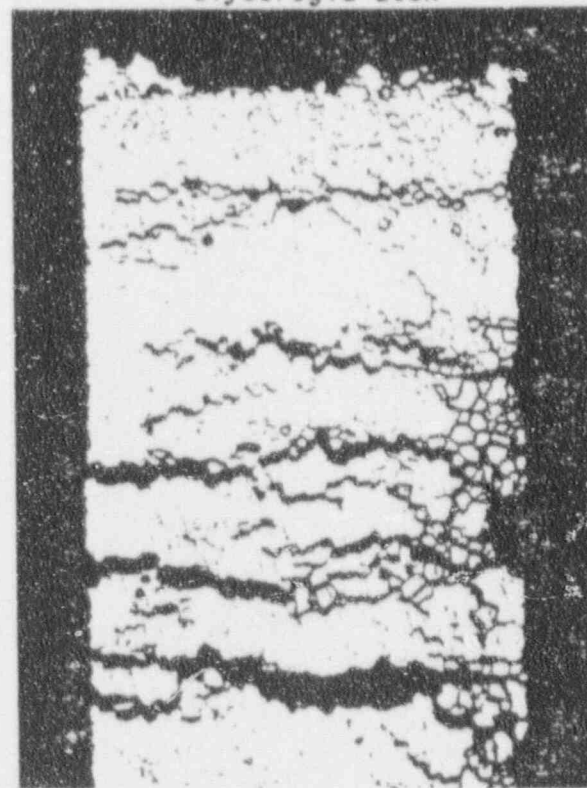
Figure 11-1. Light Photomicrograph of Seam Generator A Tube R13L147
Near the Fracture (Longitudinal View).

- ALL OD INITIATED
- ALL STRESS CORROSION CRACKING
- SUPERFICIAL OR NO IGA PRESENT
- NO EVIDENCE OF TRANSGRANULAR CRACKING
- NO EVIDENCE OF PWSCC
- AVERAGE DEPTH OF ATTACK RANGED FROM 88-94% TW
- ATTACK EXTENDED 360 DEGREES AROUND THE TUBES WITH 100% TW FOR 110-150 DEGREES OF THE CIRCUMFERENCE
- ATTACK APPEARED TO BE A COMBINATION OF INDEPENDENT CRACKS JOINED TOGETHER
- NO EVIDENCE OF PITTING OR ANY OTHER DAMAGE MECHANISM
- ATTACK LIMITED TO THE STRESSED EXPANSION REGION
- SLUDGE PILE IMPURITIES, INCLUDING LEAD AND SULFUR, ASSOCIATED WITH THE DEFECTS

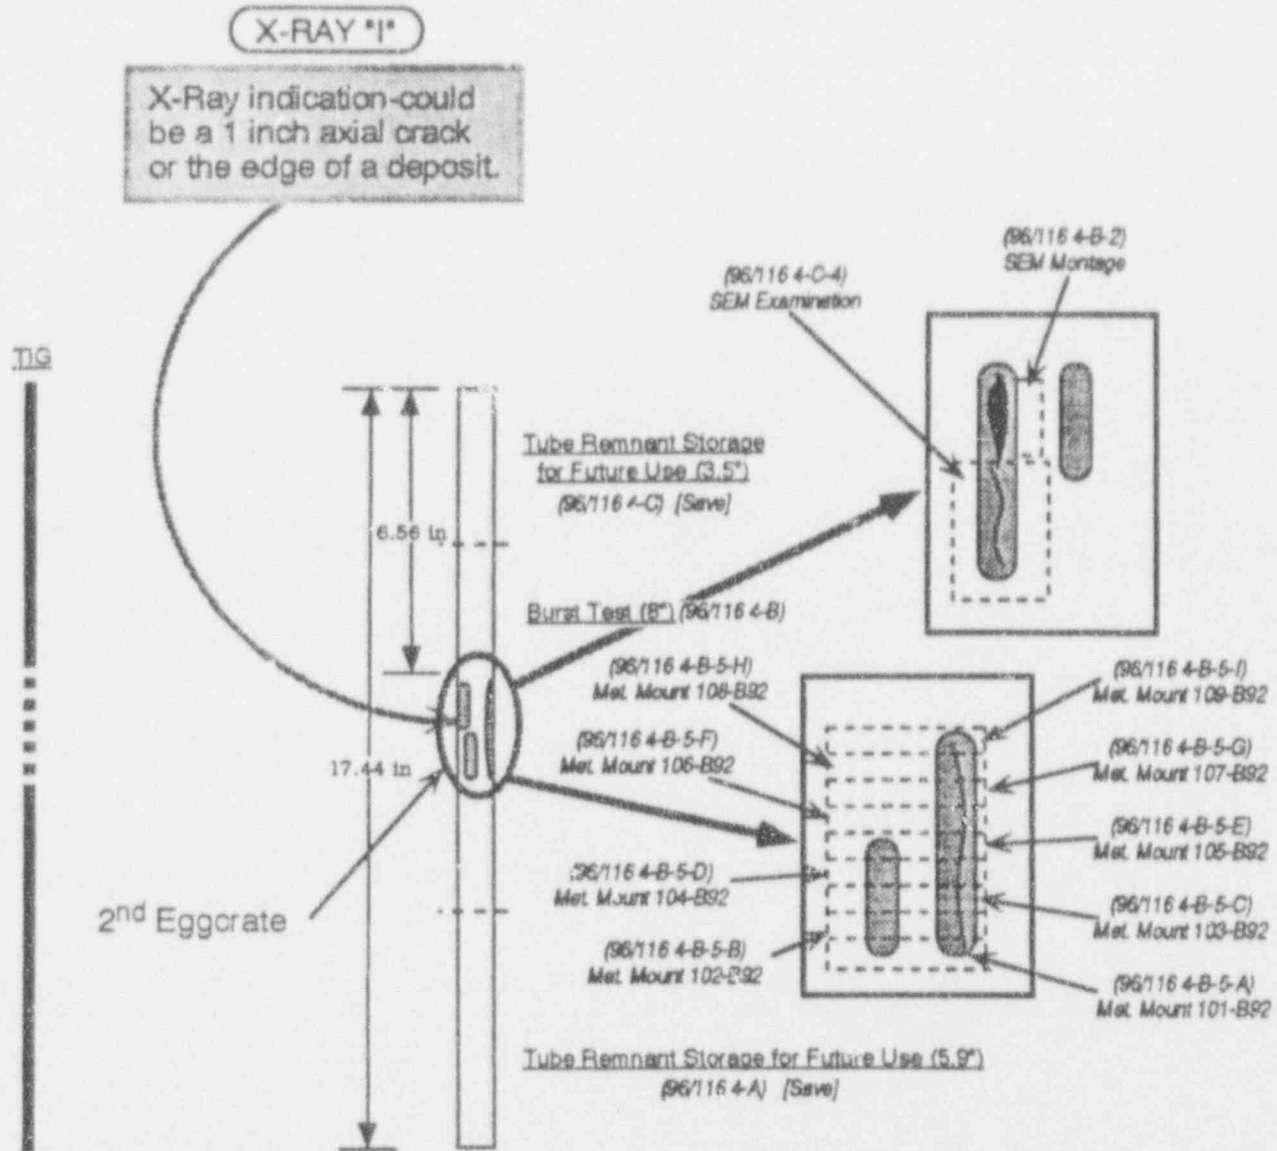
Tube 96/116 Section 4

- Bobbin Coil 1% TW 0.99 V
0.44 in. above Support CL
- MRPC Axial Indication 30% TW
0.51 in. long

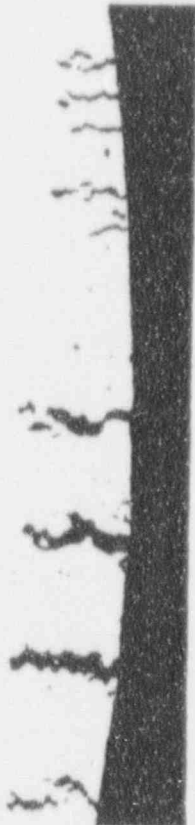
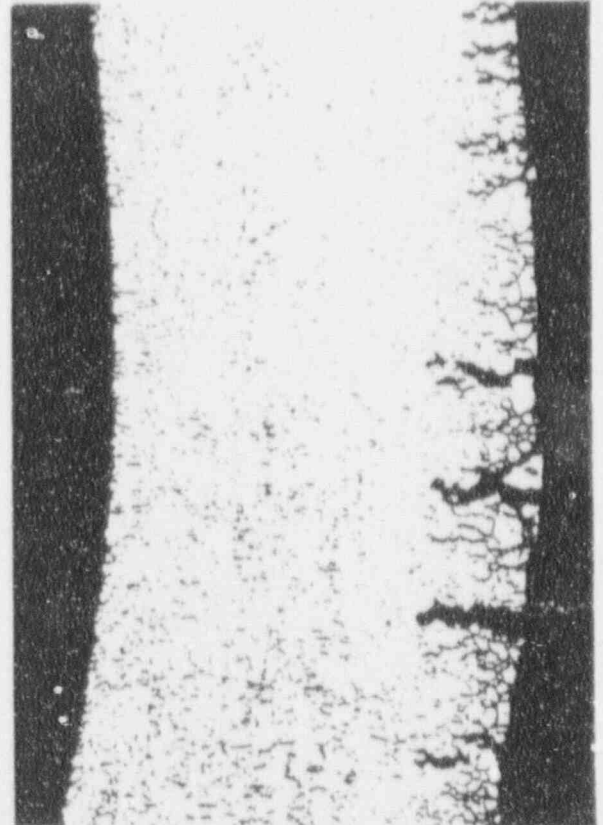
Figure 11-15. Light Photomicrographs of Steam Generator A Tube R96L116 at EC 2. IGSCC in Area of Contact with 2 inch Support Strap (Transverse View).

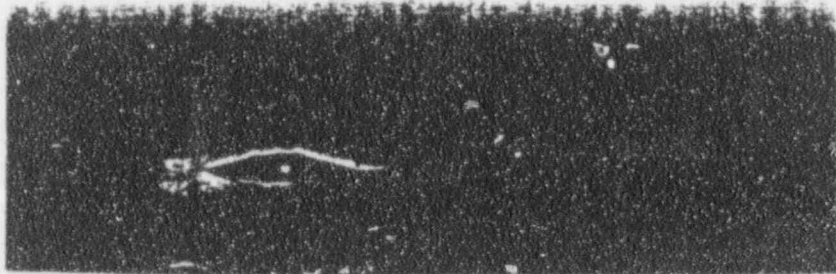
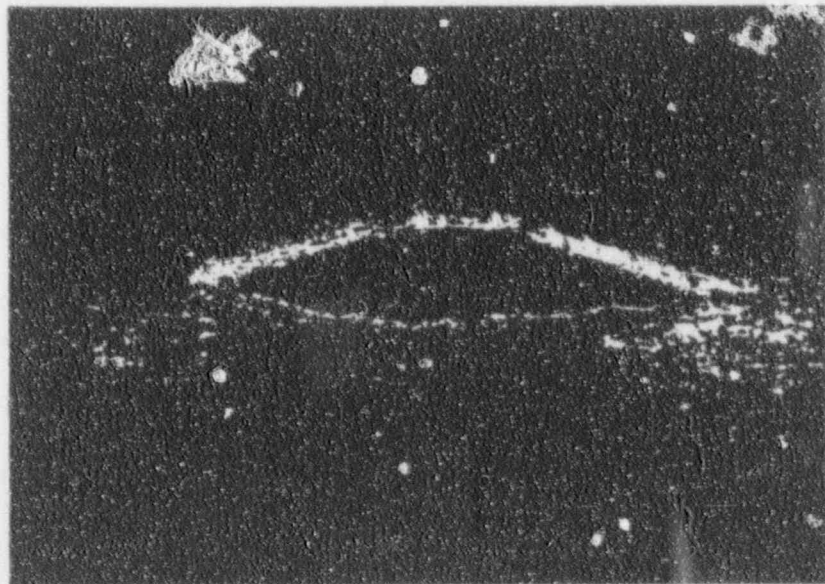
Figure 8-2. Tube R96L116 EC2 Burst Test Specimen After Test.

- * EGGCRATE #2 FROM TUBE R96/L116 BURST AT A ROOM TEMPERATURE PRESSURE OF 8,123 PSIG. THIS CORRELATES TO A BURST PRESSURE OF 6,961 PSIG AT 607 DEGREES.
- * EGGCRATE #1 FROM TUBE R19/L55 BURST AT A ROOM TEMPERATURE PRESSURE OF 9,810 PSIG. THIS CORRELATES TO A BURST PRESSURE OF 8,407 PSIG AT 607 DEGREES.
- * IN THE EGGCRATE SAMPLES, THE FAILURES ALL OCCURRED AT THE 2 INCH TUBE TO TUBE SUPPORT CONTACT POINT
- * NUMEROUS SMALL SECONDARY CRACKS PARALLEL TO THE FAILURE WERE OBSERVED. ALL CRACKS REMAINED WITHIN THE TUBE TO TUBE SUPPORT CONTACT REGION, WITH THE MAXIMUM EXTENT BEING 1.905 INCHES
