Serial No. 92-566A  
NL&P/EJW  
Docket No. 50-338  
License No. NPF-4

**VIRGINIA ELECTRIC AND POWER COMPANY**  
**NORTH ANNA POWER STATION UNIT 1**  
**SUPPLEMENT TO ASME SECTION XI RELIEF REQUEST**

Relief Request For Engineered Mechanical  
Clamp on Main Steam Line Drain Piping  
Supplemental Information

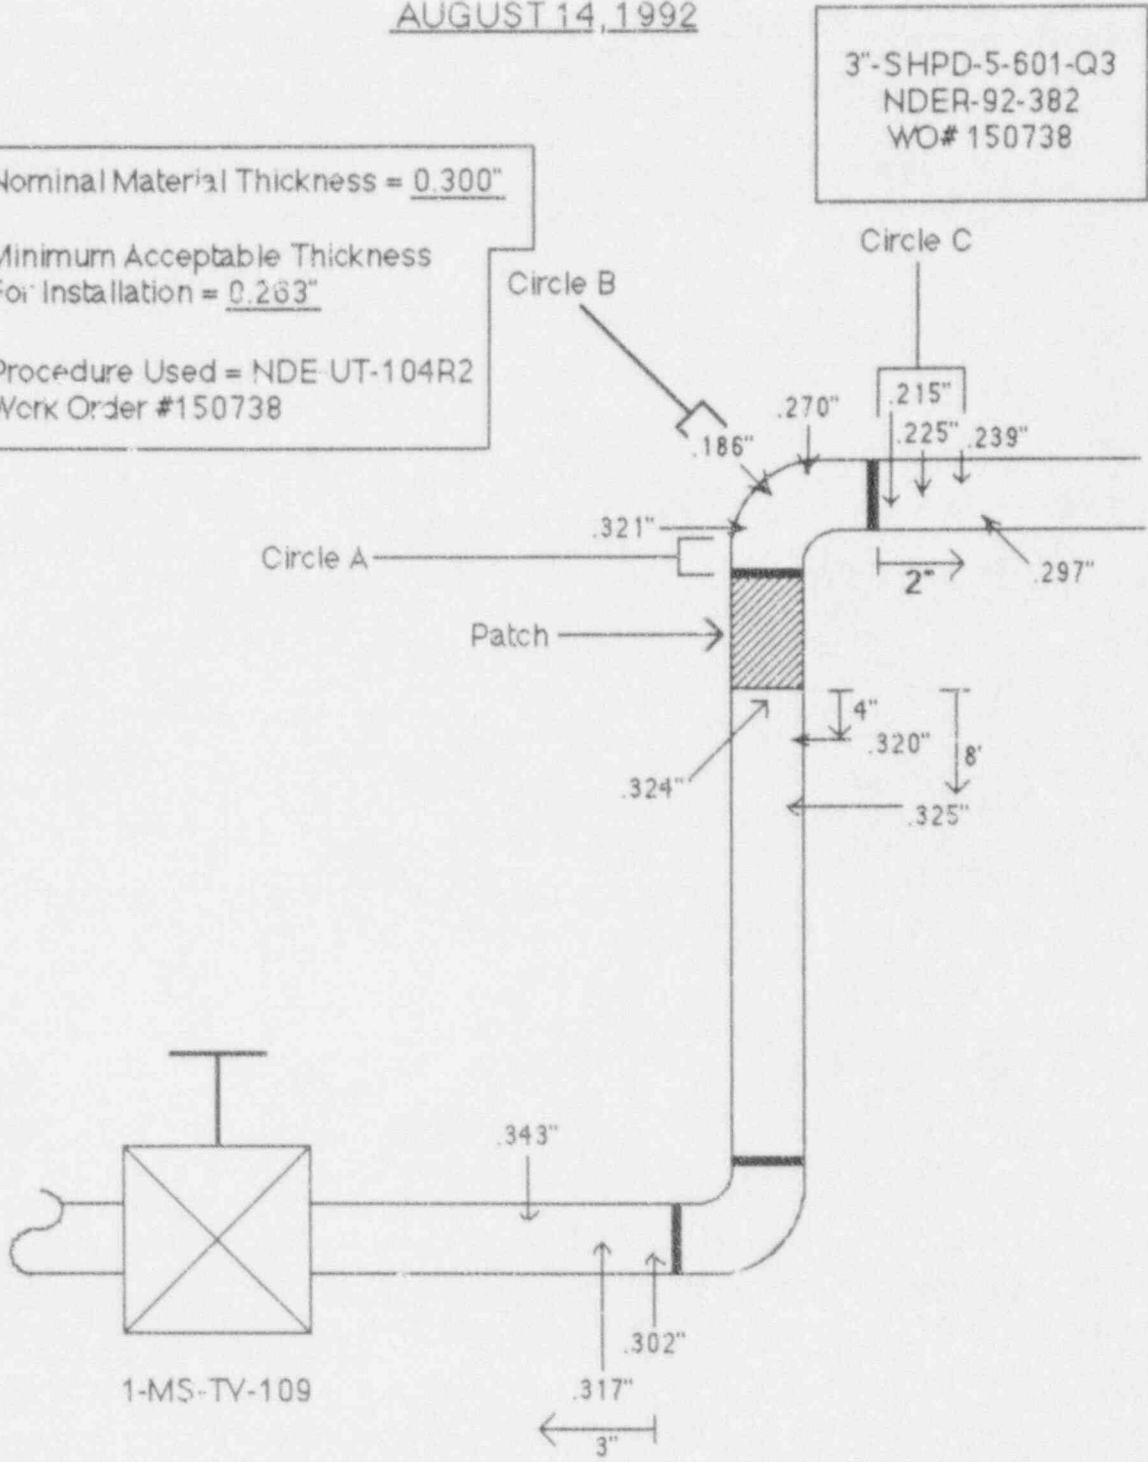
3"-SHPD-5-601-Q3  
NDER-92-382  
WO# 150738

Nondestructive examinations performed on the affected section of line 3"-SHPD-5-601-Q3 consisted of initial ultrasonic examinations of several areas both upstream and downstream of the pinhole leak (primarily centered around the elbows immediately upstream of 1-MS-TV-109) and ultrasonic examinations of three circular cross-sections of the affected pipe. The results of these examinations are provided in Attachment 1 to this document.

Nominal Material Thickness = 0.300"  
Minimum Acceptable Thickness  
For Installation = 0.263"  
Procedure Used = NDE UT-104R2  
Work Order #150738

**NOTE:** Detailed readings were taken for the 'Circle' areas and are identified on Page 2 of 2.

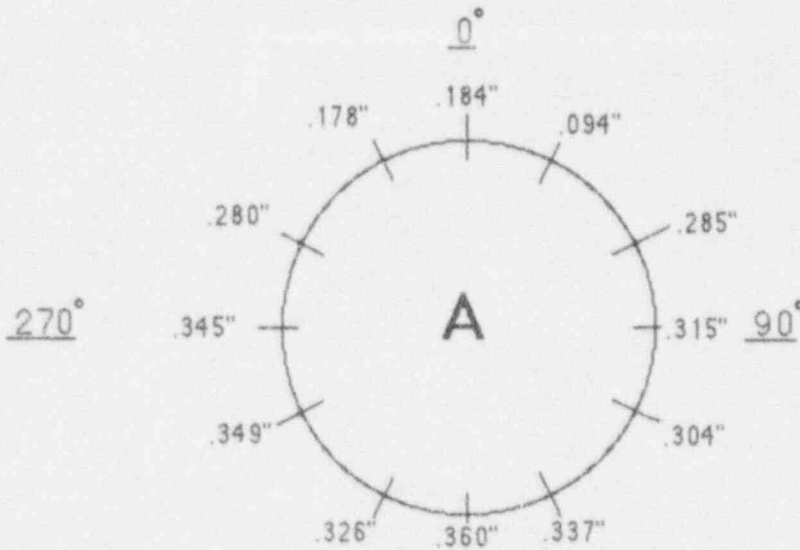
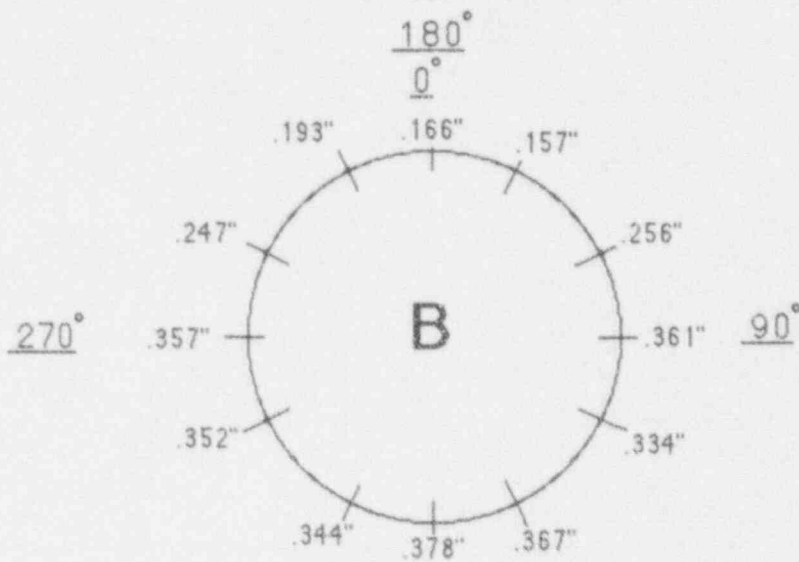
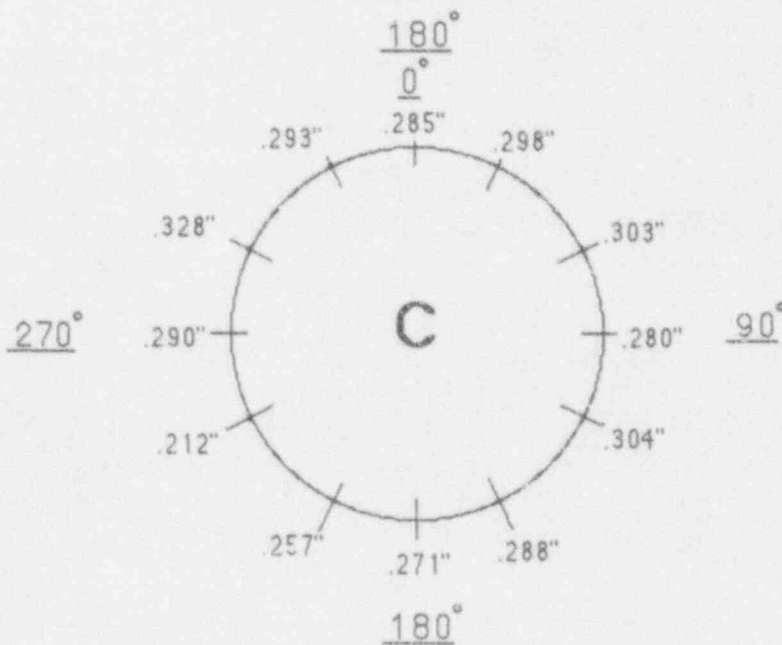
CIRCLE READINGS  
AUGUST 14, 1992

0° is Extrados of Elbow, readings taken every 30°, taken looking downstream.
