EVALUATION OF A FAILED RIVERWATER
PUMP SHAFT COUPLING FROM
THE BEAVER VALLEY POWER PLANT

C. J. CZAJKOWSKI

JUNE 1992

Nuclear Waste and Materials Technology Division

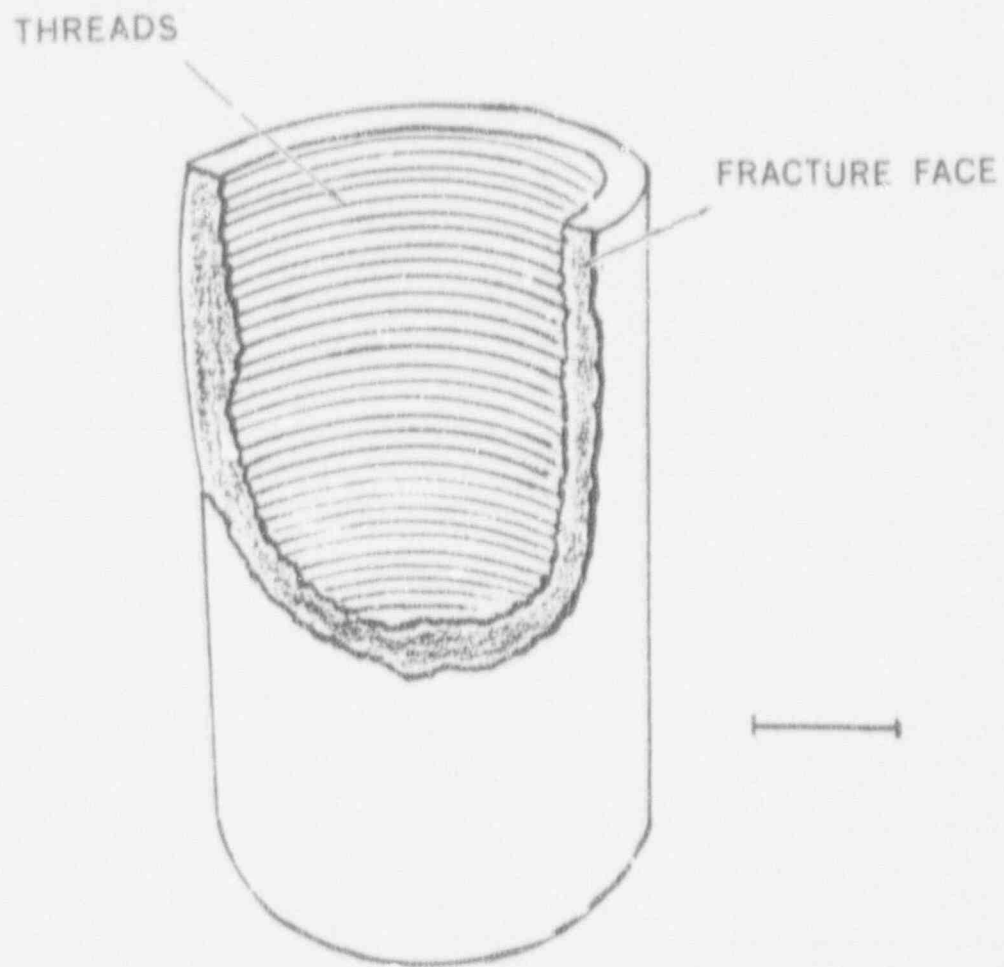
A broken coupling (Figure 1) was received at BNL. The coupling had been sectioned into six pieces by Lehigh University personnel prior to shipment.

Visual inspection of the pieces showed an oxide coating on the fractures and the appearance of worn threads on the inside surface of the coupling. Various sections were cut from the fracture face for SEM evaluation, while other sections were cut for the mechanical and chemical analysis specimens.

Figure 1 Sketch of broken riverwater pump shaft coupling from Beaver Valley Plant.

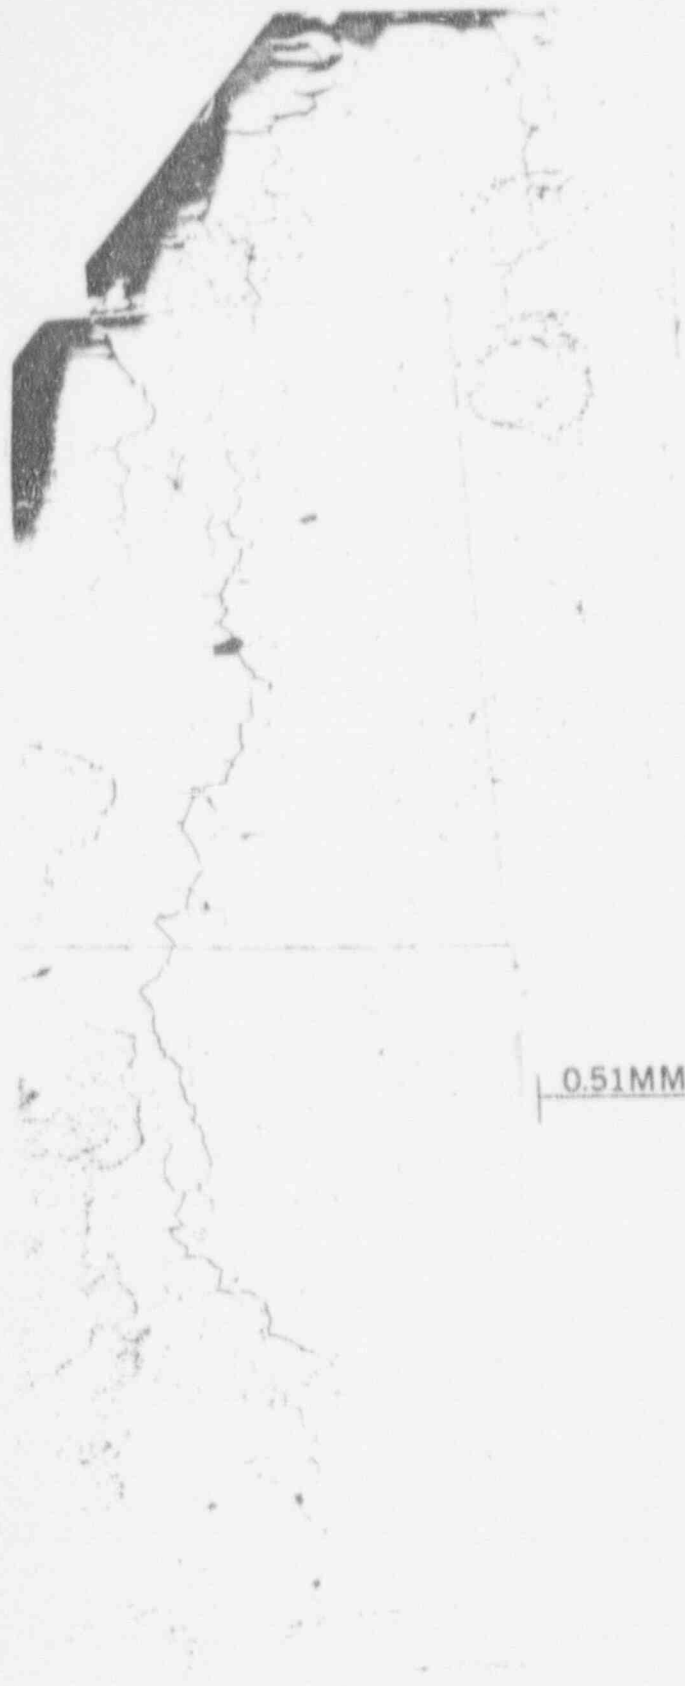
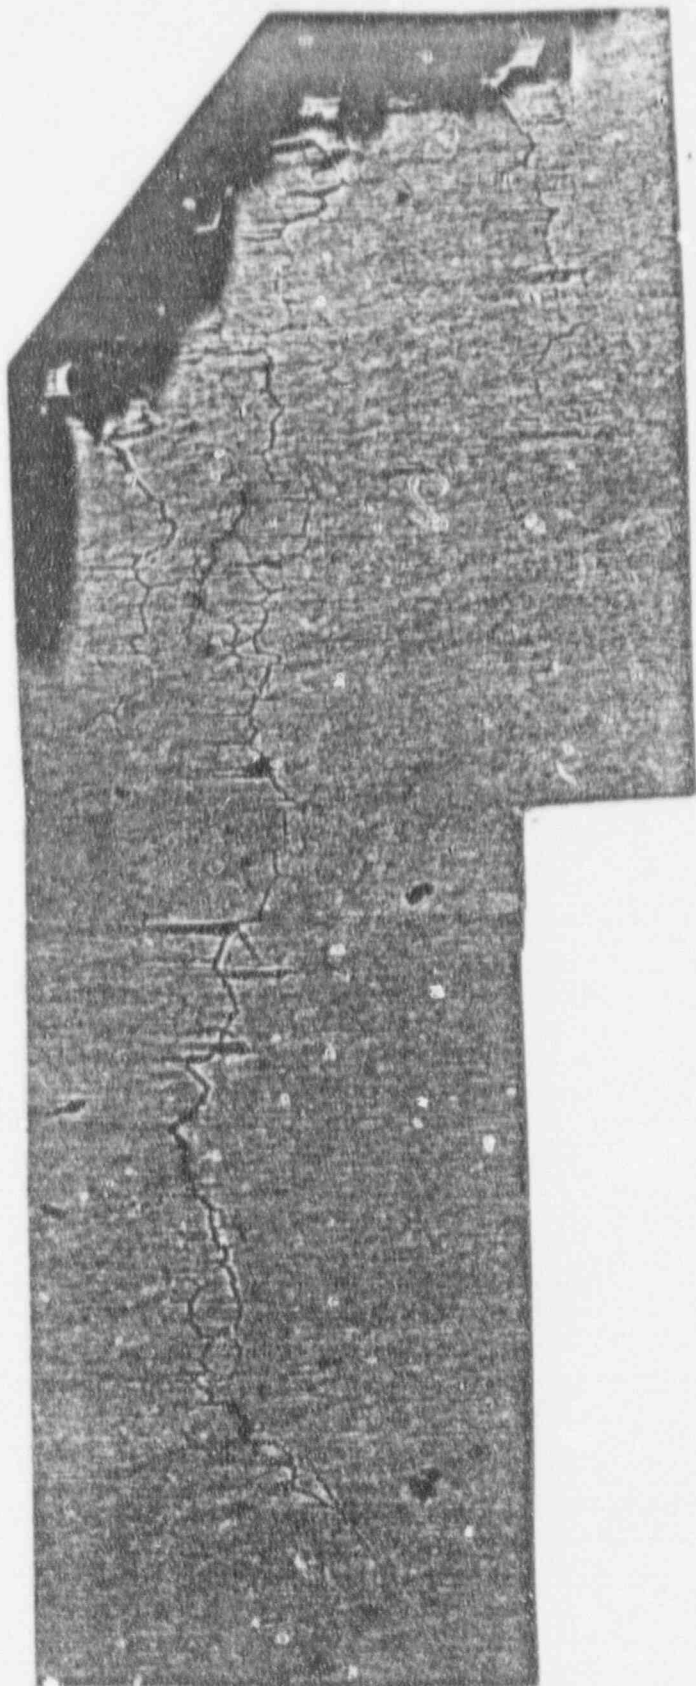
Figure 2 is a low magnification photomicrograph of the area of cracking on the mounted specimen. The crack was intergranular with the cracking following prior austenite grain boundaries as seen in Figure 3. The material structure was that of tempered martensite (Figure 4) which is typical for the 410 stainless steel alloy.

Figure 2 Low magnification photograph of optical mount -A- (unetched) -B- (etched).

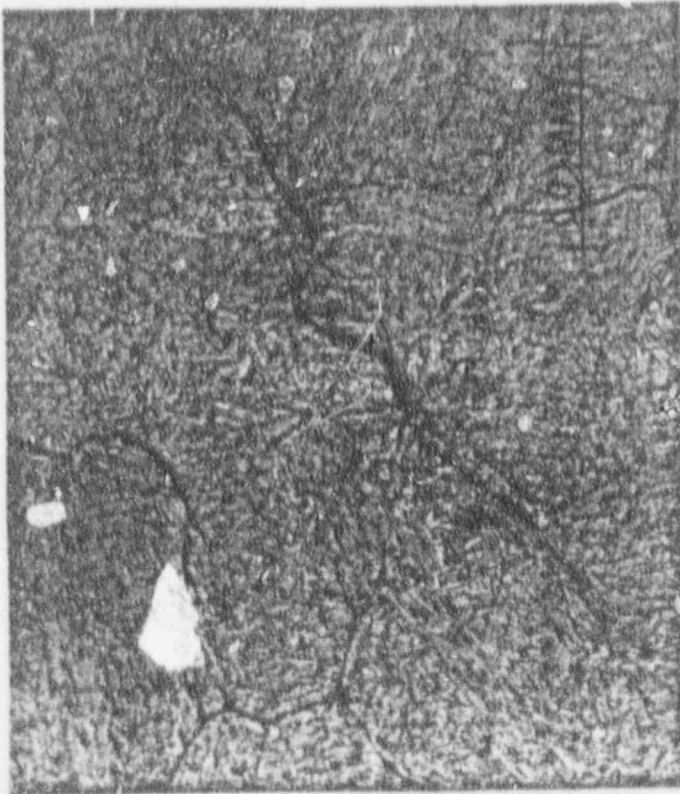
Figure 3 Higher magnification photomicrograph showing cracks following prior austenite grain boundaries (intergranular).

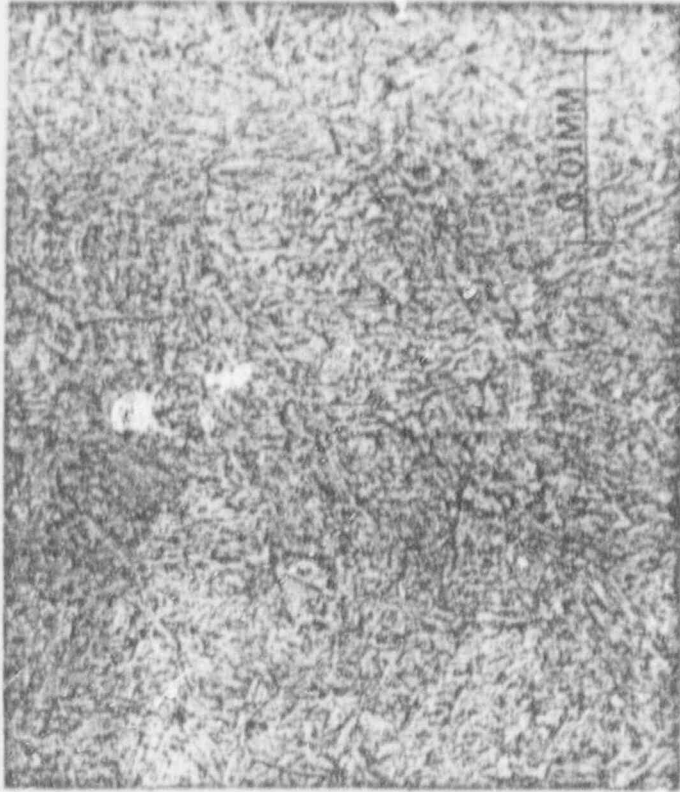
Figure 4 This photomicrograph depicts the structure of the coupling as tempered martensite.

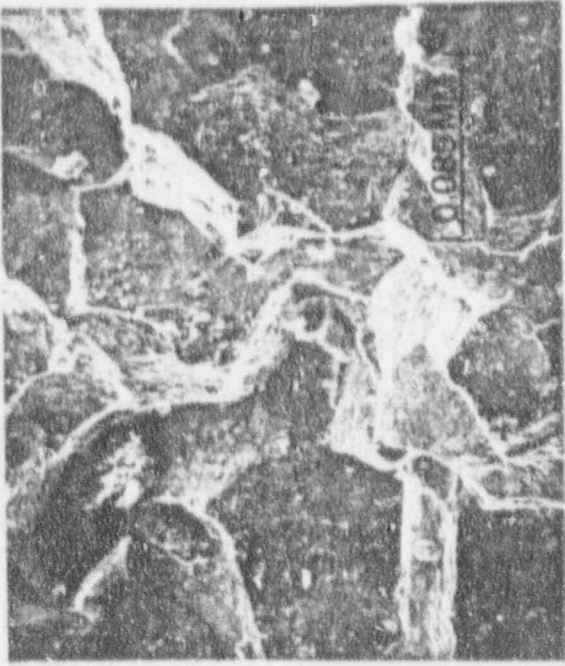
Various fracture areas were examined along the fracture face of the crack (Figure 1). The fracture surfaces were covered by an oxide film (Figures 5a-c) and were definitely intergranular. After initial examination, the specimens were deoxidized using an electrolytic process as follows:

Figure 5a SEM photo of fracture showing intergranular cracking.

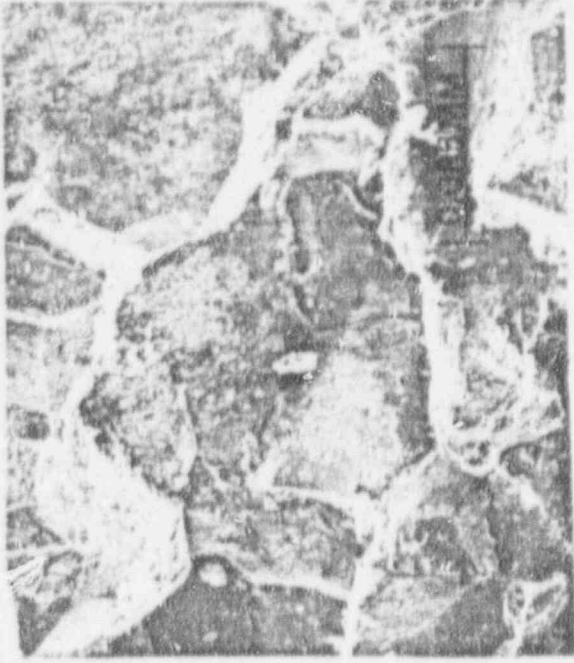
Figure 5b The cracking in this section was also intergranular.

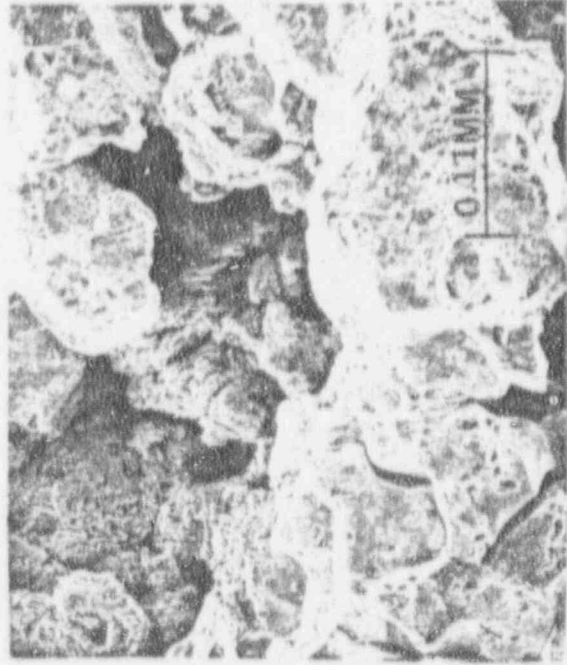
Figure 5c Definite intergranular cracking was seen in this third area examined.

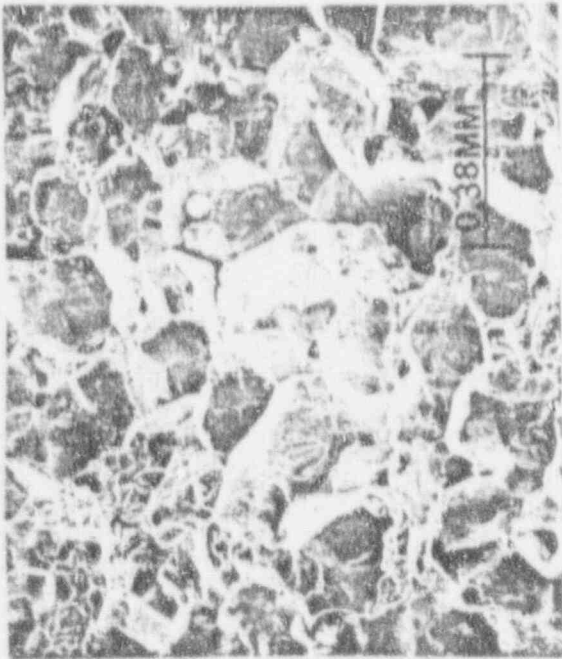
The specimens were reexamined after this treatment by SEM (Figures 6a-c). There was no evidence of fatigue interaction (beach marks, etc.) nor indication of other than an intergranular mode of failure.

Figure 6a Fracture after deoxidation treatment
(intergranular).

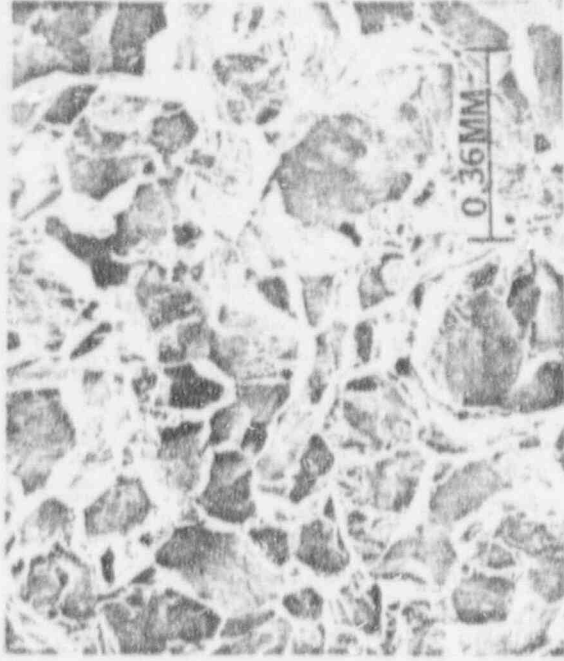
Figure 6b Second area also showing intergranular
fracture.

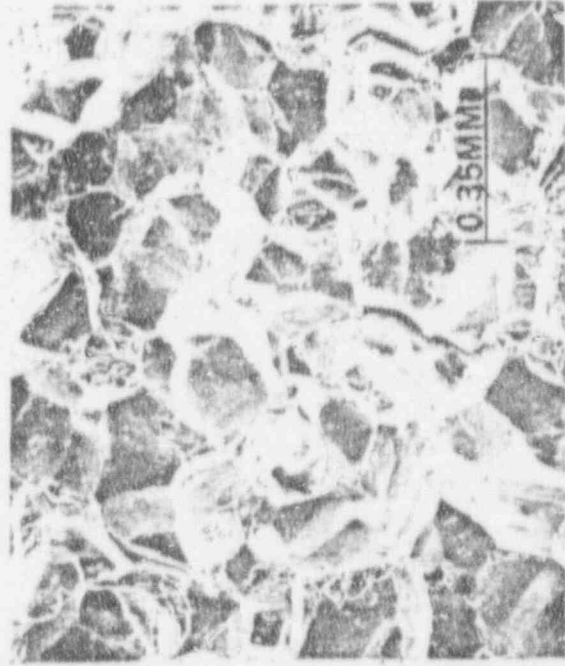
Figure 6c Third area examined - typically
intergranular.

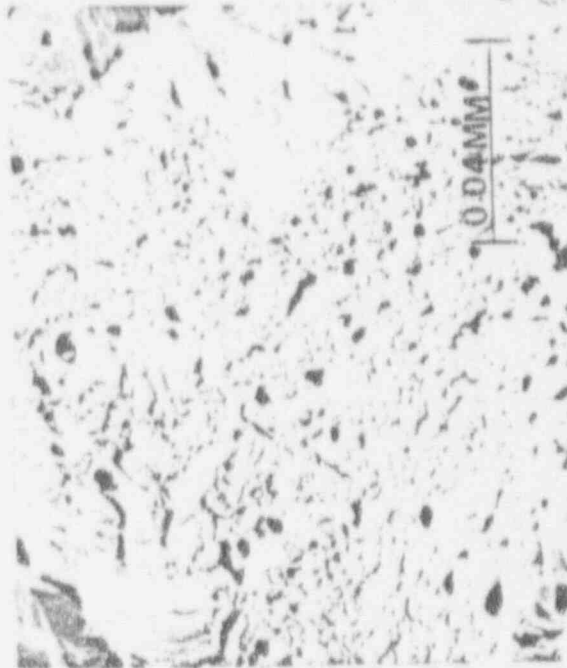
Figure 10b Higher magnification photo of specimen 4 show same type failure as seen in specimen 1 (Figure 9b).

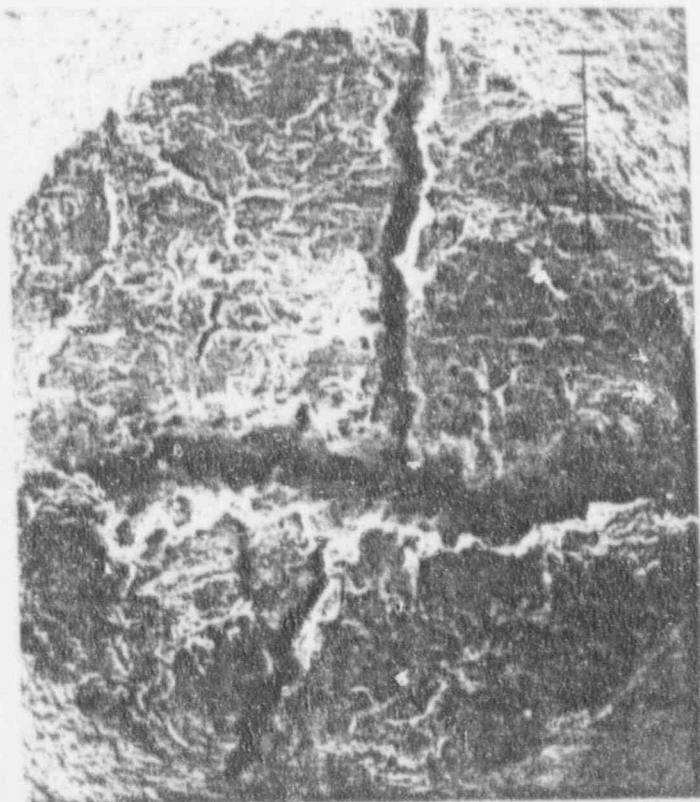
rupture) is present on both of the specimens. The secondary cracking and decohesion of apparent grain boundaries are a clear indication that the material was somehow embrittled.

Figure 9a SEM photo tensile specimen 1.

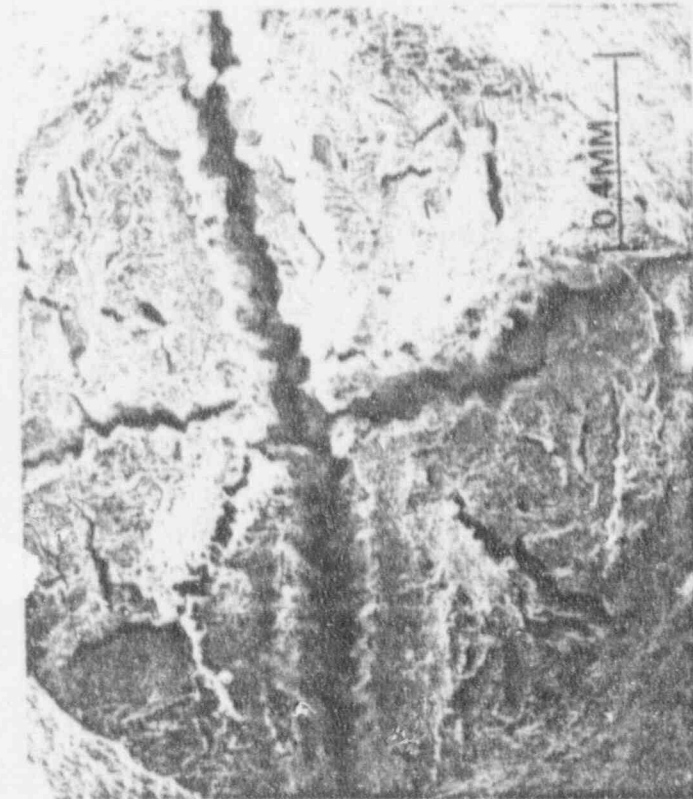
Figure 10a SEM photo of tensile specimen 4.

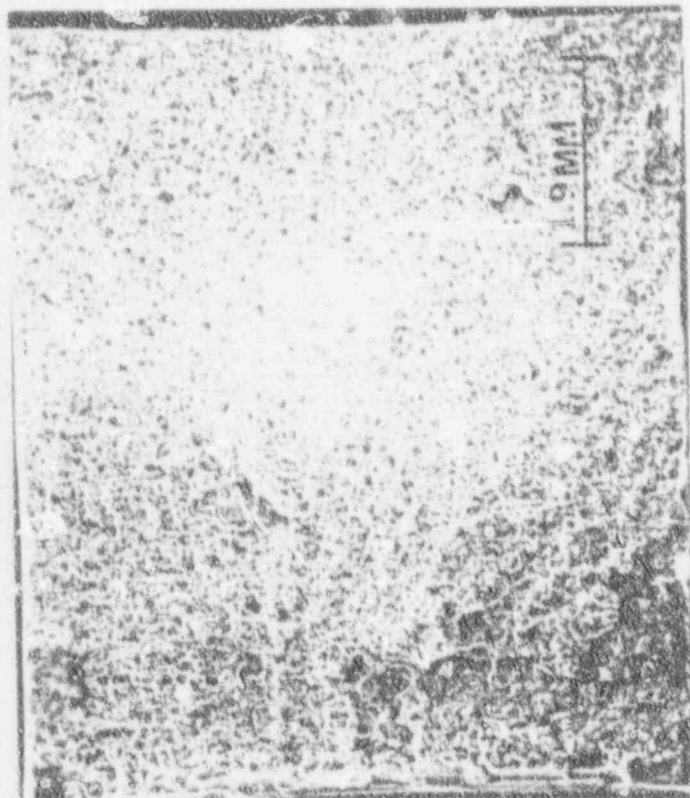
The "as received" and the vacuum degassed specimens (C1, C2, C4 and C6) were virtually 100% intergranular with no apparent area of shear fracture (Figures 11a - 14b).

Figure 11a The fracture face for impact specimen C1 was essentially all intergranular.

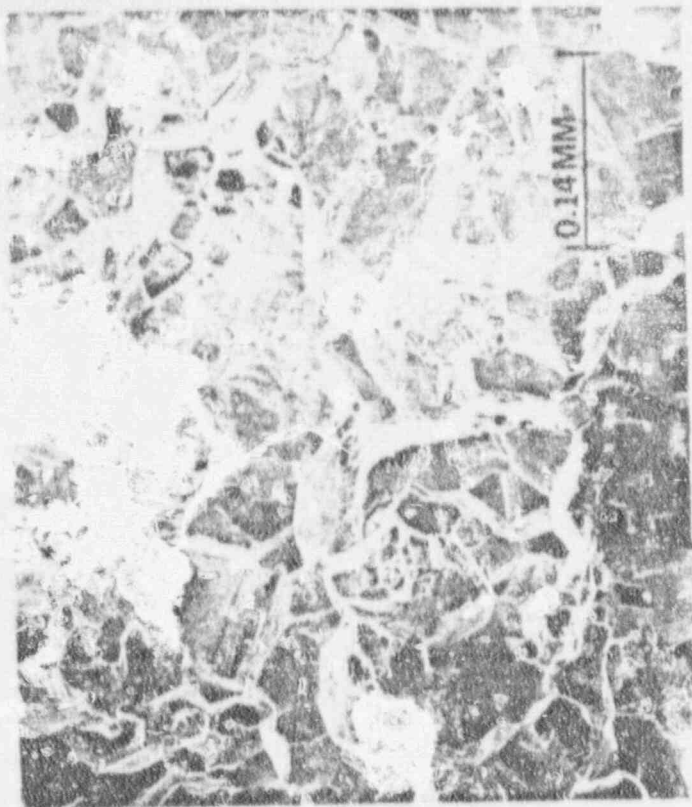
Figure 11b Higher magnification fractograph showing intergranular features.

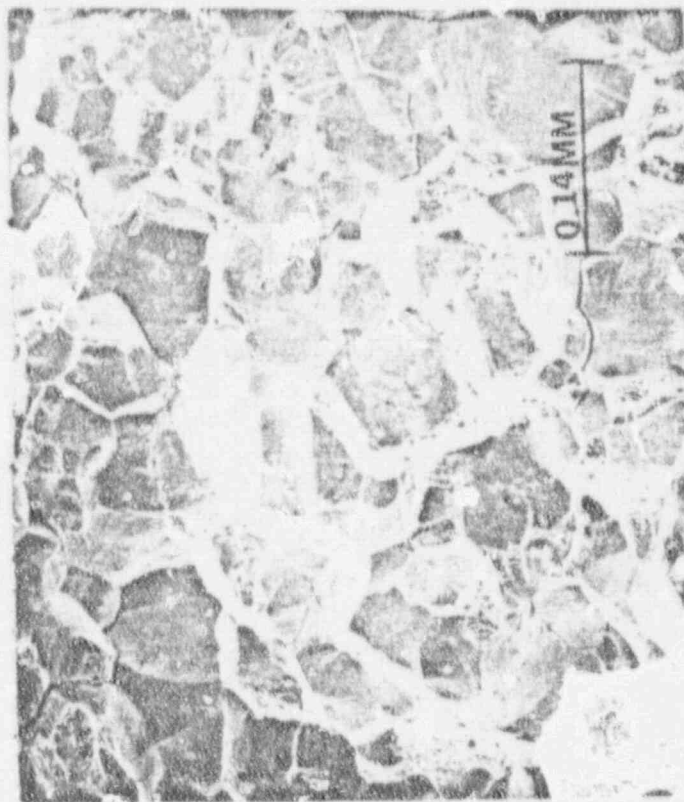
Figure 11c Higher magnification fractograph of C2.

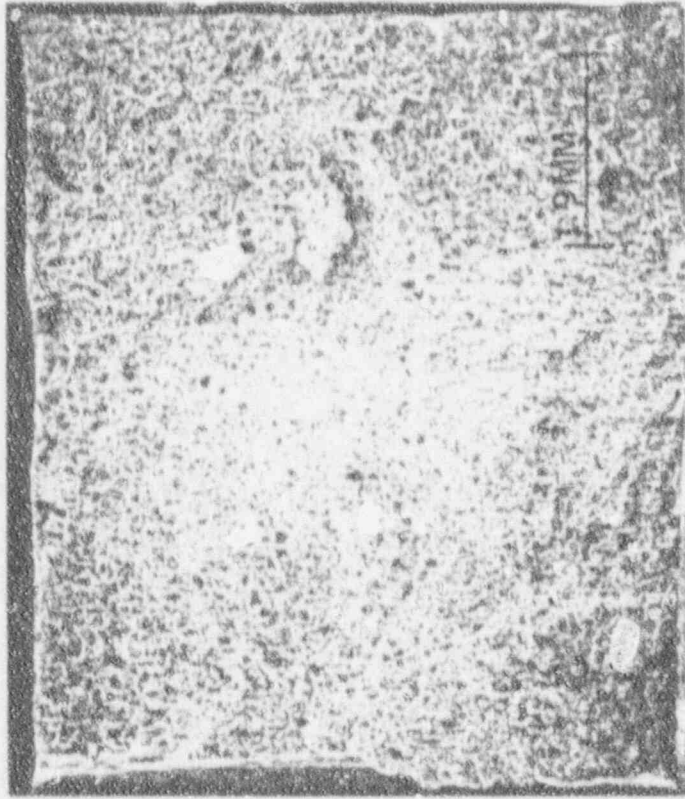
14 Figure 13a C4 fracture face was also intergranular.

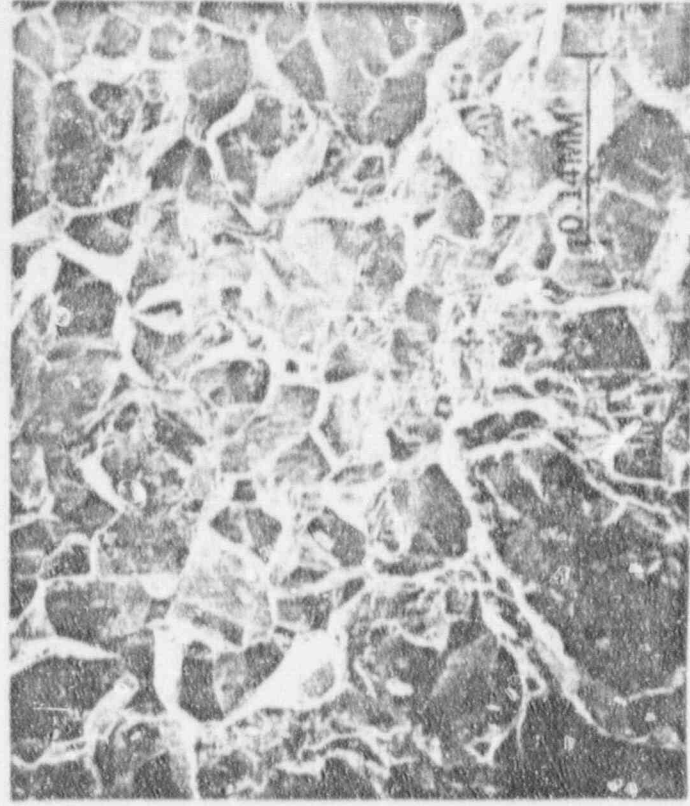
Figure 13b Intergranular facets are clearly evident on C4

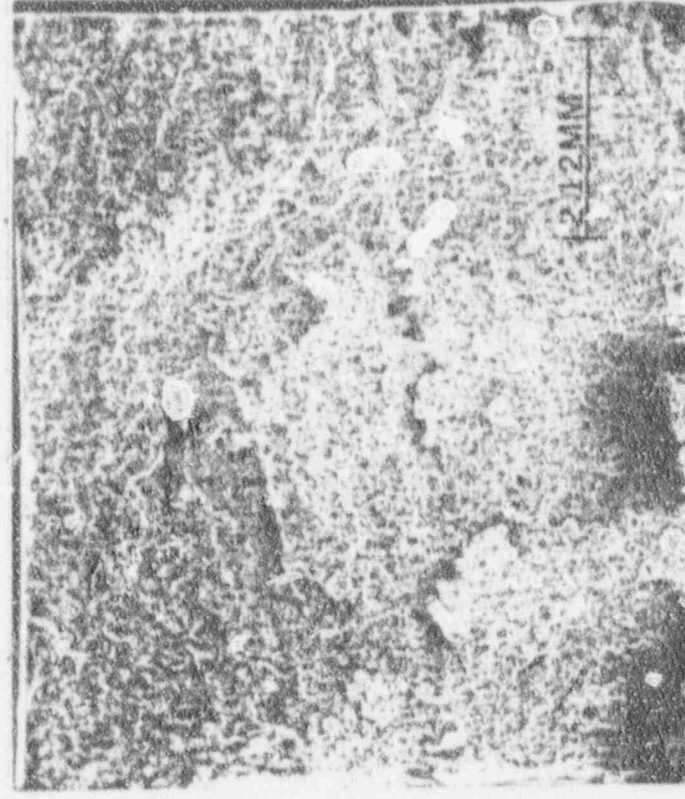
Figure 14a C6 fracture face was also essentially all intergranular

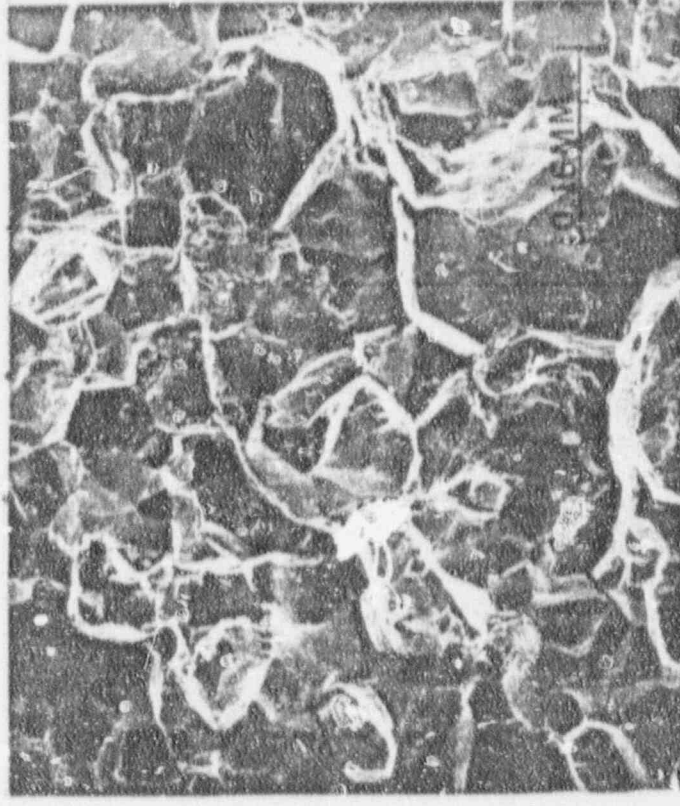
Figure 14b Higher magnification fractograph of C6.

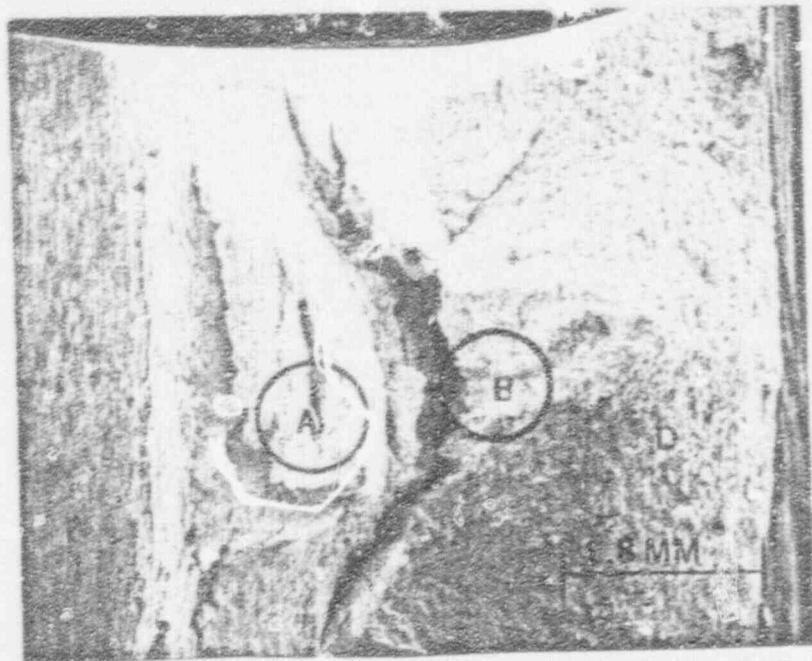
Figure 15a Low magnification fractograph of C7.
 Area A - shear fracture;
 Area B - quasi cleavage area
 broken at liquid N₂ temperatures.

This specimen displayed a shear fracture for all of the specimen which broke in the impact test (Figure 15b) with the remainder of the specimen (Figure 15b) exhibiting quasi-cleavage failure as a result of the liquid nitrogen immersion and subsequent separation.

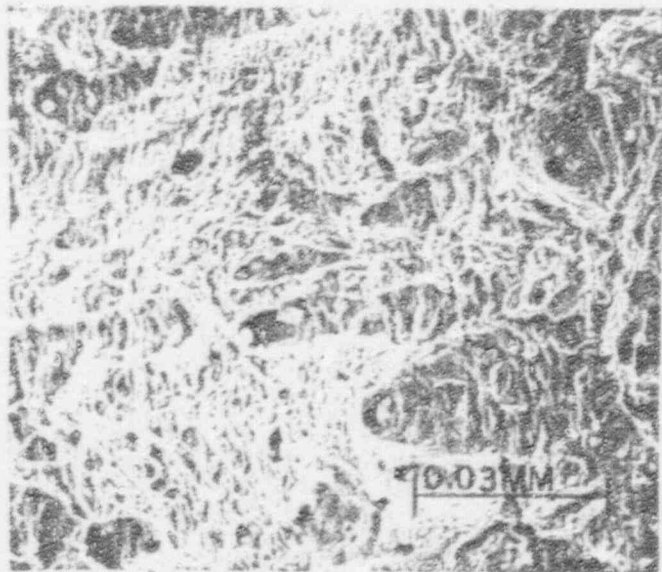
Figure 15b Dimpled rupture failure is characteristic
 of Area A.

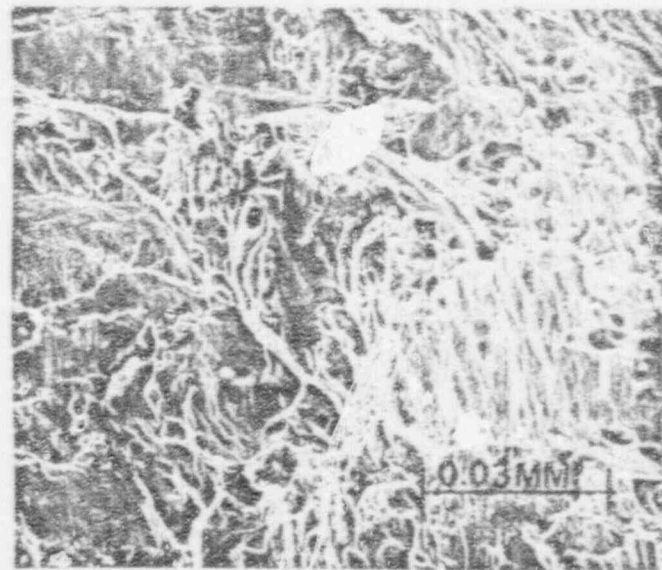
Figure 15c Quasi-cleavage failure of Area B
 was typical.

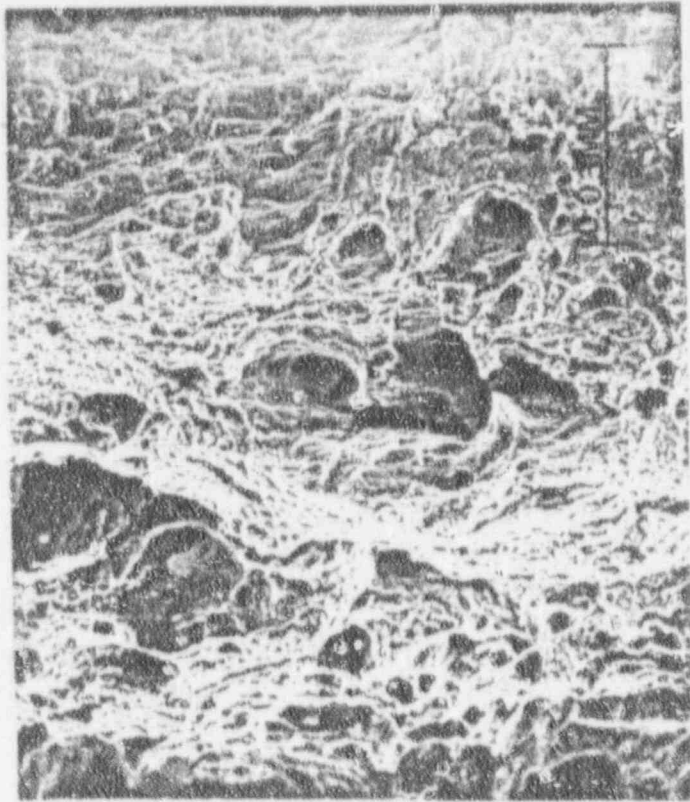
This dimpled rupture shear fracture was also found on specimen C8. Virtually all of the fracture face (over 90%) failed by shear (Figures 16a and 16b). This is a clear indication that the embrittlement process is reversible.

Figure 16b The ductile nature of the fracture is evident in this higher magnification fractograph of C8.

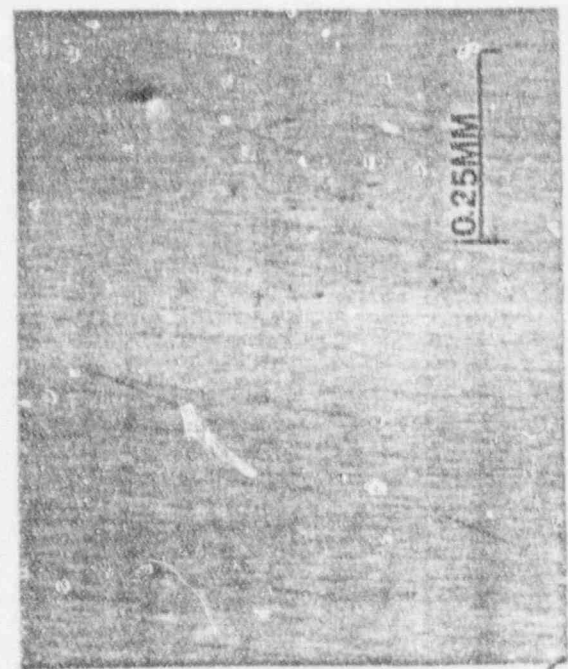
After immersion of the specimens for 7 minutes, they were examined by visible light microscopy. Initial examination of the section from specimen C8 (1300°F heat treatment and oil quench) showed no evidence of grain boundary etching at two magnifications 100X (Figure 17a) and 300X (Figure 18a). This is contrast to the etching in evidence at similar magnifications for the "as received" specimen from C2 (Figures 17b and 18b).

Figure 17: Low magnification photomicrograph from sample C8 - no grain boundary etching (7 minutes).

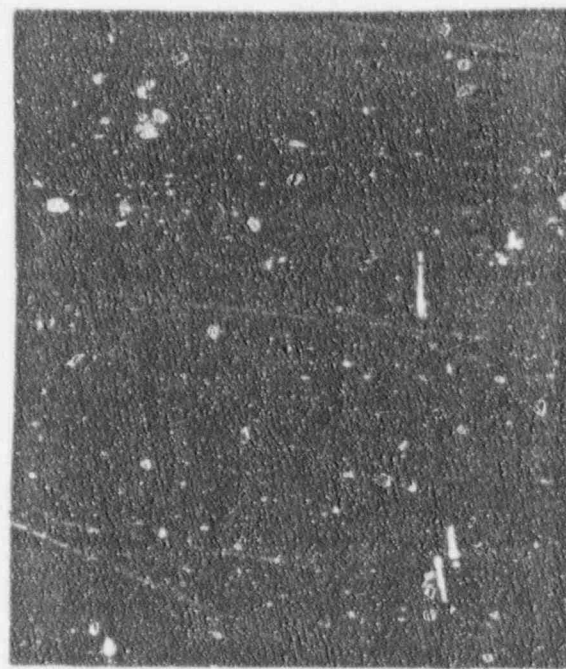
Figure 18: No evidence of grain boundary etching at higher magnification on C8 (7 minutes).

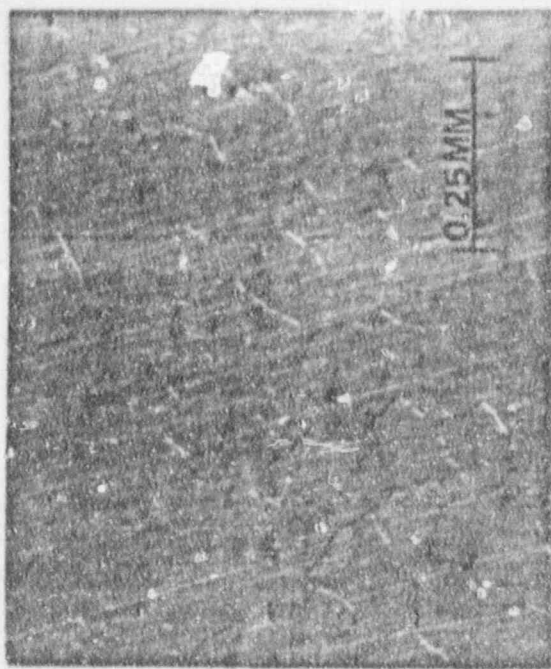
Figure 17b Grain boundary etching is evident on sample C2 specimen.

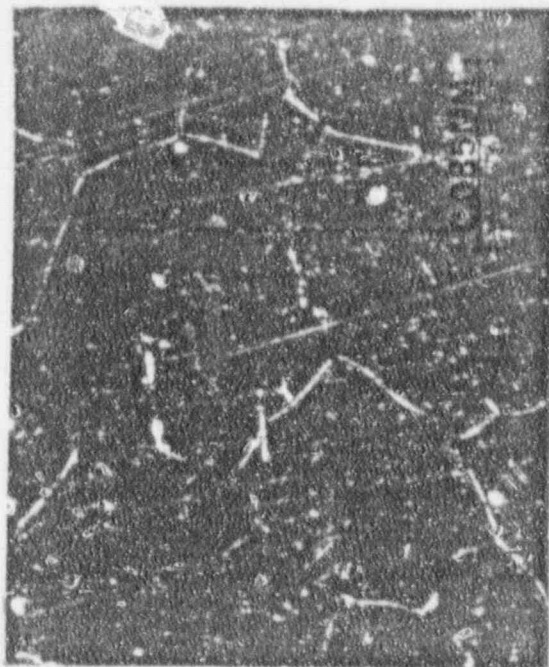
Figure 18b Grain boundaries are clearly delineated on sample C2.

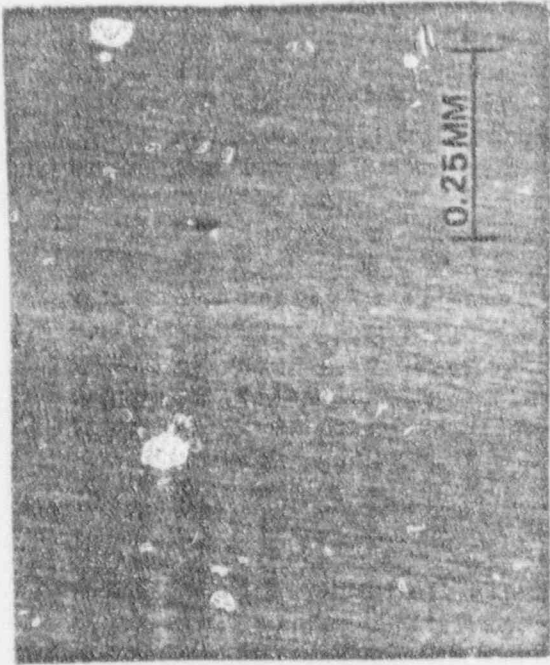
The same results were seen on the two samples after 14 minutes of etching (Figures 19a - 20b). It is evident that the etchant has the effect of highlighting the grain boundaries of embrittled martensitic 410 stainless steel, but by what exact mechanism is yet unclear. Further research should be carried out to determine if this etch can provide a consistent nondestructive test for temper embrittlement in these steels.

Figure 19a Fourteen minutes of etching did not reveal grain boundaries on specimens from C8.

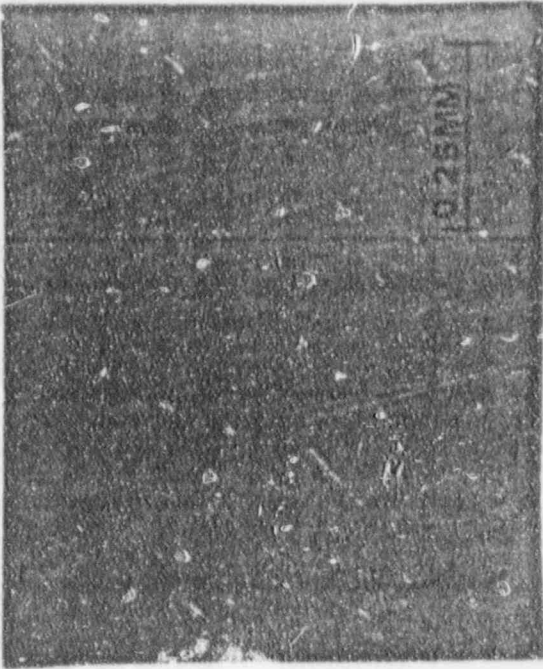
Figure 19b Grain boundaries are seen on C2 after 14 minutes of etching.

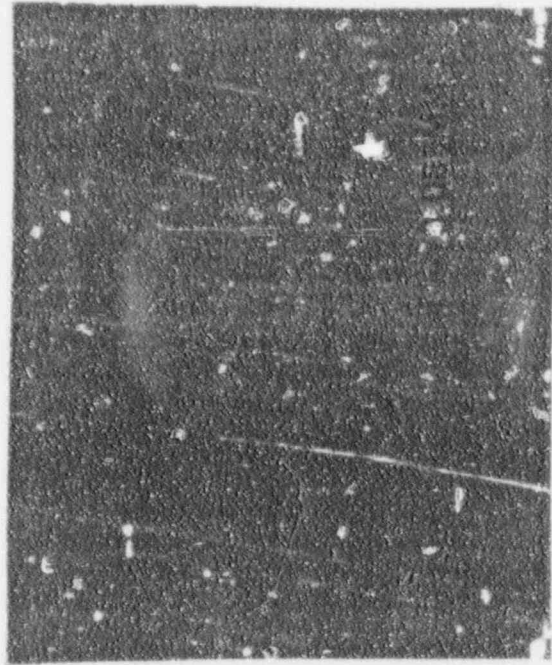
Figure 20a Higher magnification photo showing no boundary etching.

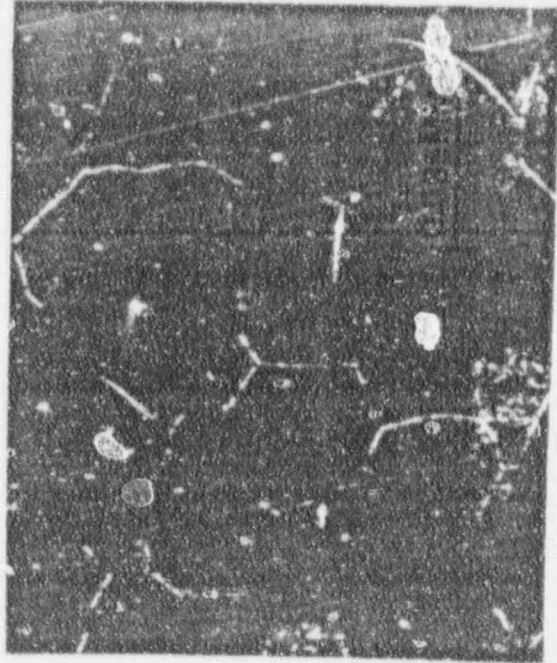
Figure 20b Grain boundaries are clearly seen on C2 at higher magnification.
