# INTERIM TECHNICAL EVALUATION REPORT

EVALUATION OF DIESEL GENERATOR FAILURE  
AT SHOREHAM UNIT 1

INTERIM REPORT ON PHASE 1, FAILURE CAUSE EVALUATION

NRC DOCKET NO. 50-322

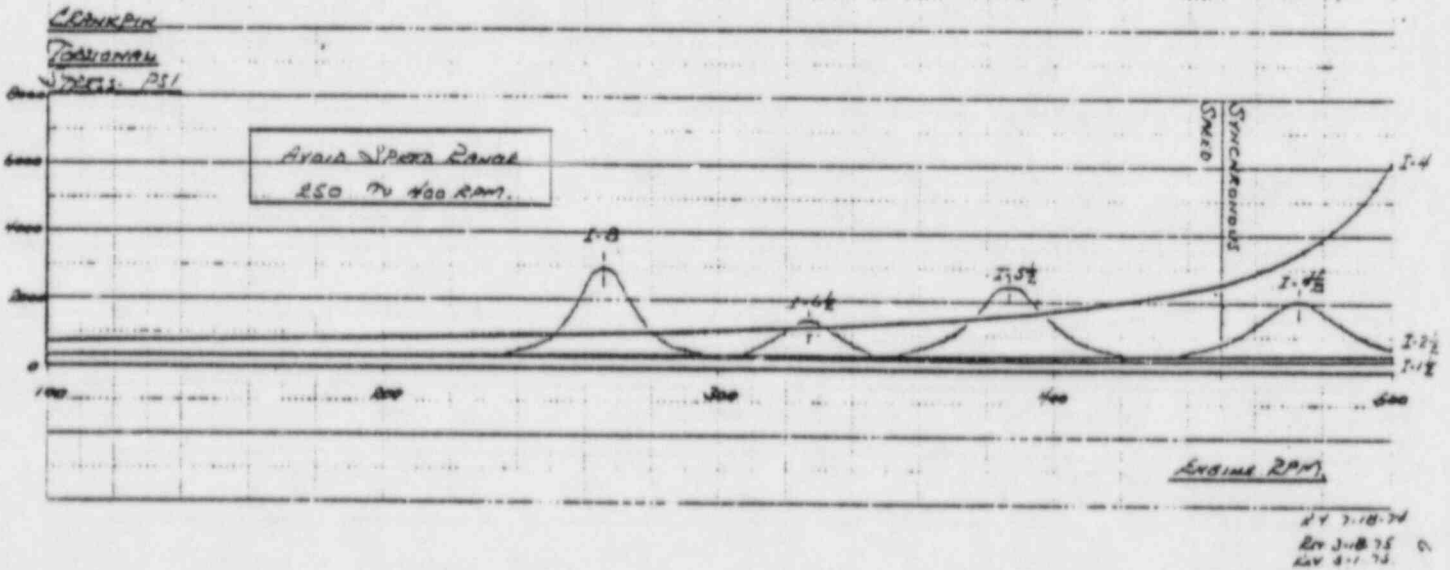
Figure 1. Torsional Stress and Critical Speeds

NATURAL FREQUENCIES:

- N<sub>1</sub> 2130 RPM
- N<sub>2</sub> 5455 "
- N<sub>3</sub> 6495 "

When received, the torsional analysis report indicated that the 30-Hz firing rate of the engine (4th order) would be sufficiently close to the first mode natural frequency, 35.5 Hz, to build moderately high amplitudes of oscillation at 30 Hz, which is one-half the electrical generation frequency. Accordingly, recommendations were made [8] to ensure that any possible electrical-mechanical interaction would not be missed by the recording of data. These recommendations are included in Appendix B.
