ARIZONA

PUBLIC SERVICE COMPANY

February 1, 1984  
ANPP-28770-EEVB/ACG

NOTICE OF VIOLATION AND PROPOSED IMPOSITION OF CIVIL PENALTIES

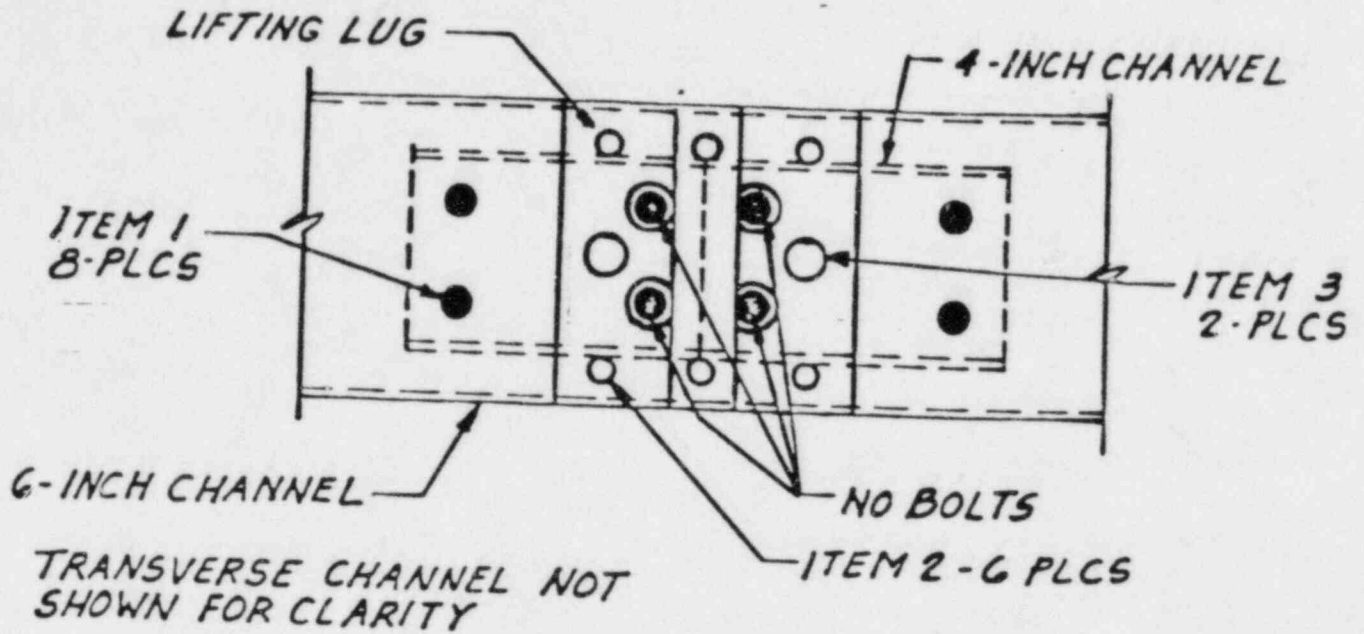
FIGURE 1 - FRONT LIFTING LUG ASSEMBLY (Two per cabinet)

Item 1 - Holes for 3/8 inch diameter mounting bolts which attach the C4 support girt to the C6 base. These bolts are required after lifting lug removal.

Item 2 - Mounting holes for the lifting lugs attachment bolts. No bolts are required after lifting lug removal.

Item 3 - Holes for 5/8-inch diameter bolts used to attach the lifting lug. These bolts are not required after lifting lug removal.

Note A - After lifting lug removal 2-5/8-inch diameter bolts (Item 3) may be installed as a substitute for the 4-3/8-inch diameter bolts (Item 1).

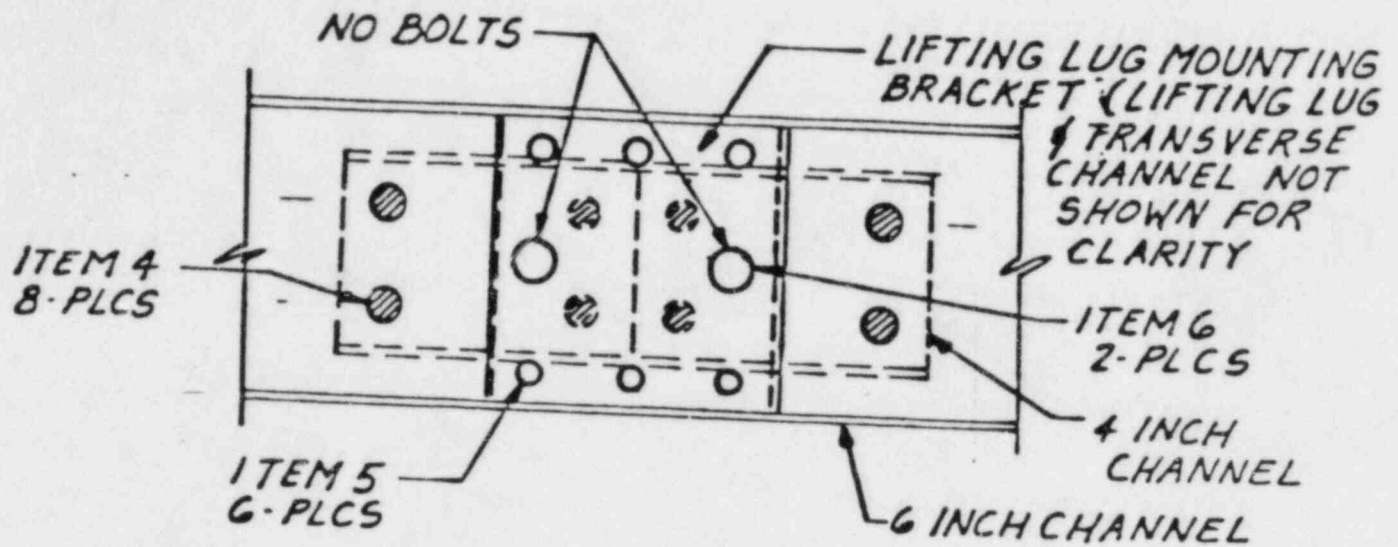
FIGURE 2 - BACK LIFTING LUG LOCATION (Two per cabinet)

Item 4 - Holes for 3/8-inch diameter mounting bolts which attach the C4 support girt to the C6 base (See Note B).

Item 5 - Mounting holes for the lifting lug attachment bolts. No bolts are required after lifting lug removal.

Item 6 - Holes for 5/8-inch diameter bolts used to attach the lifting lug. These bolts are required to be reinstalled after lifting lug removal.

Note B - The C6 lifting lug mounting bracket, which is welded in place, covers the four middle 3/8-inch diameter bolt locations. This makes installation of the middle 3/8-inch diameter bolts impossible. The two 5/8-inch diameter bolts shall be reinstalled as a substitute after lifting lug removal.

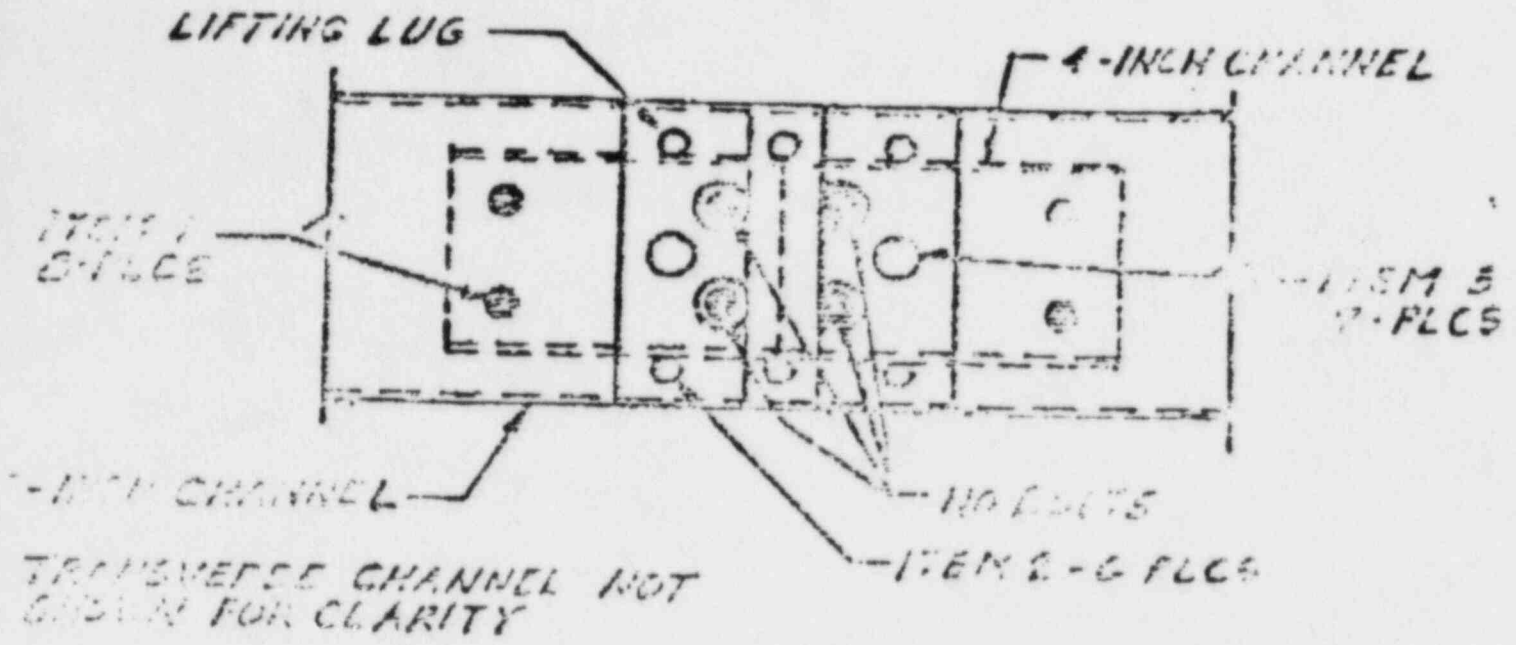
FIGURE 1 - FRONT LIFTING LUG ASSEMBLY (Two per cabinet)

Item 1 - Holes for 3/8 inch diameter mounting bolts which attach the lifting lug to the cabinet. These bolts are required after lifting lug removal.

Item 2 - Mounting holes for the lifting lug attachment bolts. No bolts are required after lifting lug removal.

Note: After lifting lug removal 2-1/2 inch diameter bolts (Item 3) can be installed as a substitute for the 4-3/8-inch diameter bolts (Item 1).

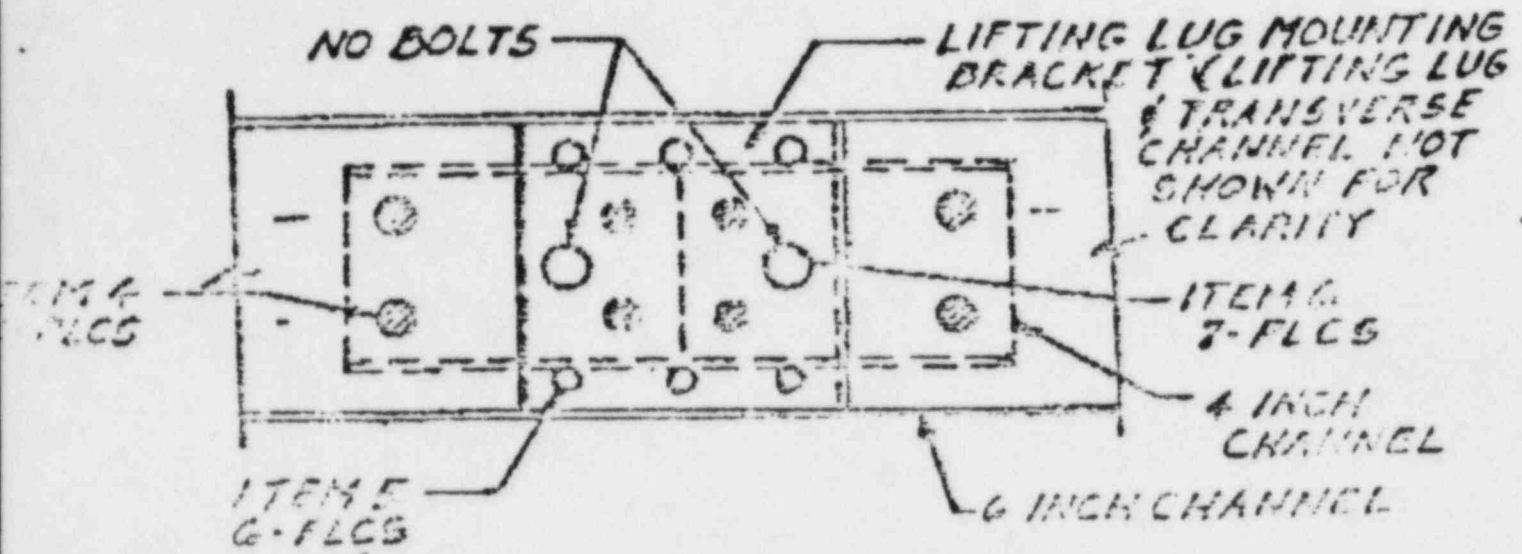
FIGURE 2 - BACK LIFTING LUG LOCATION (Two per cabinet)

Item 4 - Holes for 3/8-inch diameter mounting bolts which attach the CE support skirt to the CE base (See Note E).

Item 5 - Mounting holes for the lifting lug attachment bolts. No bolts are required after lifting lug removal.

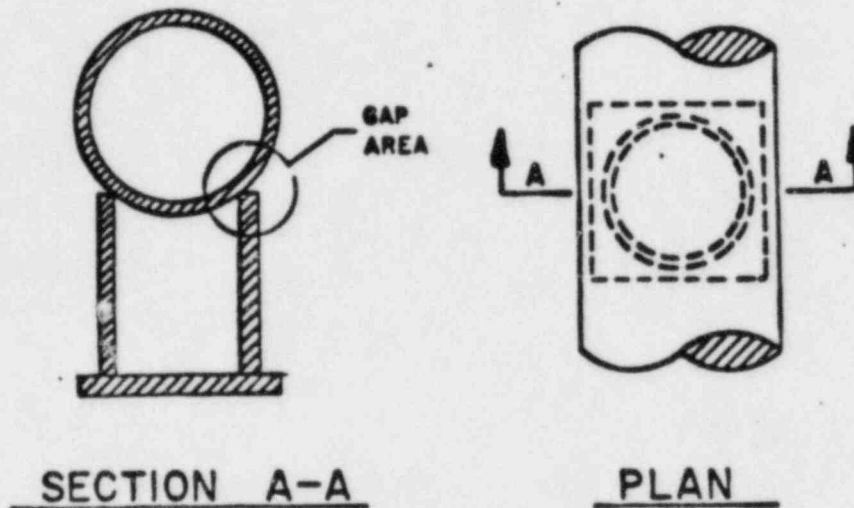
FIGURE 1

arise when a pipe stanchion or a pipe lug is prepared to fit up to a pipe (see Figure 1).

As shown in Section A-A of Figure 1, the normal fit-up of pipe spools and support stanchions leaves a gap between the inside and outside diameters of the stanchions. Although the design drawing specified the pipe spool to support stanchion attachment weld to be an all-around

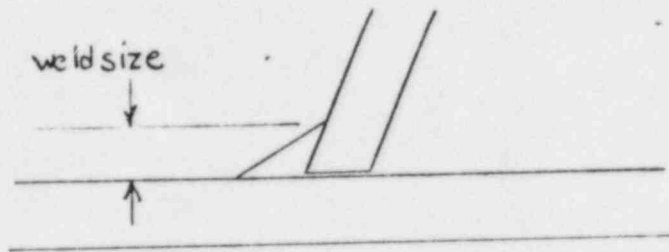
The AWS D.1.1 Code 1974 shows, in Figure 2.7.1, that skewed fillet welds are measured thus:

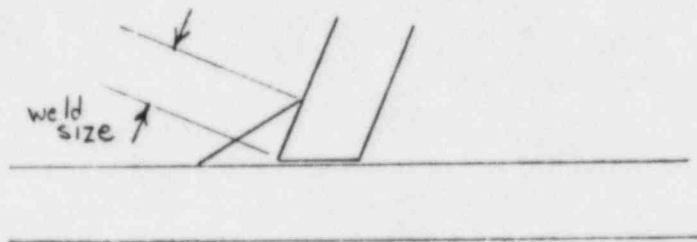
At Palo Verde the QC Engineer states weld are "measured" as shown below (it is not clear how this is "measured" since there is no access to one of the measurement points):

To "measure" by the Palo Verde method to a given size (e.g., 5/16 inch on a 120-degree weld) will result in an undersize weld by the Code definition (in this case by 3/64 inch). Nonetheless, QC inspectors are required by WPP/QCI 201.1 to inspect to AWS D.1.1 criteria for this weld. The AWS D.1.1 criteria are clear and are not superceded by verbal instructions from engineering.

The failure of welding QC to identify pipe support weld conditions which are not in accordance with the drawing or welding code requirements is an apparent violation of NRC regulations(OII 50-528/83-34-02).
